December 8, 2022

Project Reference #19270

**RE: Additional PCB Investigation, Sediment Sampling, and Sewer Level Monitoring
South Marina Drive Storm Sewer
Milwaukee, Wisconsin
BRRTS No. 02-41-587190 and FID No. 341331430**

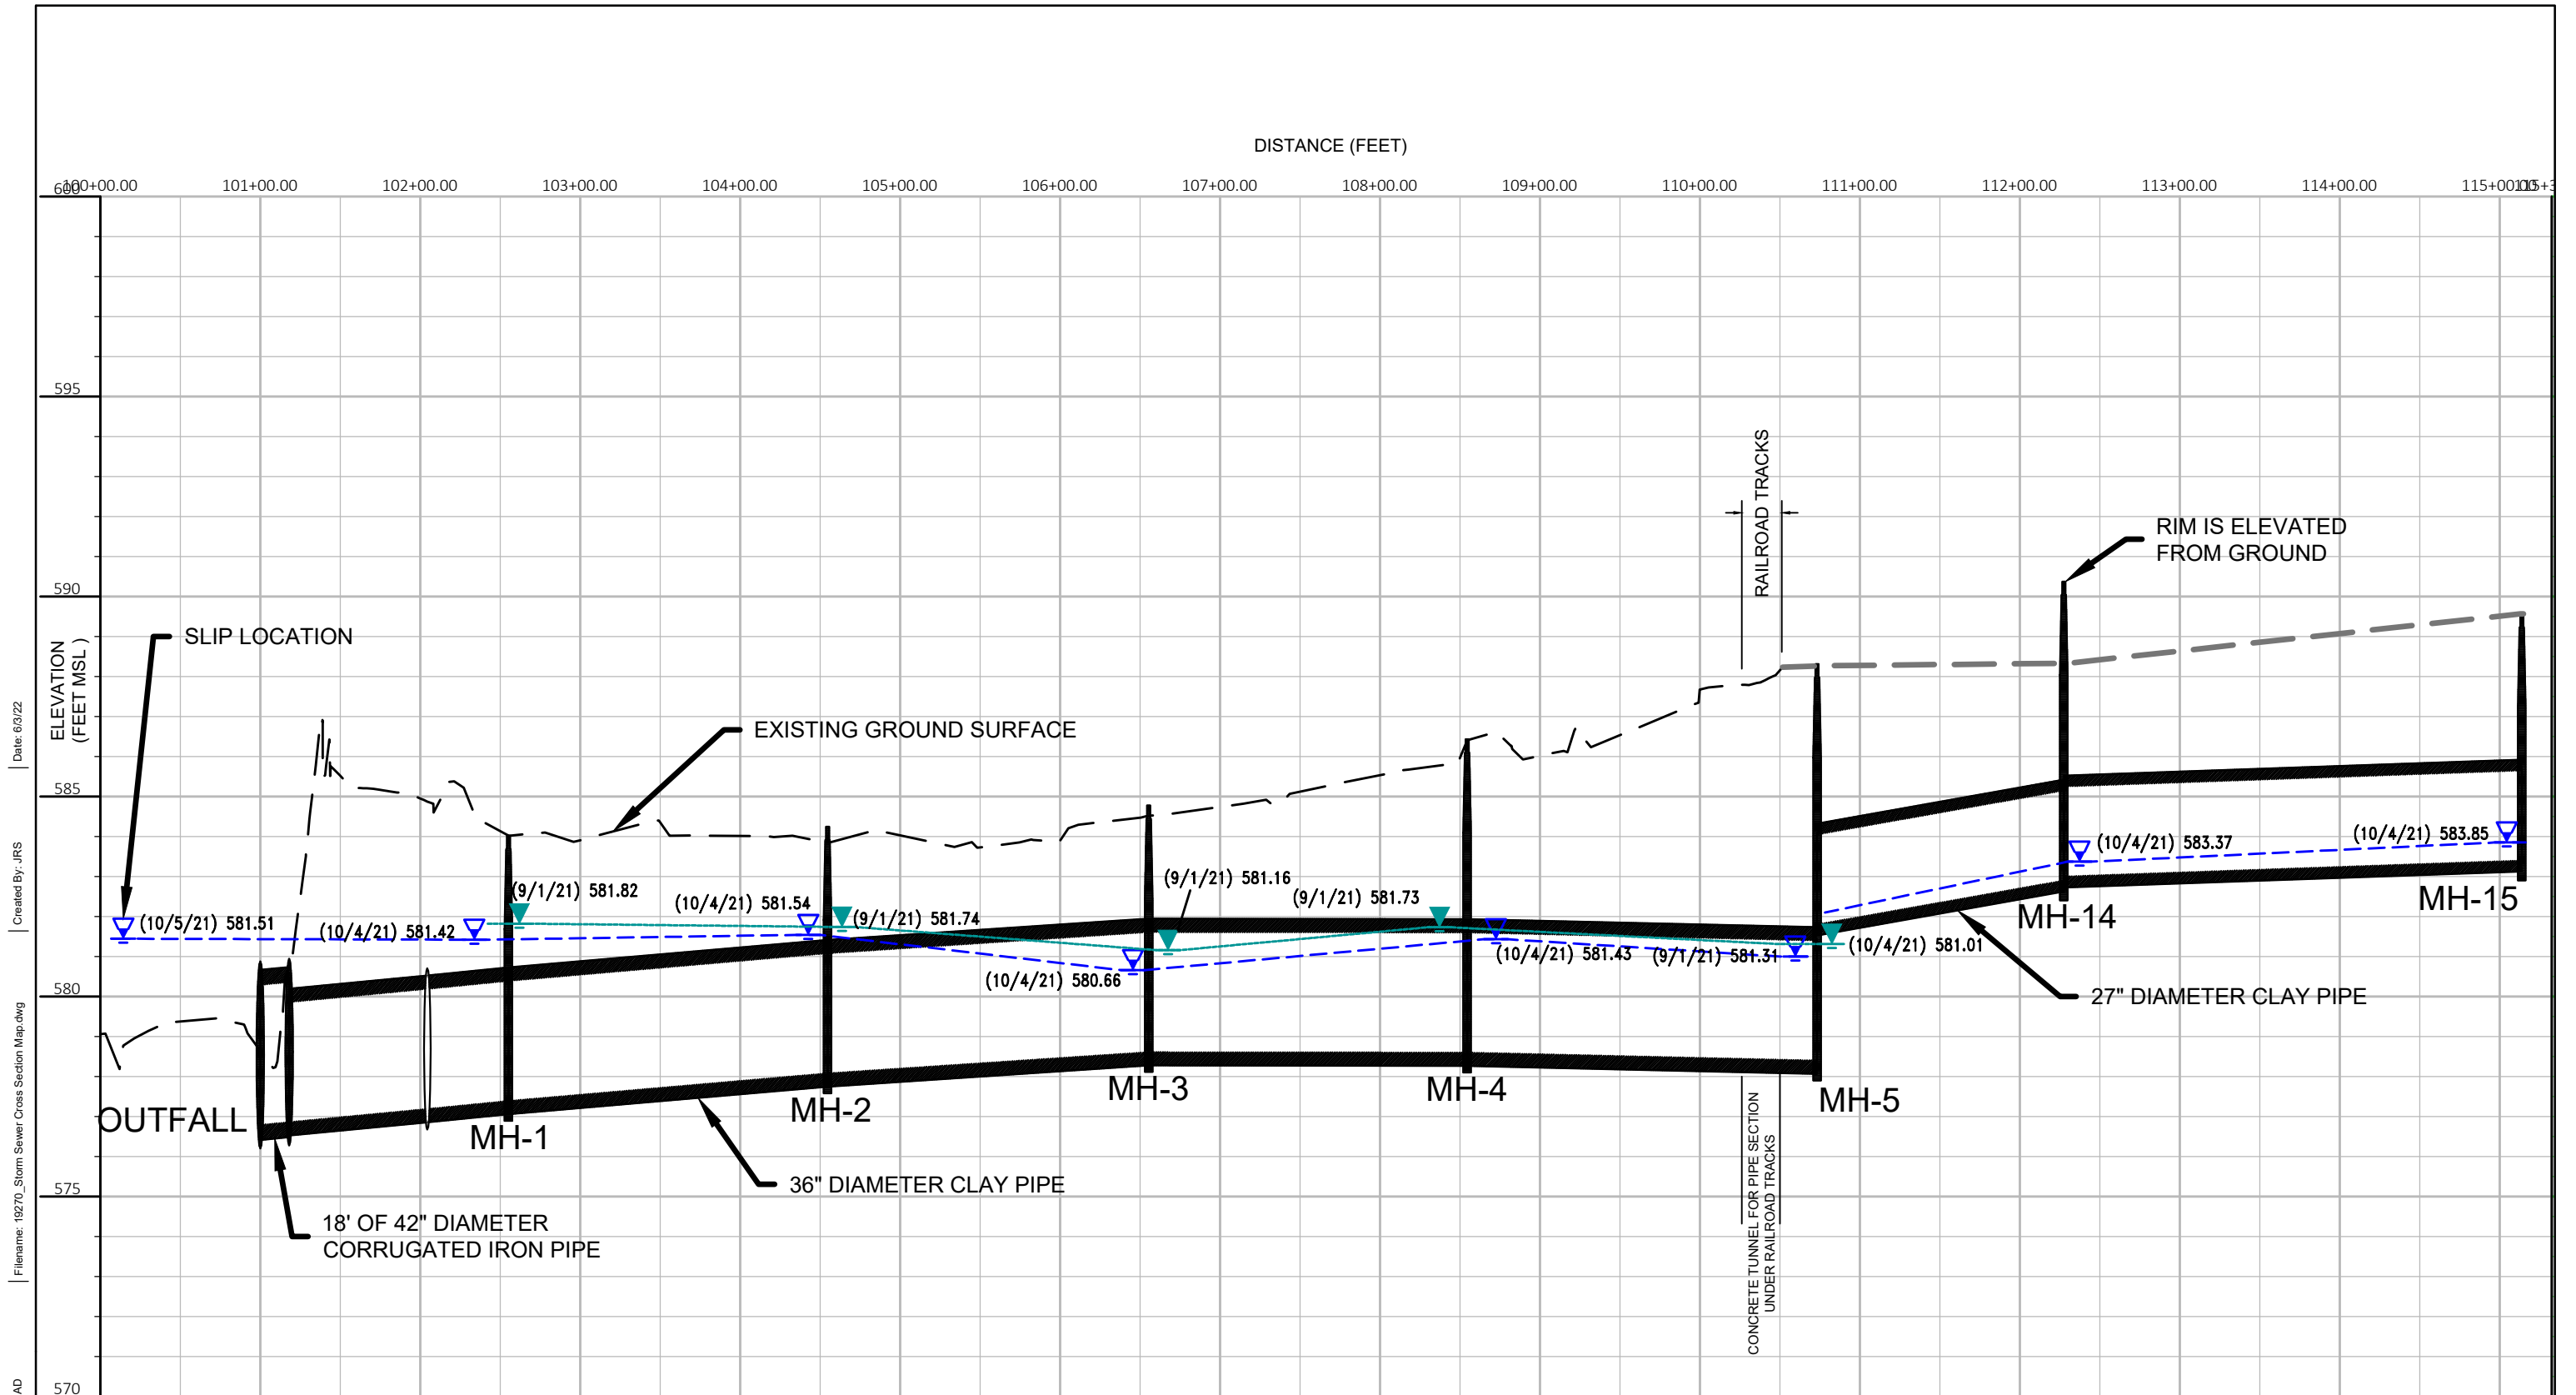
FIGURE
6

The bottoms of the manholes MH-14 and MH-15 are elevated approximately 4.7 to 5.3 feet above the inverts of the pipes connecting manholes MH-1 through MH-5, and the water column in the October 2021 sampling round was measured to be between only 0.1 feet (MH-15) and 0.2 feet (MH-14). A cross section showing the alignment of the storm sewer from the slip to manhole MH-1, and manholes MH-1 to MH-15 is provided as **Figure 6**. This cross section depicts the difference in elevation between the inverts between manholes MH-14 and MH-15, and the north-south inverts from manholes MH-1 to MH-5.

STORM SEWER CROSS SECTION
(SLIP TO MH-15)
 SOUTH MARINA DRIVE STORM SEWER
 PCB CLEANUP PROJECT
 MILWAUKEE, WISCONSIN

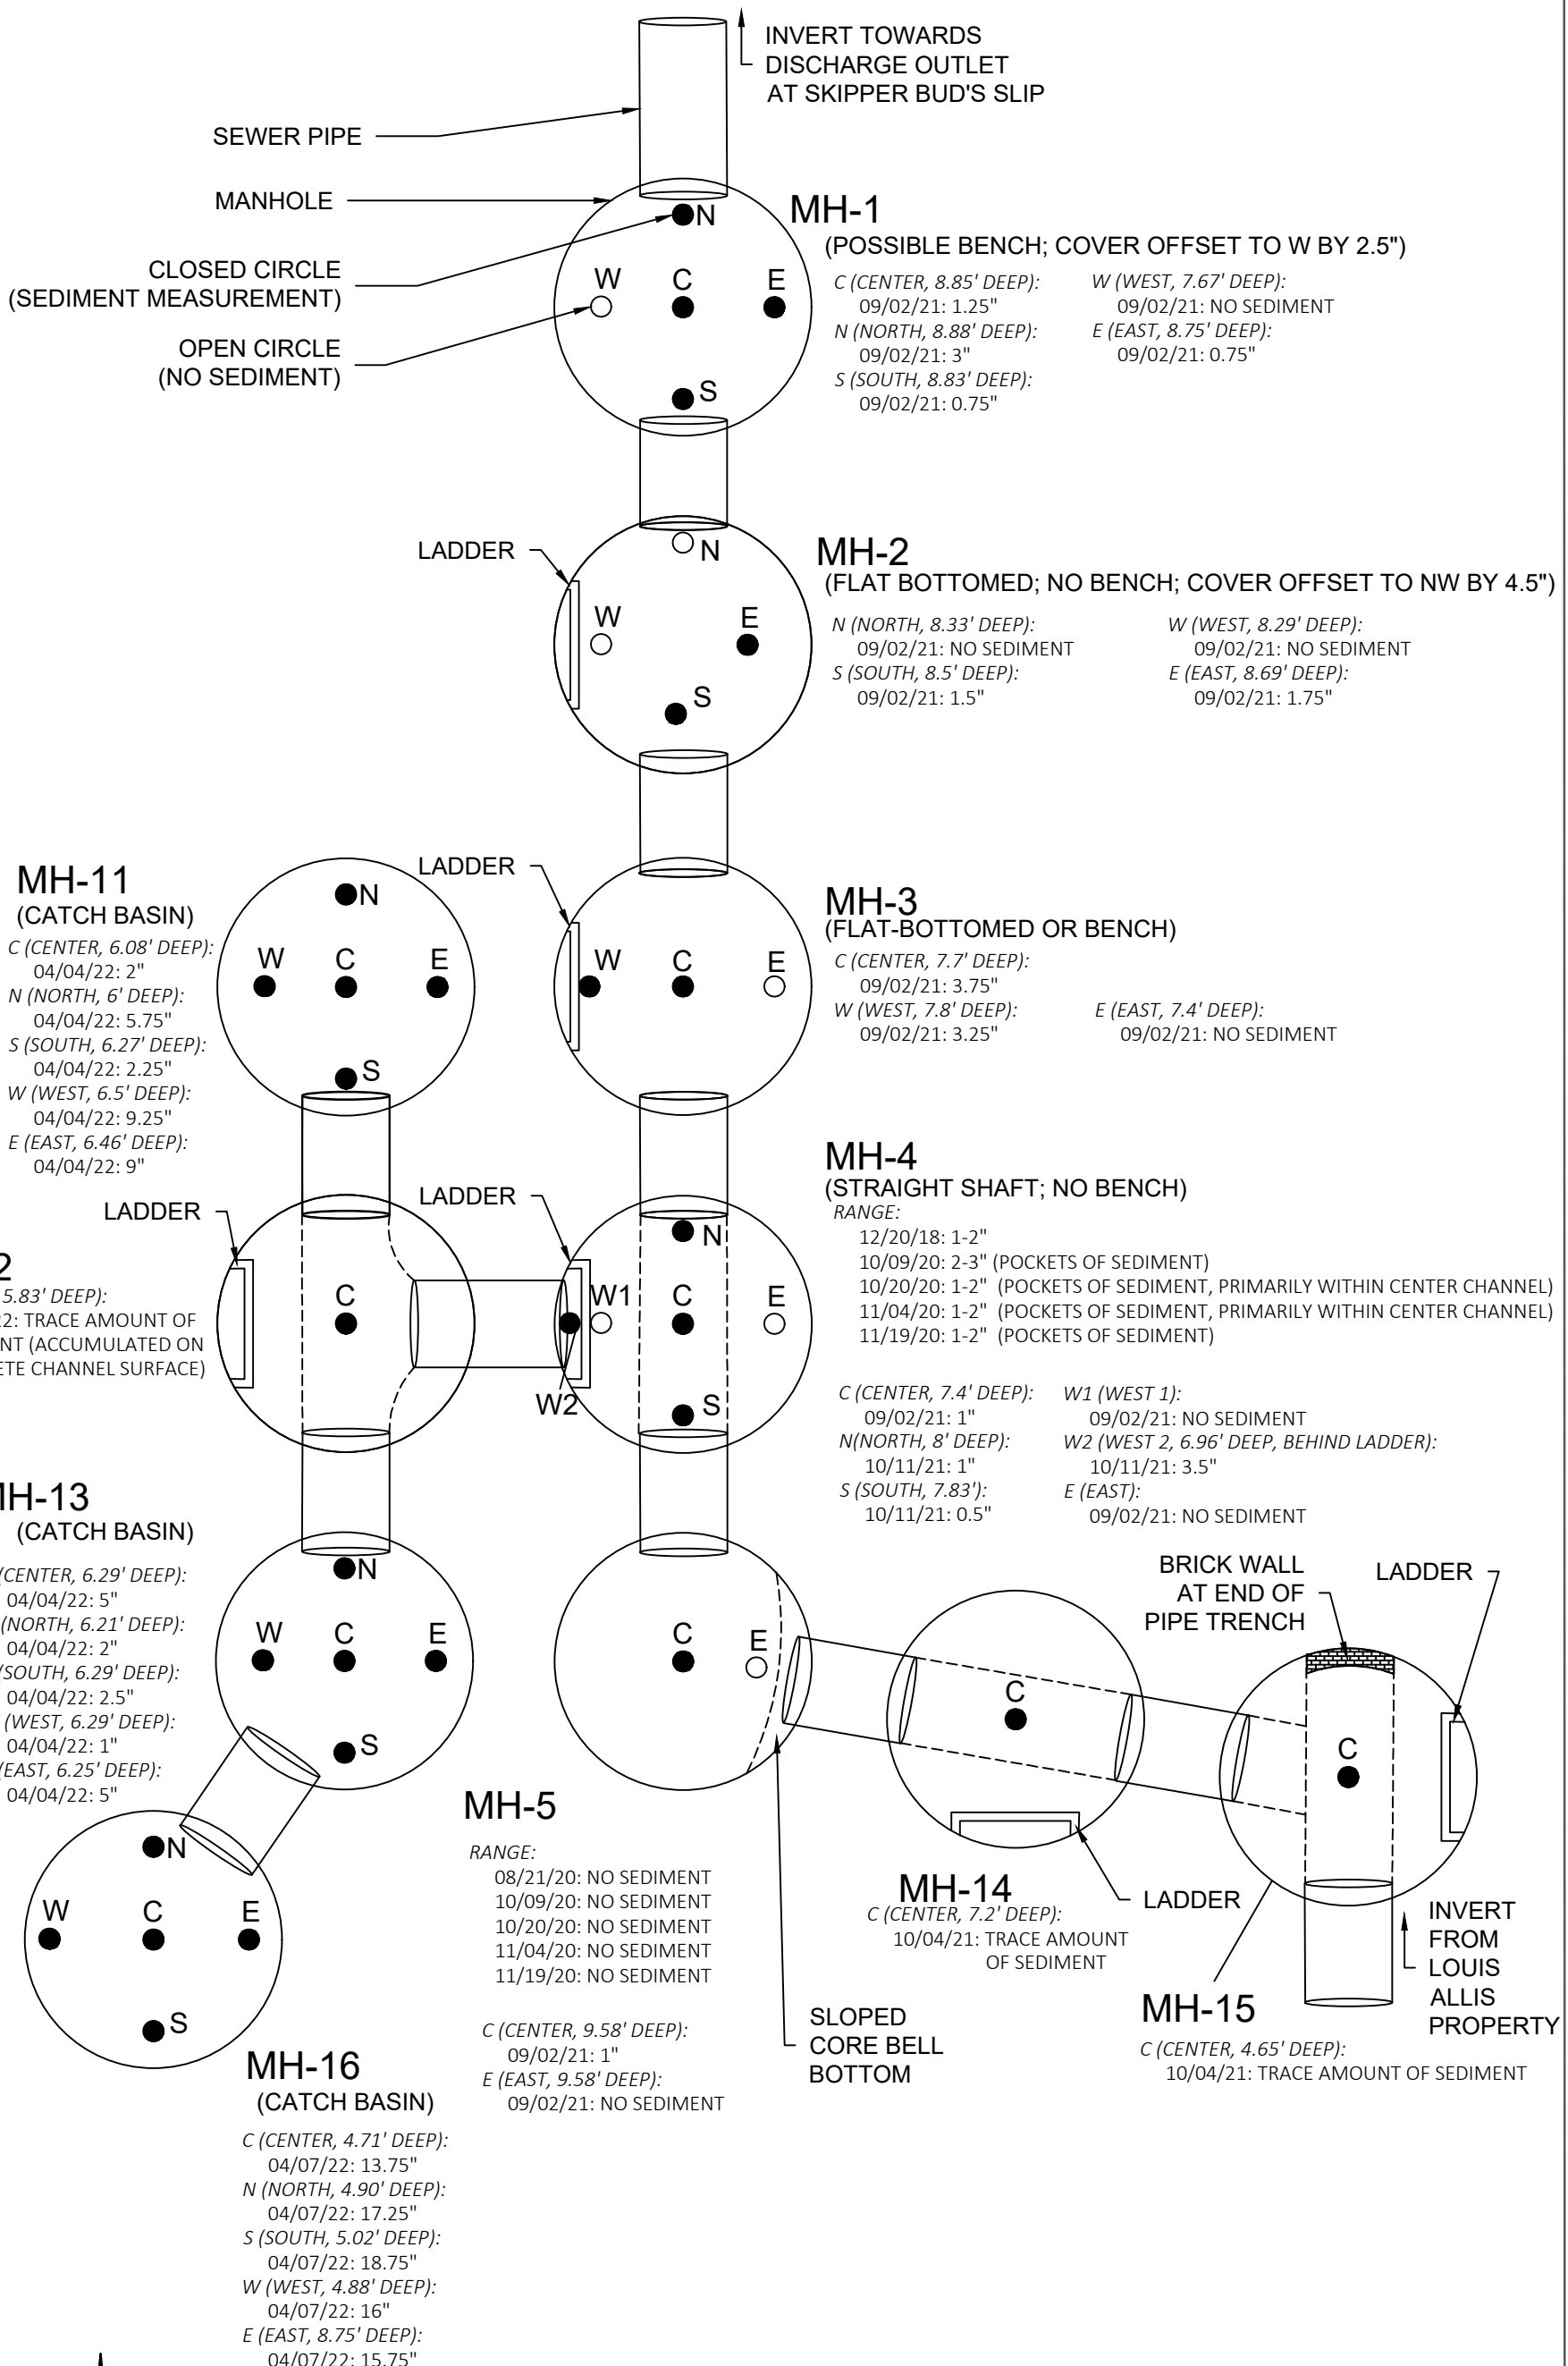
Details of the sediment observation are presented within **Table 1**. The sediment measurements are shown as **Figure 7**.

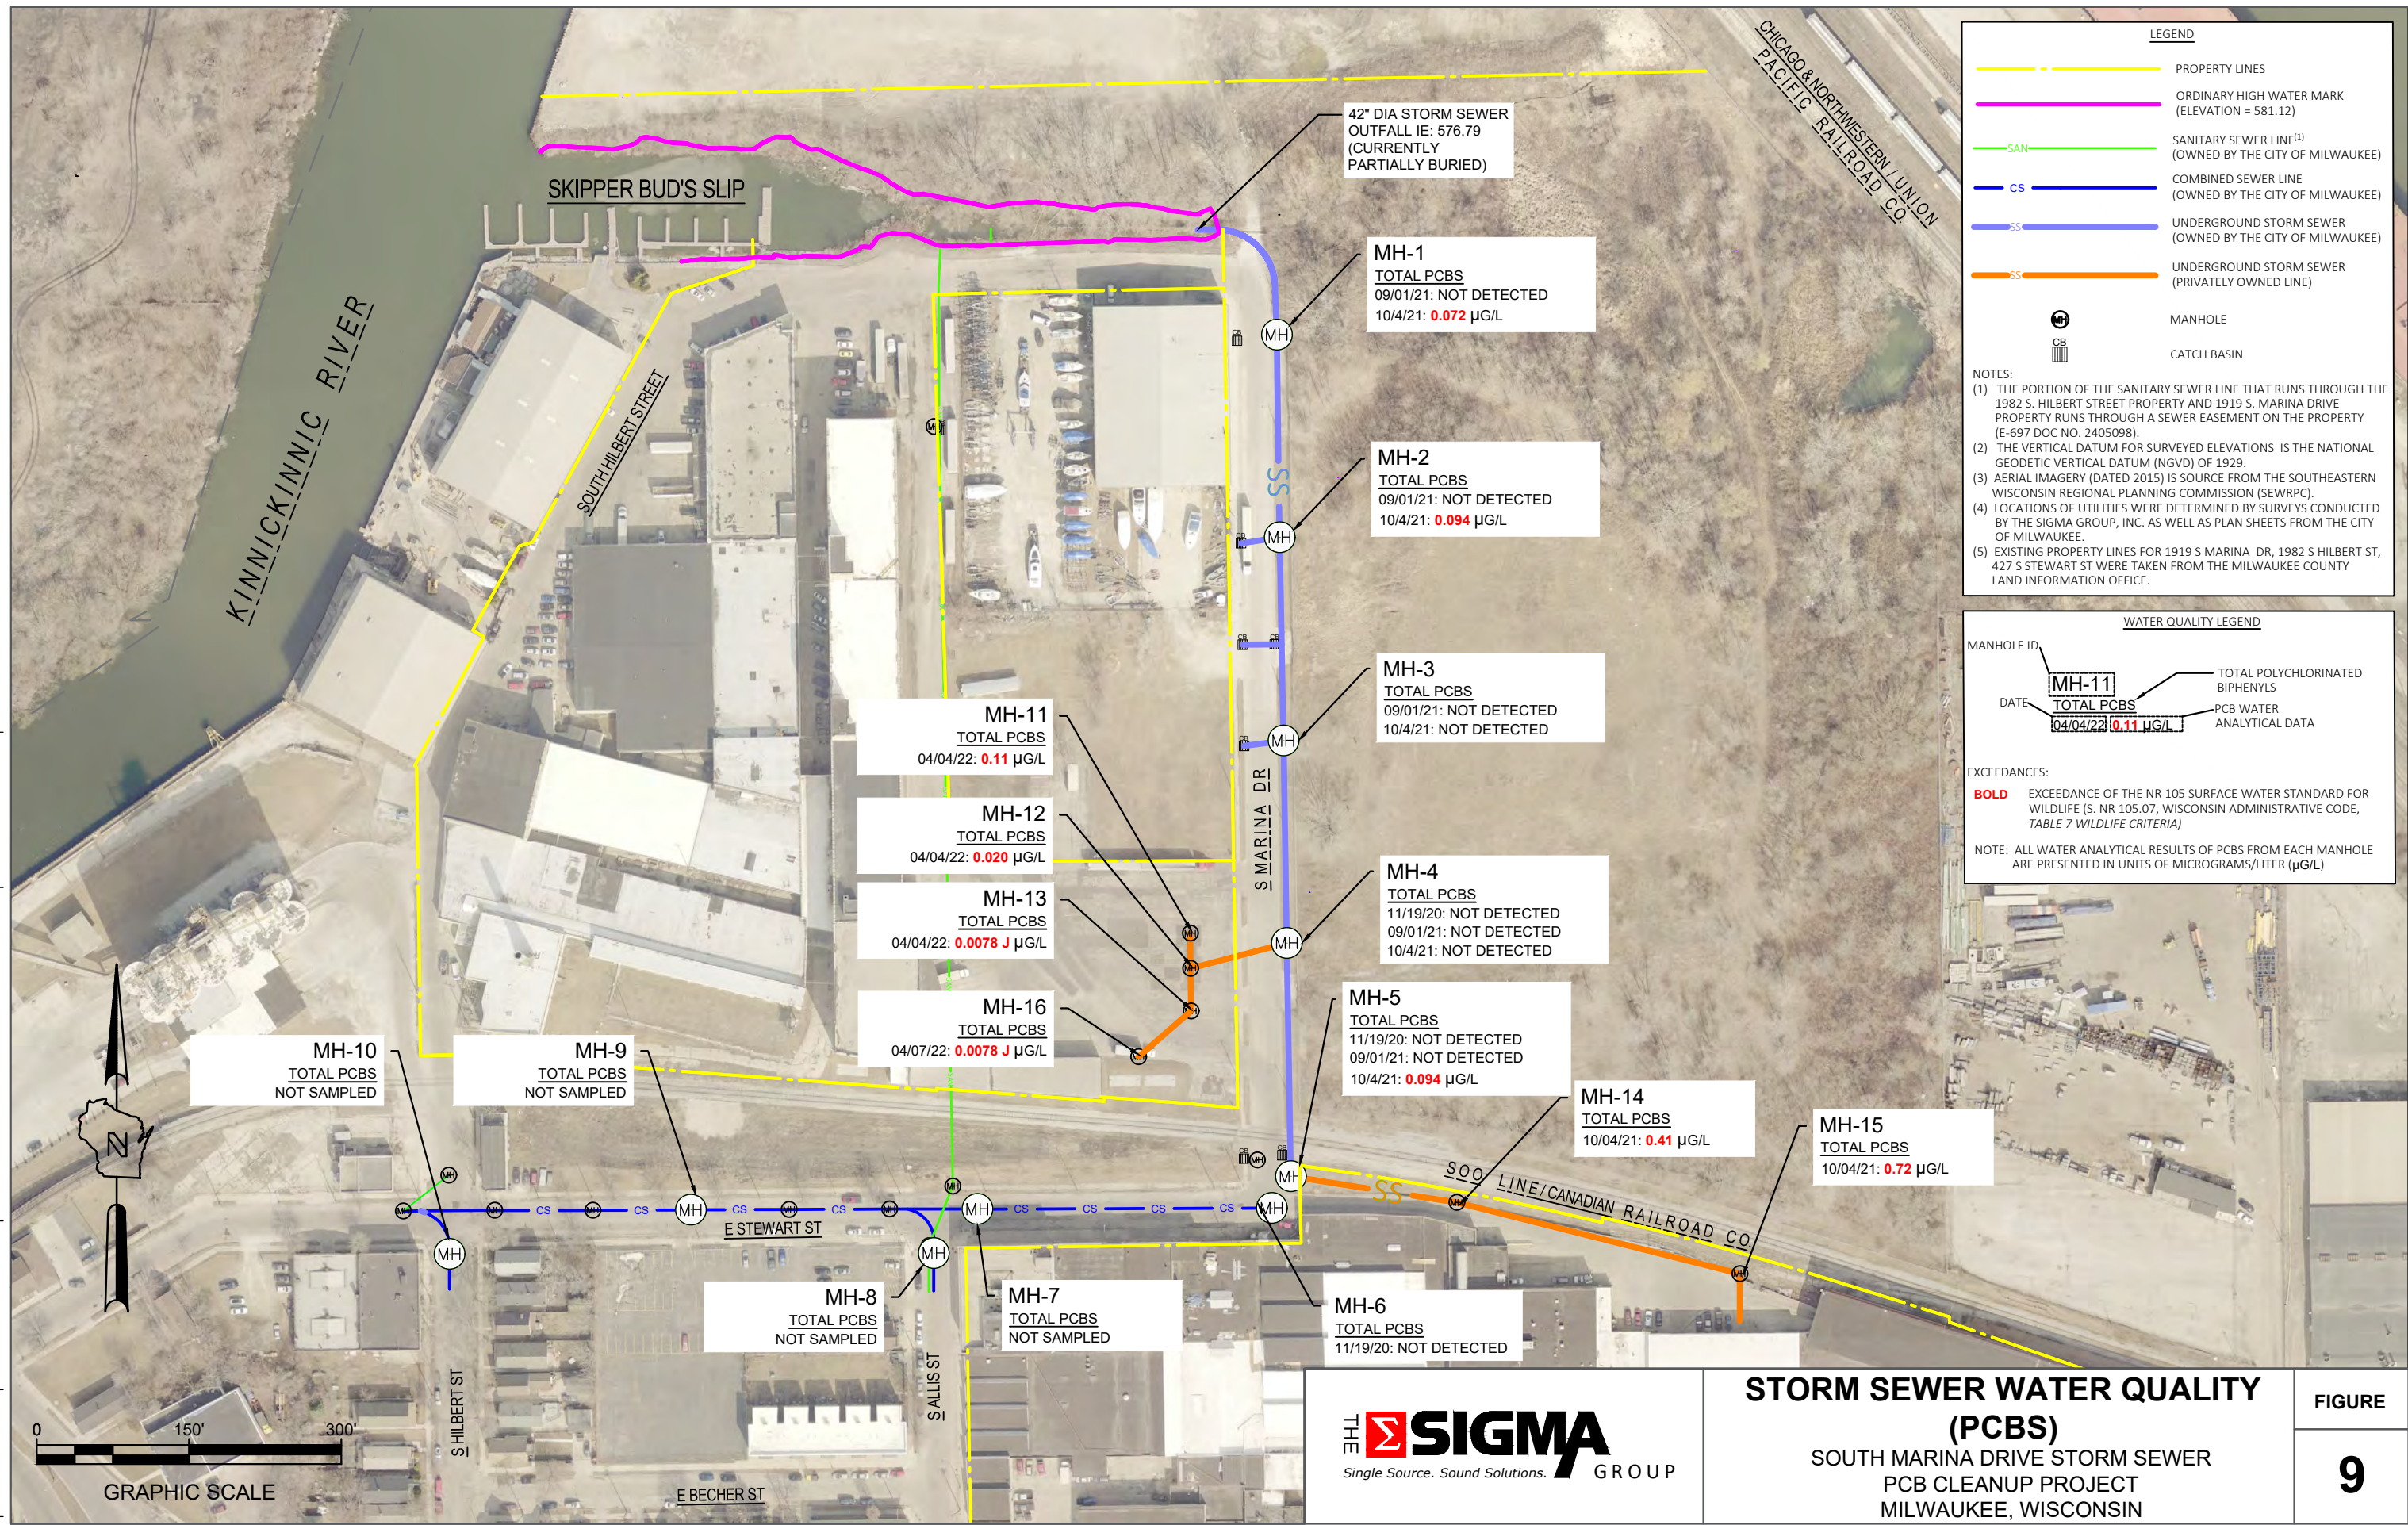
FIGURE
9

Attached **Figure 9** presents the distribution of PCBs detected within manhole water samples collected at the Site. Copies of the laboratory analytical reports for water samples collected from September 2021 through April 2022 are included as **Attachment 5**. (The initial September 2021 water samples was included on the same chain-of-custody as the sediment samples and is included in the lab report in **Attachment 4**.)

STORM SEWER WATER QUALITY (PCBS)
 SOUTH MARINA DRIVE STORM SEWER
 PCB CLEANUP PROJECT
 MILWAUKEE, WISCONSIN

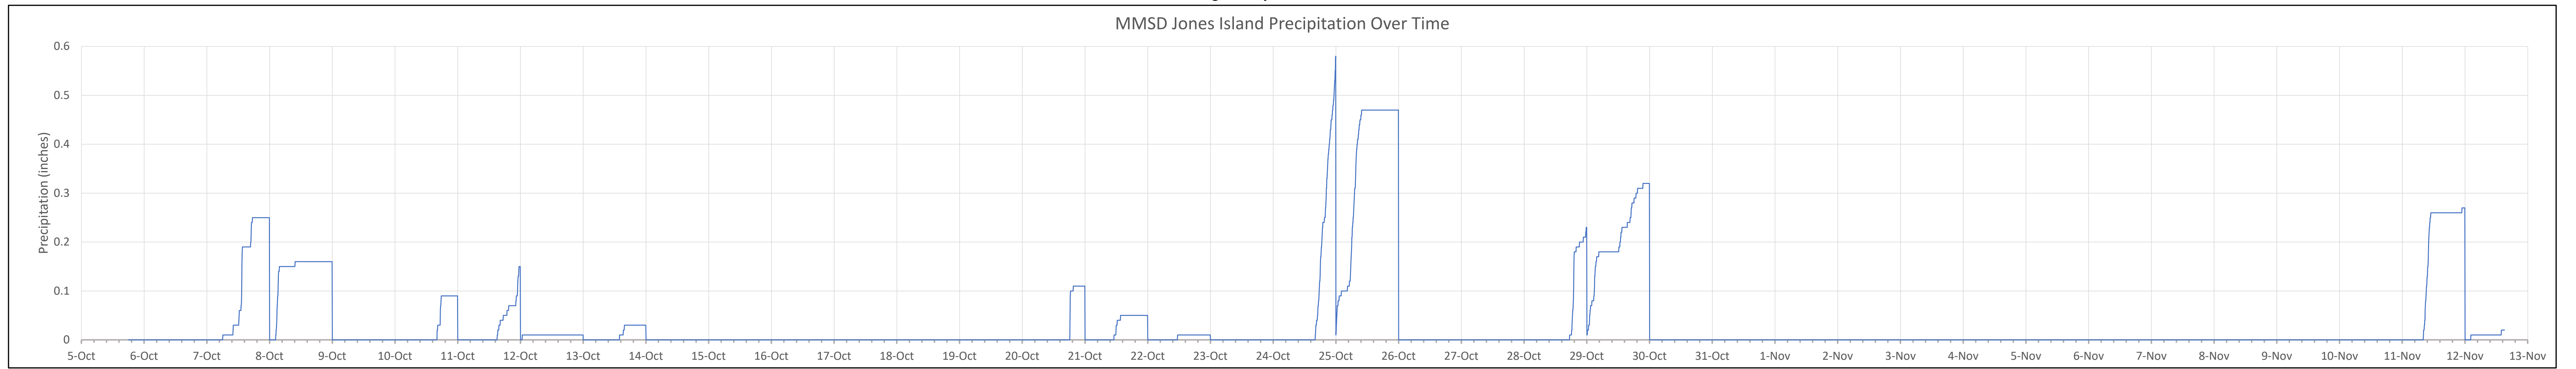
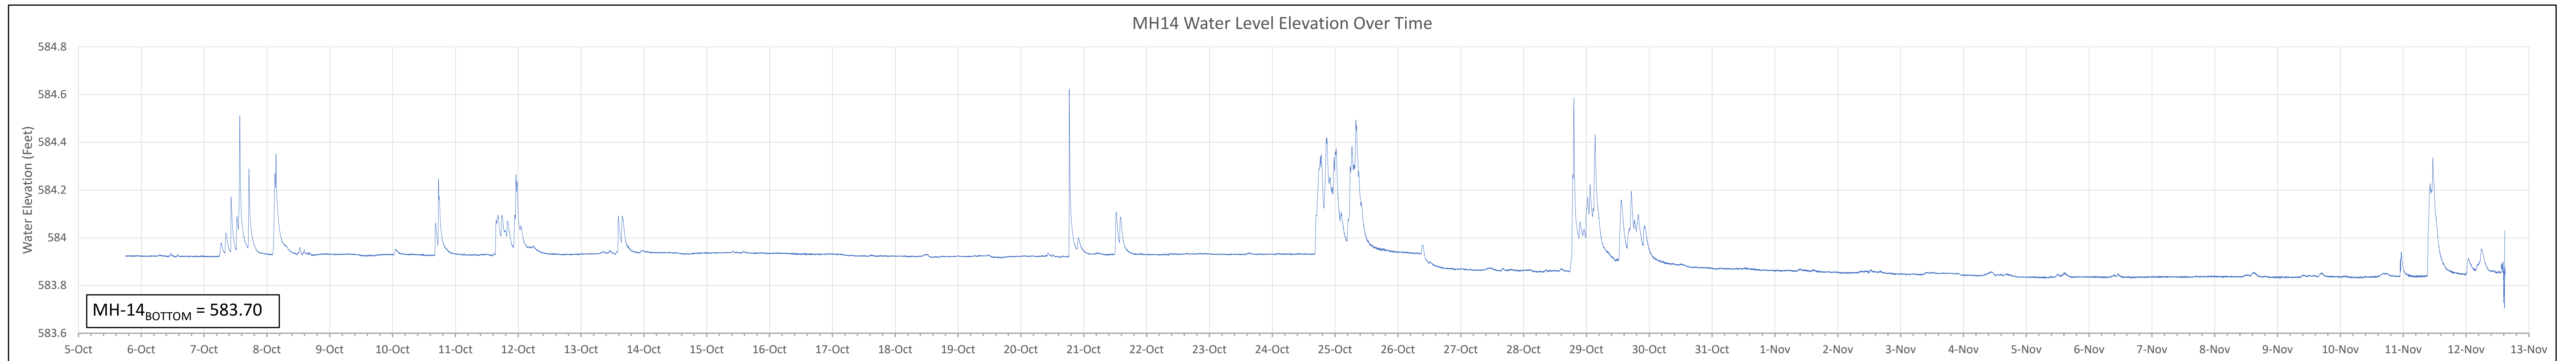
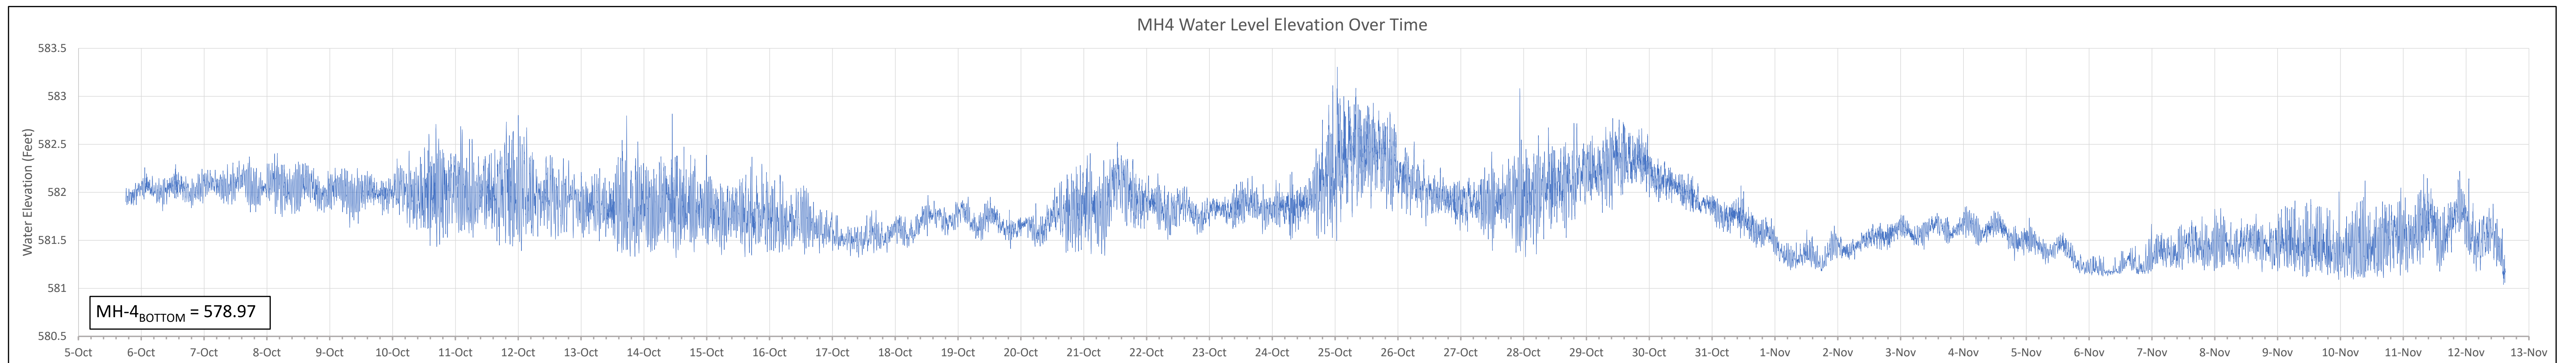
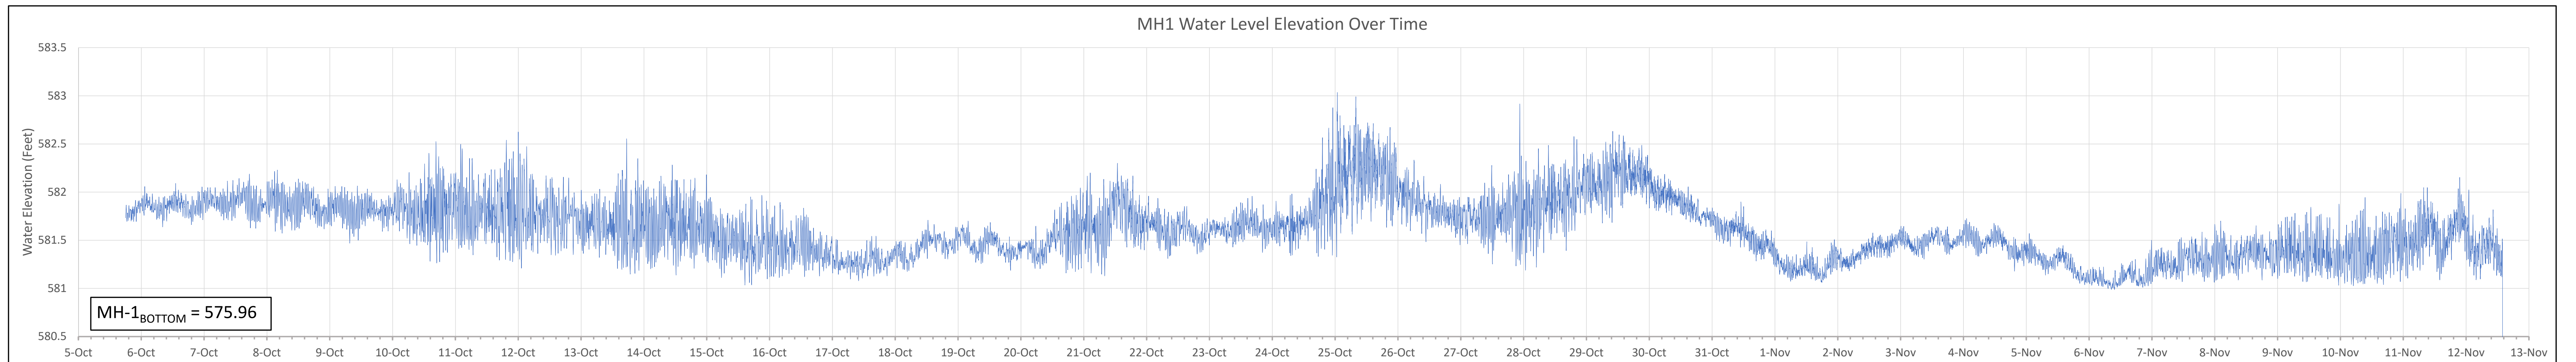
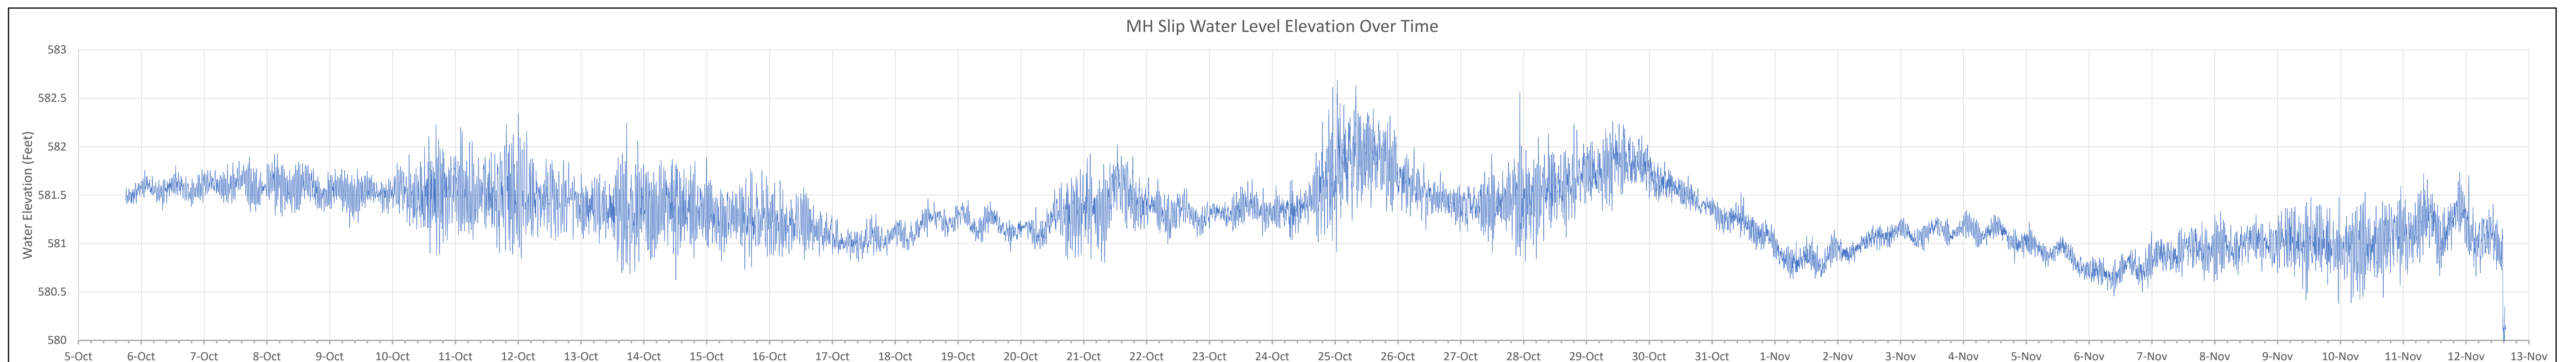
Figure 11. MH Water Elevation Data Over Time
South Marina Drive Storm Sewer
Sigma Project No. 19270

The water levels measured over the month-long recording period were compared with precipitation data collected from the MMSD's Jones Island location to determine if changes in the water level within the Skipper Bud's slip could potentially causing inflow in the storm sewer and resulting sediment deposition upstream of the outfall. This plot is shown on **Figure 11**.

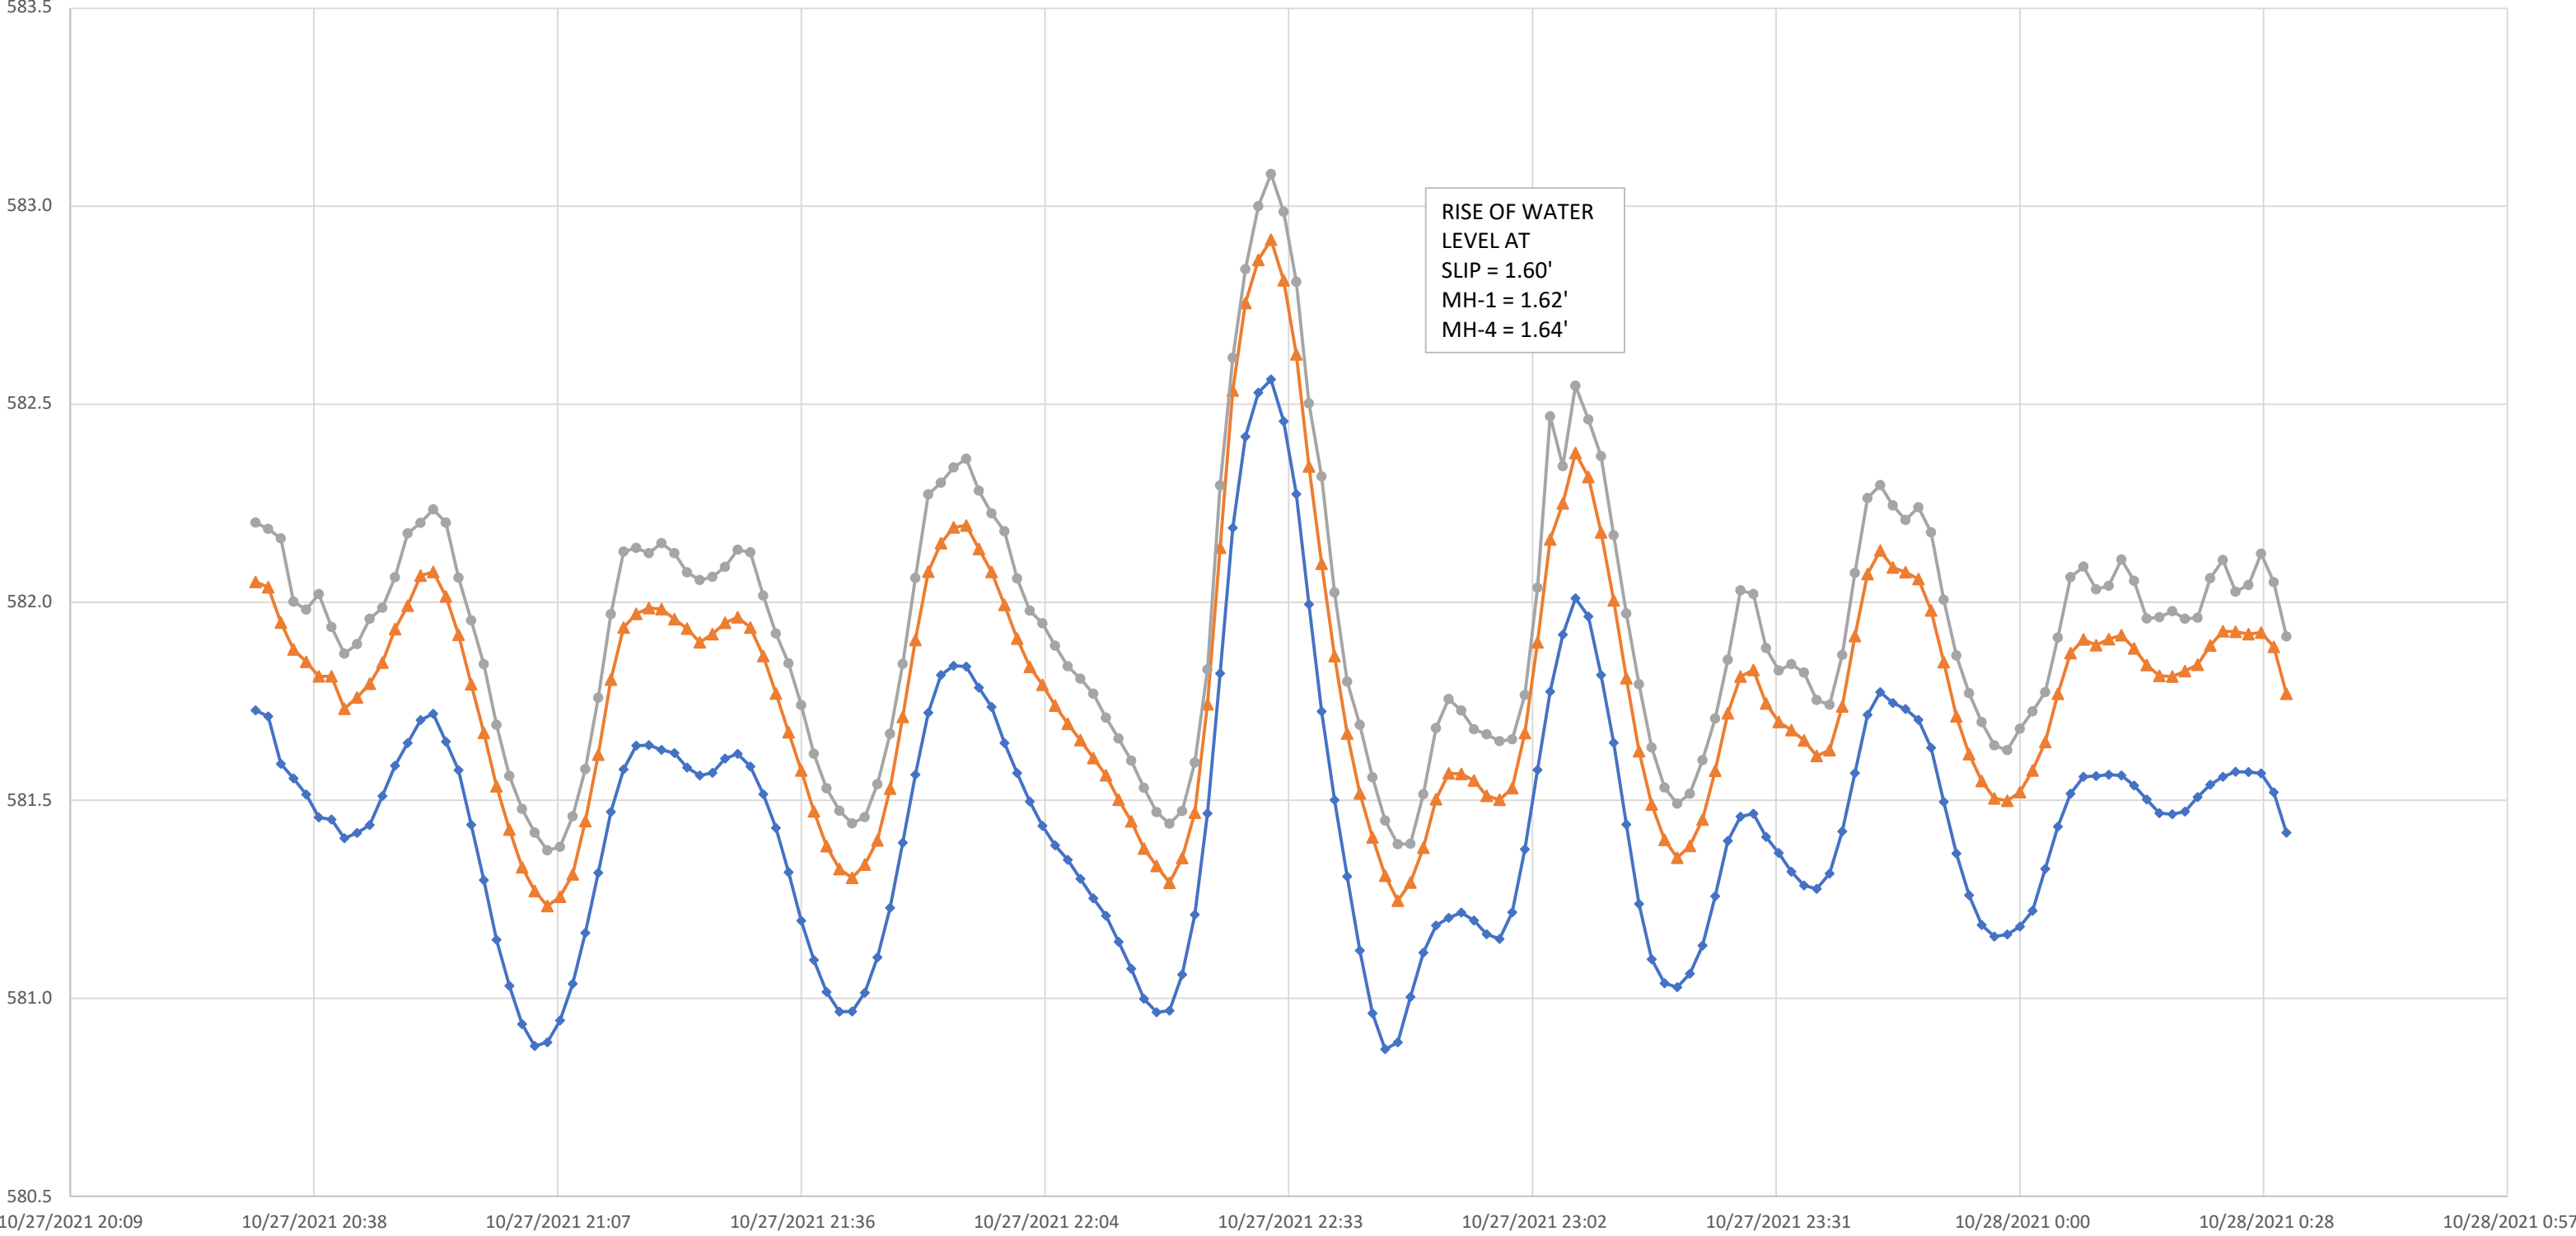
FIGURE 12. WATER LEVEL RISE ON A DRY EVENING

A single event was identified in October 2021, where a water level rise occurred within the manholes during a dry day. The water level rose approximately 1.60 to 1.64 feet at the slip, manhole MH-1, and manhole MH-4. This sudden increase in the water level may be attributed to a surge of unknown origin within the system. This plot is shown on **Figure 12**.

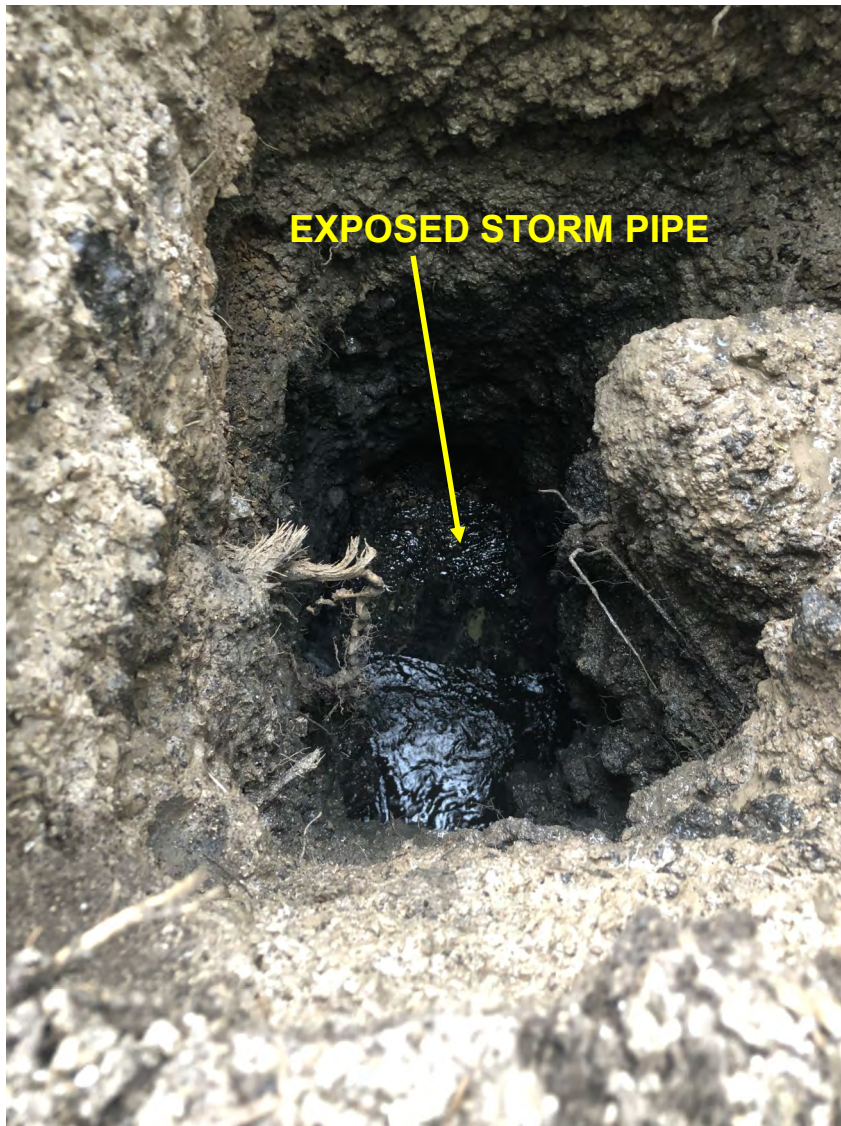
Photo 2: The open HydroVac excavation northeast of manhole MH-1. View to west; photograph taken on September 20, 2021.

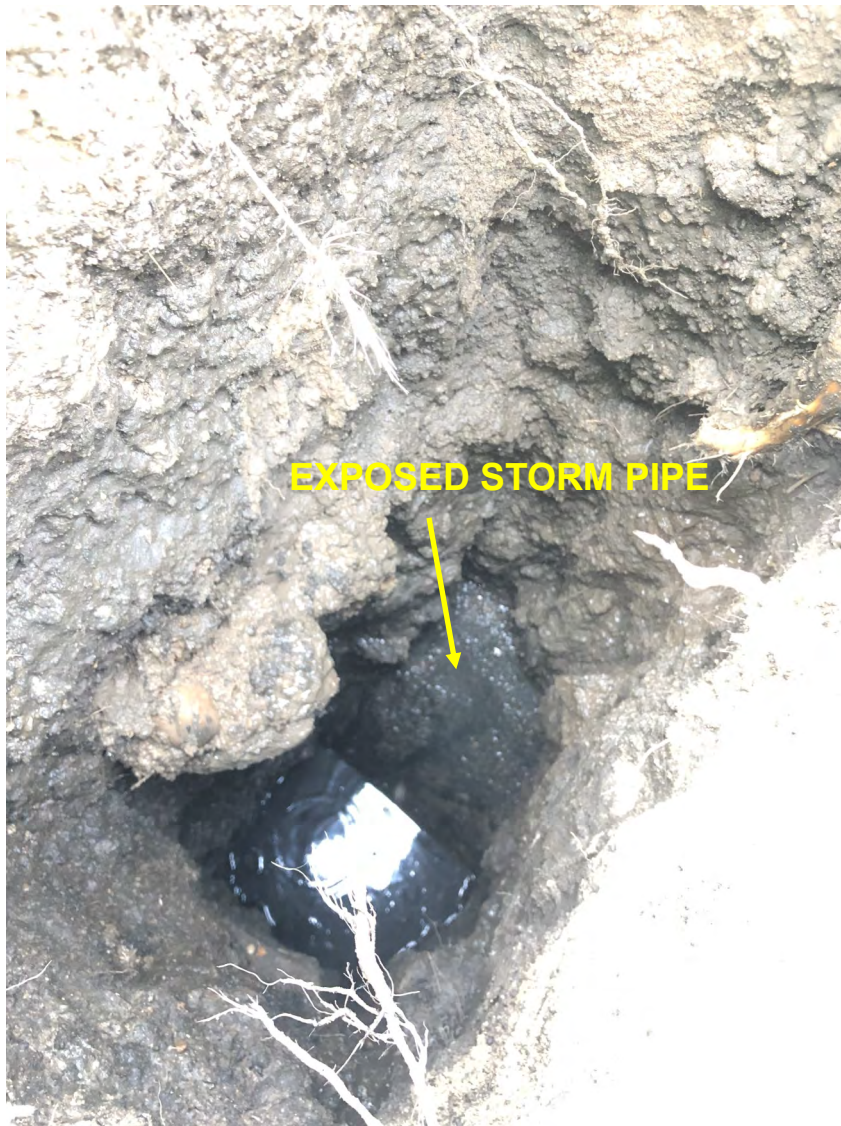
Photo 12: The open HydroVac excavation northeast of manhole MH-3. Exposed stormwater pipe. View to west; photograph taken on September 20, 2021.

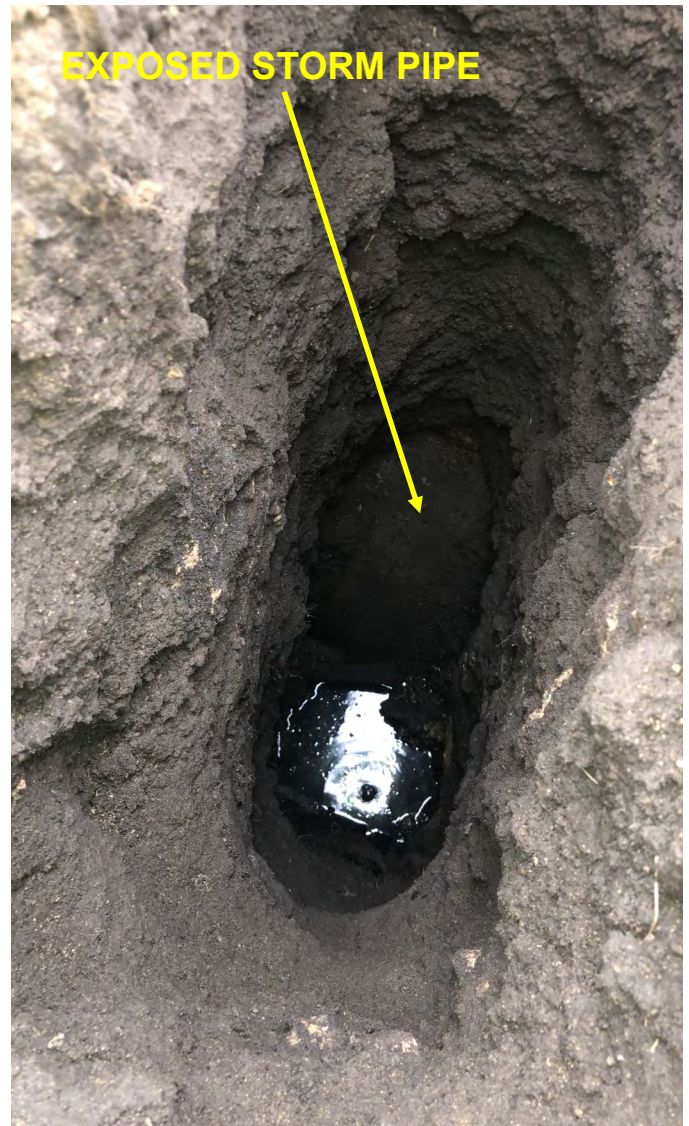
Photo 16: The open HydroVac excavation northeast of manhole MH-4. Exposed stormwater pipe. View to west; photograph taken on September 20, 2021.

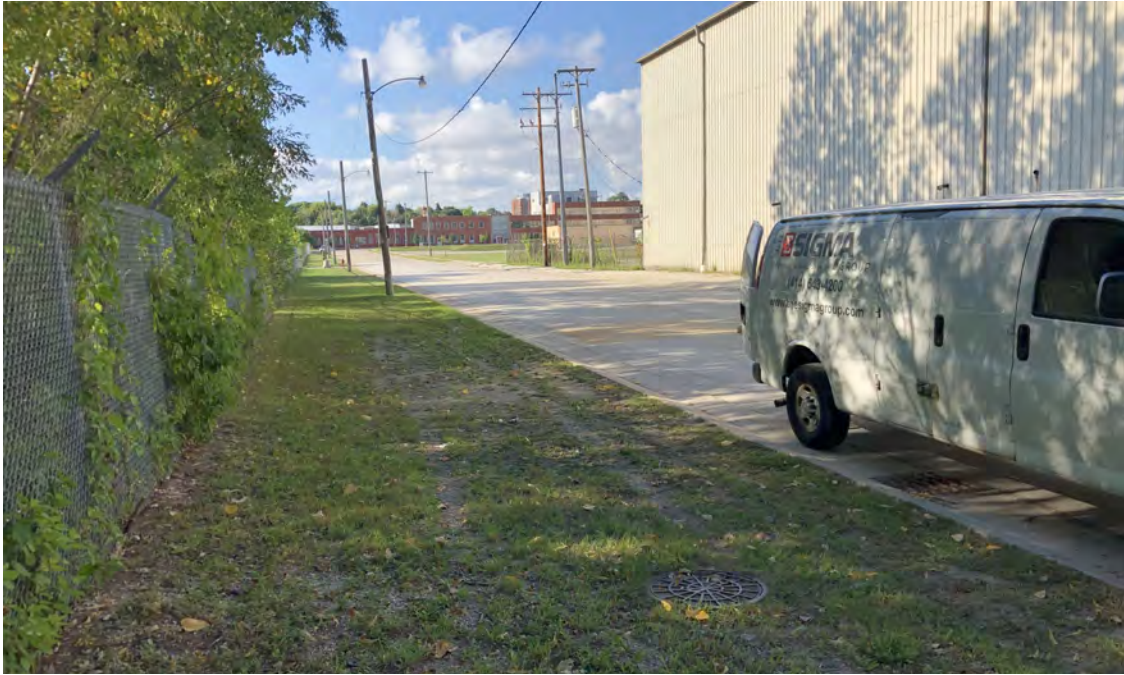
Photo 1: Manhole MH-1 within grass east of South Marina Drive. View to south; photograph taken on September 1, 2021.
