December 8, 2022

Project Reference #19270

**RE: Additional PCB Investigation, Sediment Sampling, and Sewer Level Monitoring
South Marina Drive Storm Sewer
Milwaukee, Wisconsin
BRRTS No. 02-41-587190 and FID No. 341331430**

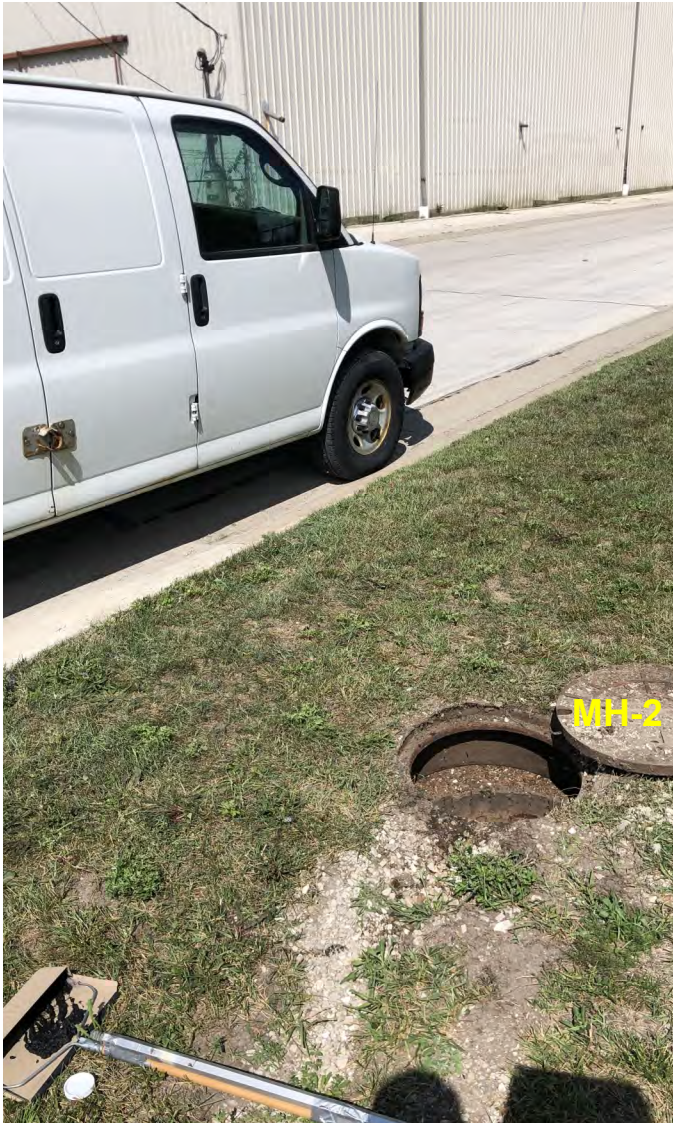
Photo 3: Manhole MH-2 within grass east of South Marina Drive. View to northwest; photograph taken on September 1, 2021.

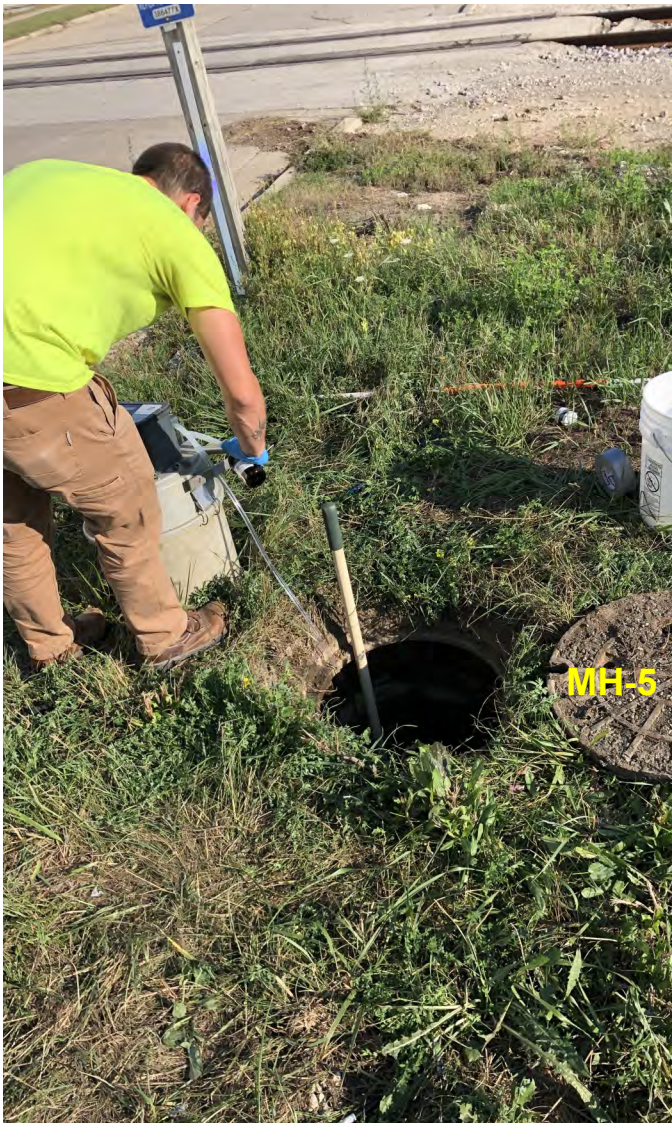
Photo 8: Water within manhole MH-5 (located in grass east of South Marina Drive) being sampled with peristaltic pump. View to northwest; photograph taken on September 2, 2021.

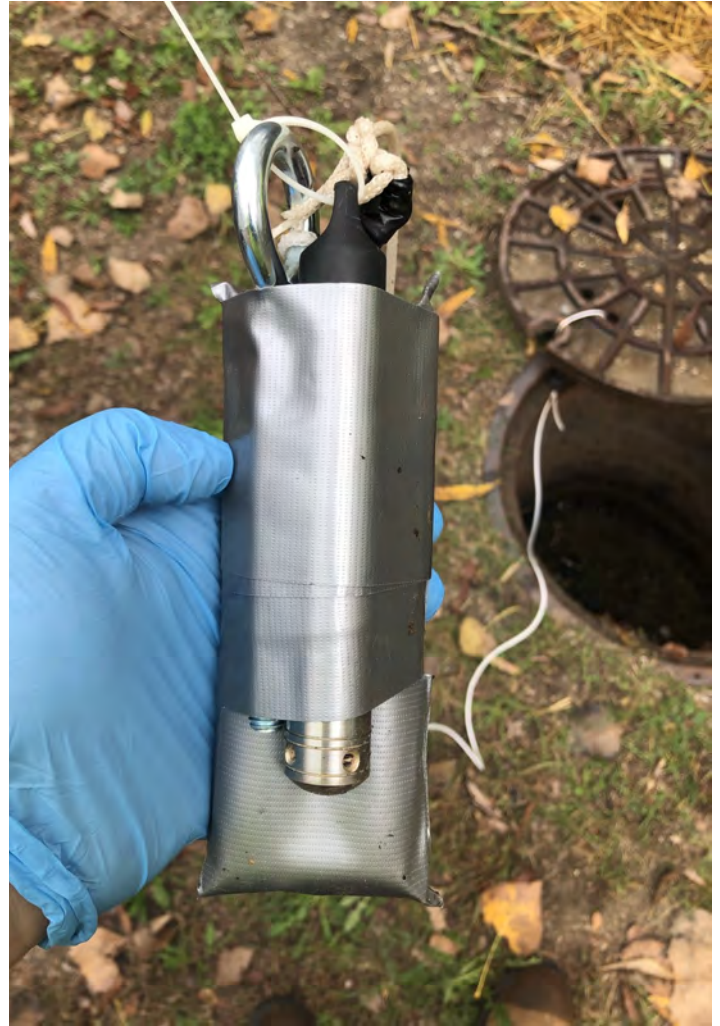
Photo 11: Levellogger MH-1 setup. Rope tied to manhole cover due to lack of ladder. View to northeast; photograph taken on October 4, 2021.

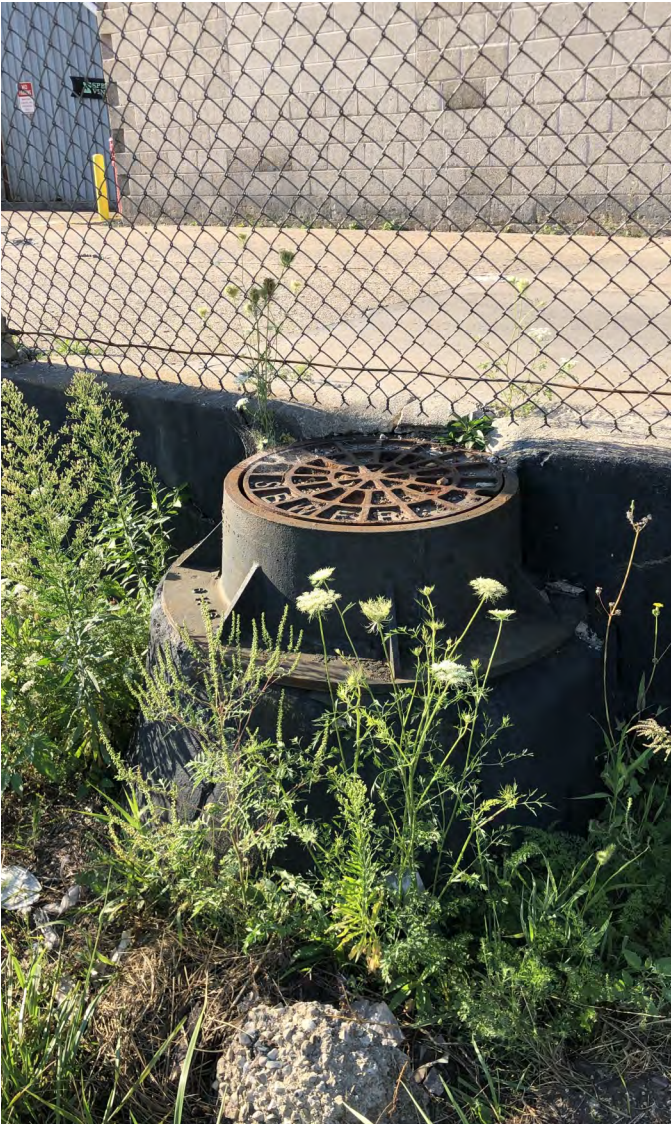
The bottoms of the manholes MH-14 and MH-15 are elevated approximately 4.7 to 5.3 feet above the inverts of the pipes connecting manholes MH-1 through MH-5, and the water column in the October 2021 sampling round was measured to be between only 0.1 feet (MH-15) and 0.2 feet (MH-14). A cross section showing the alignment of the storm sewer from the slip to manhole MH-1, and manholes MH-1 to MH-15 is provided as **Figure 6**. This cross section depicts the difference in elevation between the inverts between manholes MH-14 and MH-15, and the north-south inverts from manholes MH-1 to MH-5.

Photo 16: Manhole MH-14 elevated approximately 2.6 feet above neighboring ground surface. View to south; photograph taken on September 2, 2021.

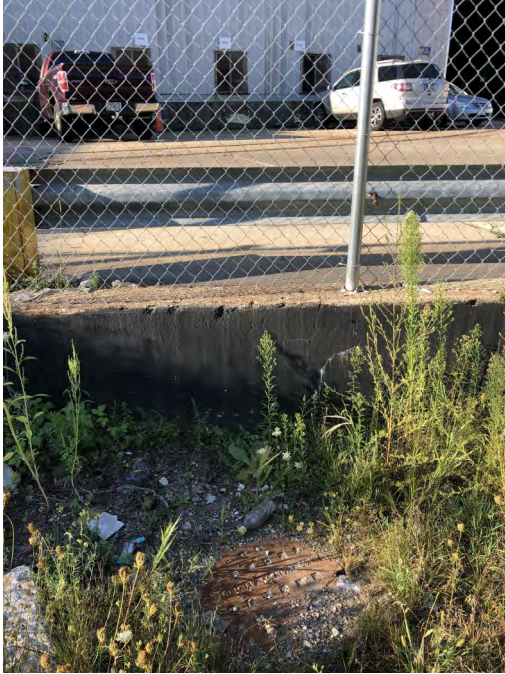
Photo 18: Manhole MH-15 exterior north of fence and elevated concrete-paved loading dock of 427 E. Stewart Street property. View to south; photograph taken on September 2, 2021.

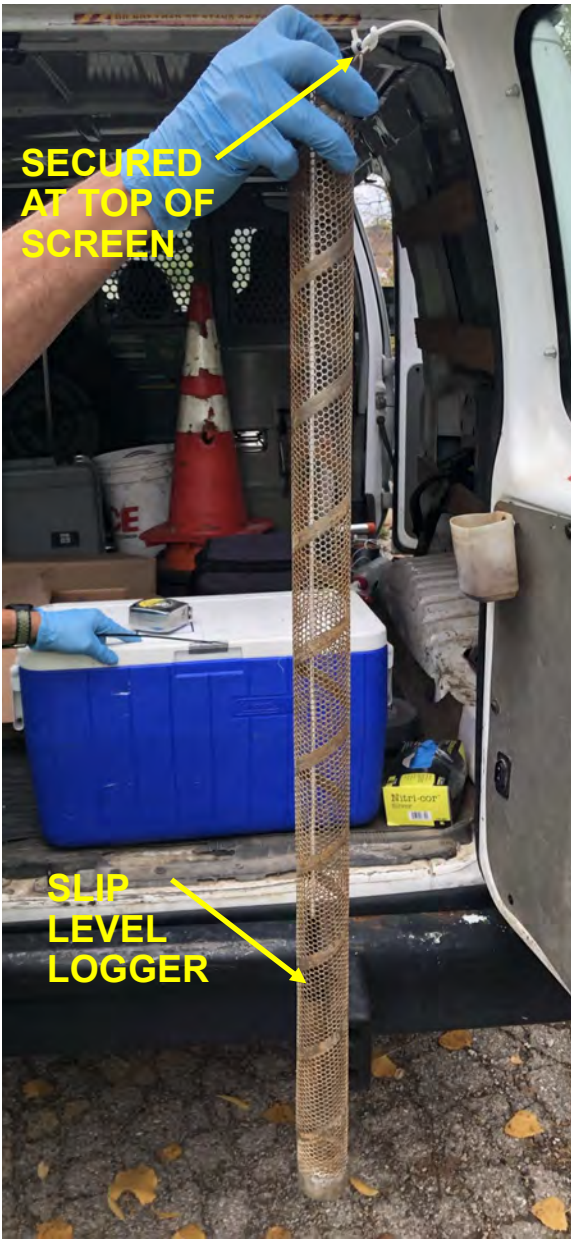
Photo 20: Metal screen used to protect SLIP level logger. The level logger is secured to the top of the screen. Photograph taken on October 4, 2021.

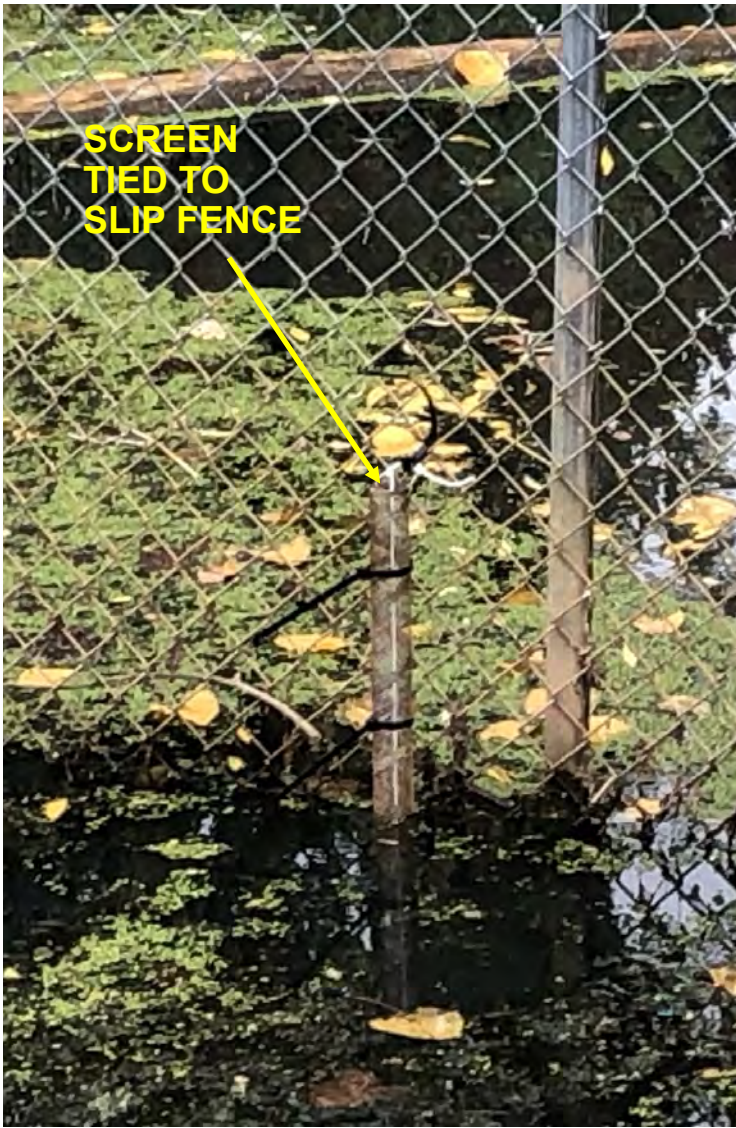
Photo 21: Metal screen fastened to fence running through the middle of Skipper Bud's Slip. The level logger is secured to the top of the screen. View to south; photograph taken on October 4, 2021.

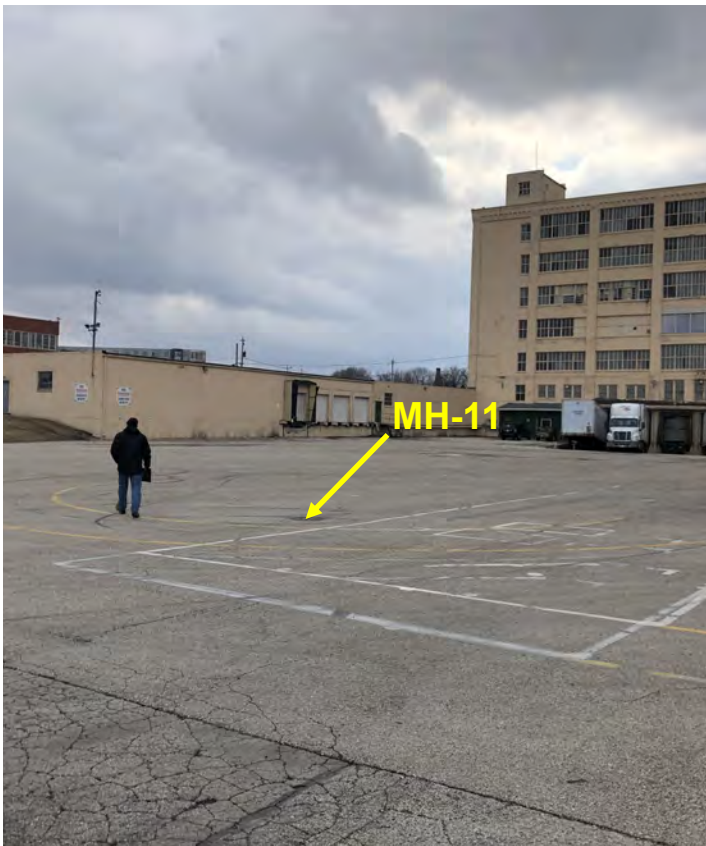
Photo 24: Manhole MH-11 exterior in 1982 S. Hilbert Street property parking lot. View to southwest; photograph taken on April 4, 2022.

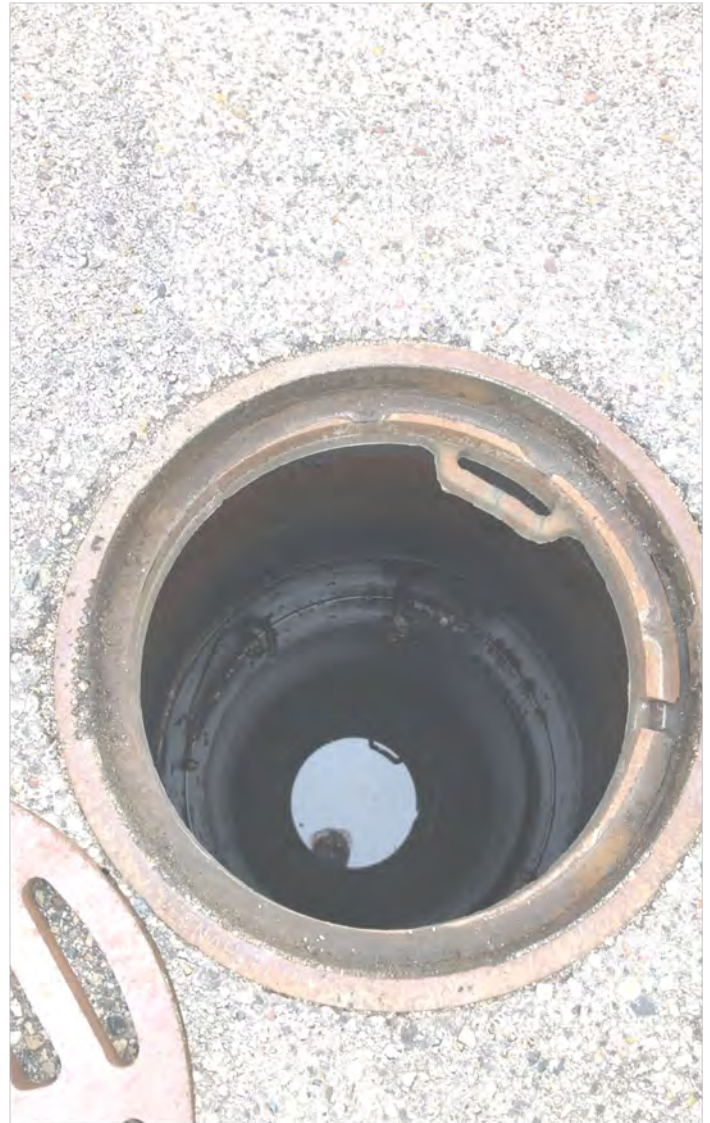
Photo 25: Manhole MH-11 interior. View to north; photograph taken on April 4, 2022,

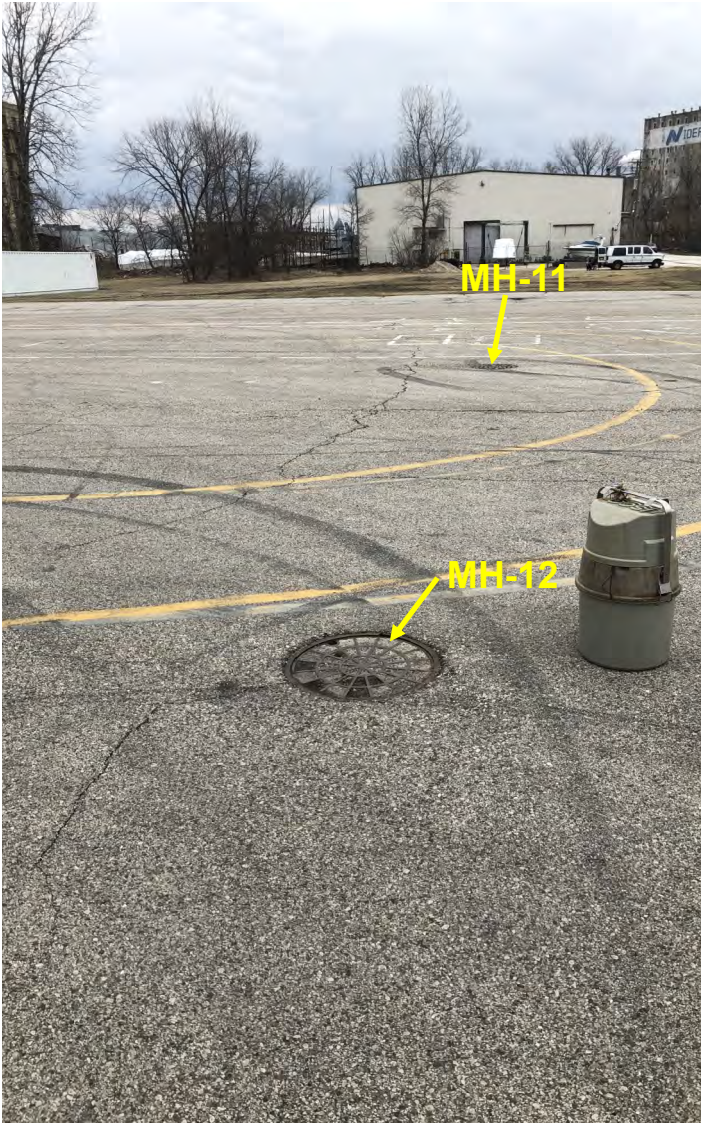
Photo 26: Manhole MH-12 exterior in 1982 S. Hilbert Street property parking lot, with manhole MH-11 in distance. View to north; photograph taken on April 4, 2022.

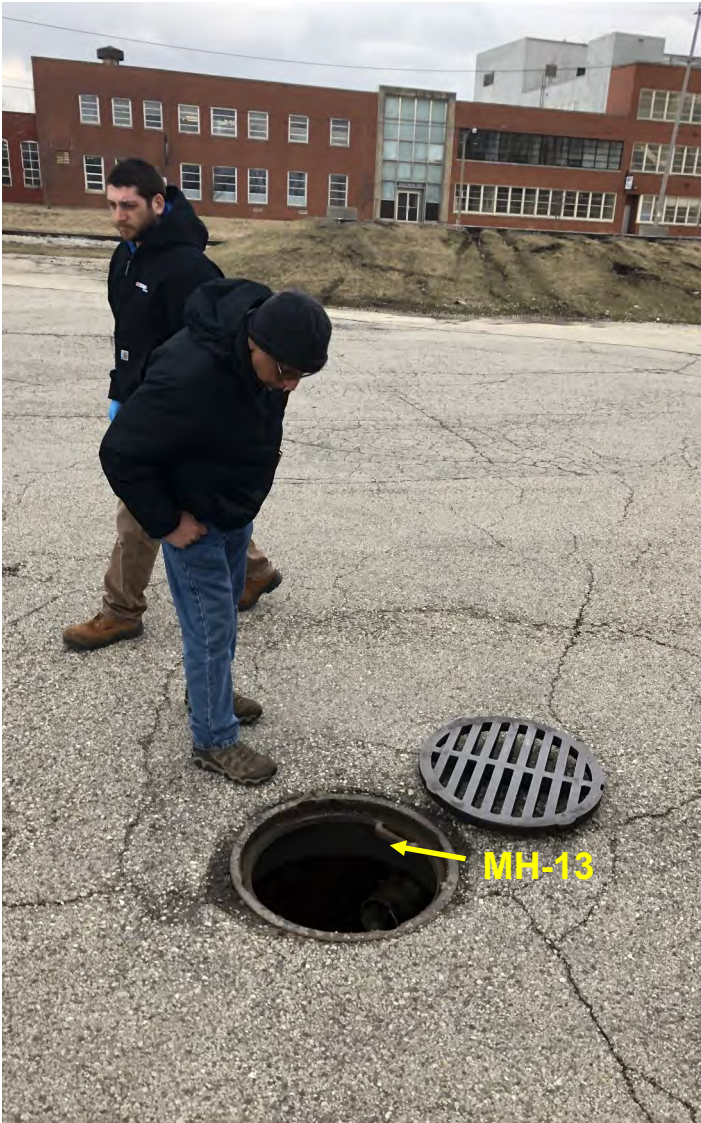
Photo 28: Manhole MH-13 exterior in 1982 S. Hilbert Street property parking lot. View to south; photograph taken on April 4, 2022.

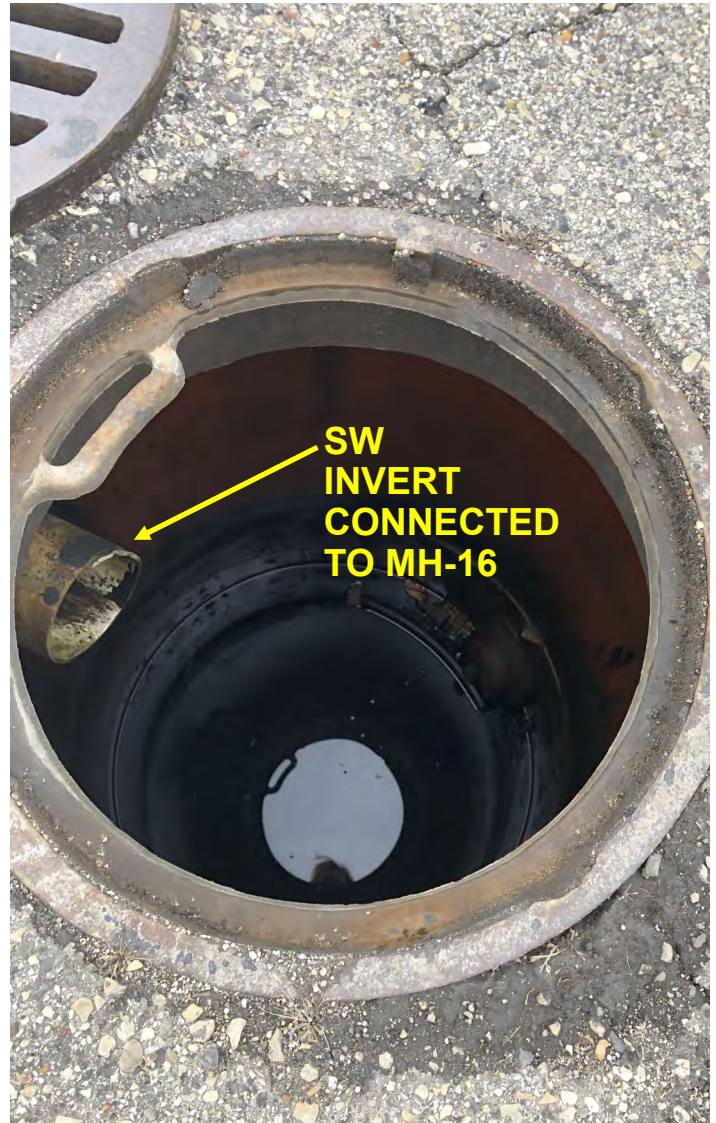
Photo 29: Manhole MH-13 interior with visible SW invert connected to manhole MH-16. View to northwest; photograph taken on April 4, 2022.

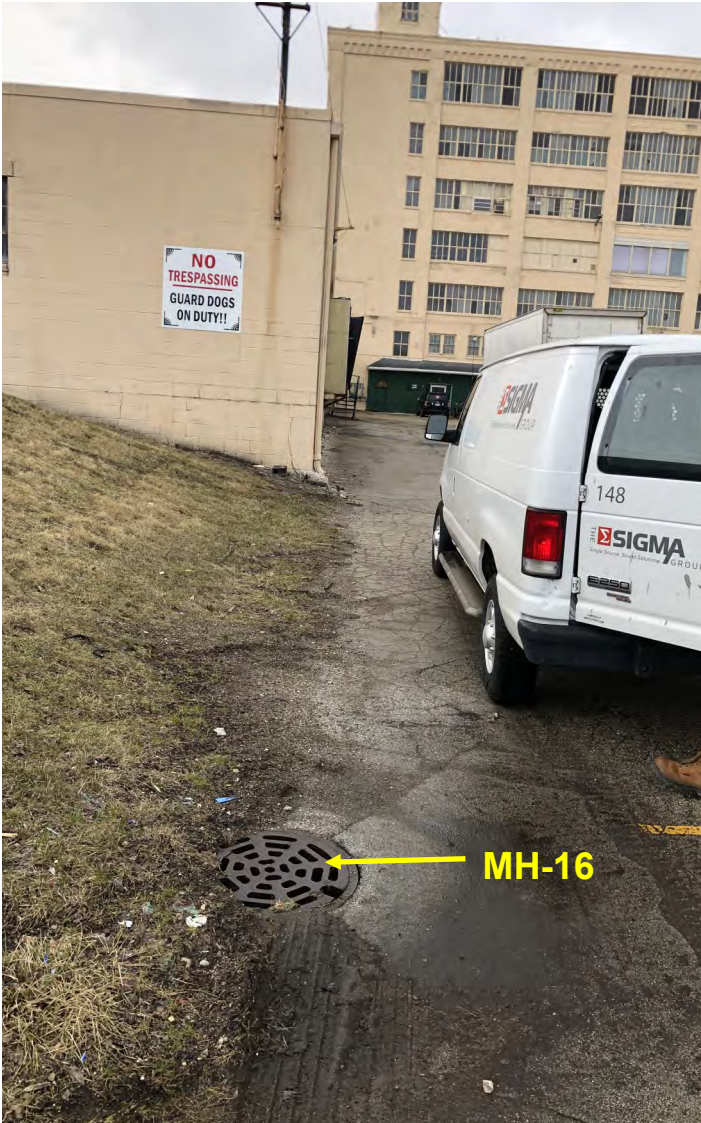
Photo 30: Manhole MH-16 exterior on edge of 1982 S. Hilbert Street property parking lot and northern edge of hill. View to west; photograph taken on April 7, 2022.
