**Re: Oconto Falls Upper, Project No. 2523, N.E.W. Hydro, Inc.
Submittal of Purple Loosestrife/Eurasian Watermilfoil Inventory for Year 2006**

**Oconto Falls Upper Project Purple Loosestrife & Eurasian Watermilfoil Inventory
August 19, August 23, & August 24, 2006
FERC Project #2523 Article 407**

Project: Oconto Falls Upper #2523
 Date: 8/19/06 & 8/23/06
 Crew: RAL & CTM

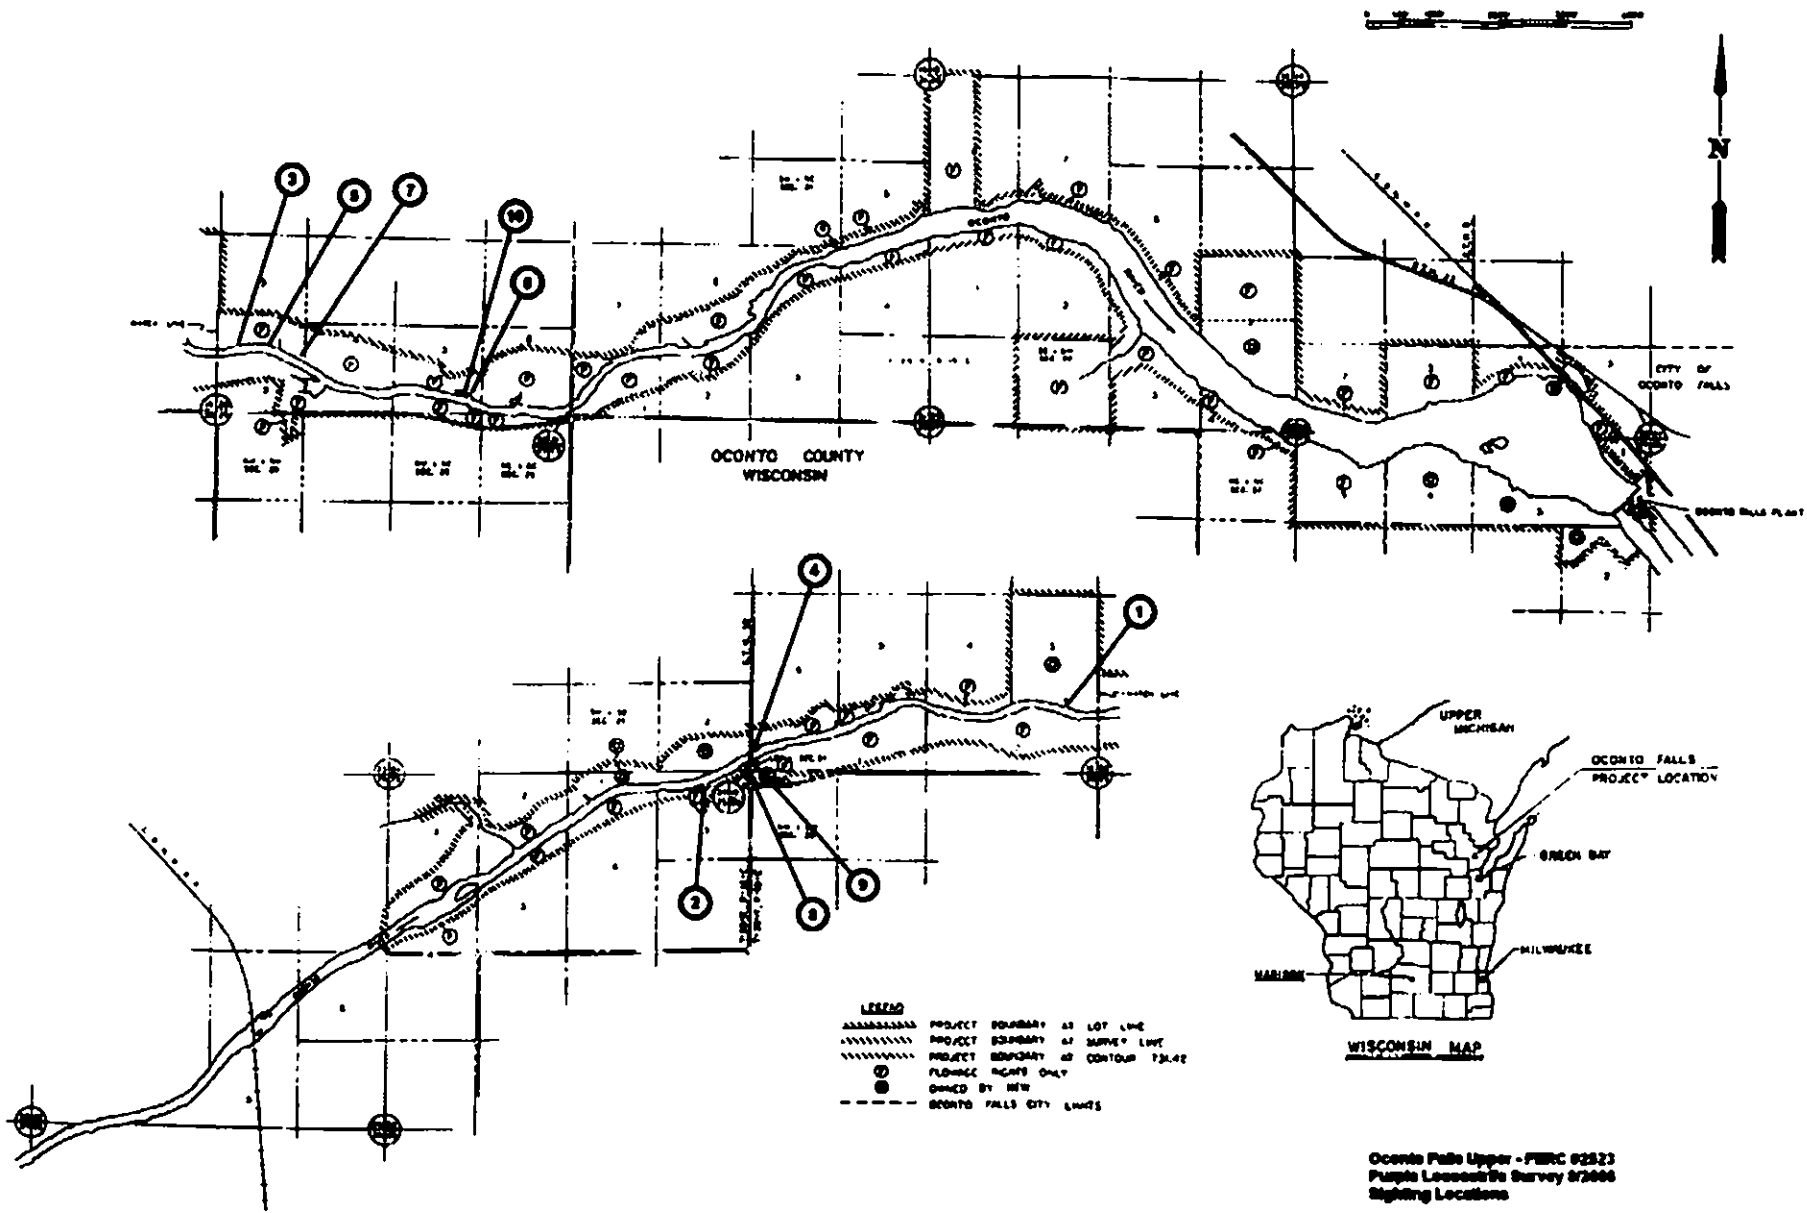
The headwaters were surveyed by boat. Five occurrences of purple loosestrife plants were observed in this area and are noted on the lake map and survey comments at the end of this report. One of these occurrences appears to be on project owned land and is so noted.

Sighting #1 (located on project owned land) was observed in 2000, 2001, 2002, 2003, 2004, and 2005 and appears not to have spread. In 2002 seed heads on three of the plants nearest the main river were removed, bagged, and burned to reduce possibility of spreading. In 2003, a permit to spray this sighting with an herbicide was acquired from the Wisconsin Department of Natural Resources and these plants were sprayed on August 24, 2003. On August 25, 2003 (more than 24 hours later) a number of the plants showed signs of stress. In 2004, a permit to spray this sighting with an herbicide was acquired from the Wisconsin Department of Natural Resources and these plants were sprayed on August 6, 2004. The amount of mature plants was noticeably reduced from the 2003 treatment although some of the reduction may have been attributed to higher than normal water levels and cooler temperatures throughout the spring and summer. It should also be noted that less mature plants appeared to have been browsed upon by animals. In 2005, a permit to spray this sighting with an herbicide was acquired from the Wisconsin Department of Natural Resources and these plants were sprayed on August 17, 2005. The amount of mature plants was about the same as during the 2004 treatment. It should also be noted that a few mature plants appeared to have insect damage such as that produced by *Gallerucella* beetles. In 2006, a permit to spray this sighting with an herbicide was acquired from the Wisconsin Department of Natural Resources and these plants were sprayed on August 23, 2006. The amount of mature plants was noticeably less than during the

Sighting #2 was observed in 2000, 2001, 2002, 2003, 2004, 2005, and 2006 and appears to have reduced in density considerably since 2005. It should be noted that in 2006, the lower portion of the remaining plants appeared to have insect damage such as that produced by *Gallerucella* beetles.

Sighting #3 was first observed in 2001 and in 2002 and 2003 seed heads on all of these plants were removed to reduce possibility of spreading. In 2004, no plants were observed, but in 2005 they had returned. Seed heads were removed again in 2005. In 2006, no plants were observed at this location.

Sighting #4 was observed, pulled, and burned in 2001 and was no longer present in 2002, 2003, 2004, 2005, or 2006.

Sighting #5 was observed in 2002, 2003, 2004, and 2005 and appears not to have spread. In 2005, a more accurate inventory was performed of this sighting. In 2006, the number of plants appeared to have been reduced and all plants were pulled.

Sighting #6 was observed in 2002, 2003, 2004. In 2002, 2003, and 2004, seed heads on all of these plants were removed to reduce possibility of spreading. In 2005, no plants were observed at this location. In 2006, two plants were once again observed and were pulled.

Sighting #7 was observed in 2005 and was pulled and destroyed. In 2006, no plants were observed at this location.

Sighting #8 was observed in 2005 and was pulled and destroyed. In 2006, no plants were observed at this location.

Sighting #9 was observed in 2006 and was pulled and destroyed.

Sighting #10 was observed in 2006 and was pulled and destroyed.
