Re: NR 716 Site Investigation Work Plan
BMO HARRIS BANK BRANCH
117-125 South Chestnut Avenue
Green Bay, Wisconsin
WDNR BRRTS No. 02-05-585287
PSI Project No.: 00542852

NR 716 SITE INVESTIGATION WORK PLAN

**BMO HARRIS BANK BRANCH
117-125 South Chestnut Avenue
Brown County, Wisconsin
WDNR BRRTS No. 02-05-585287**

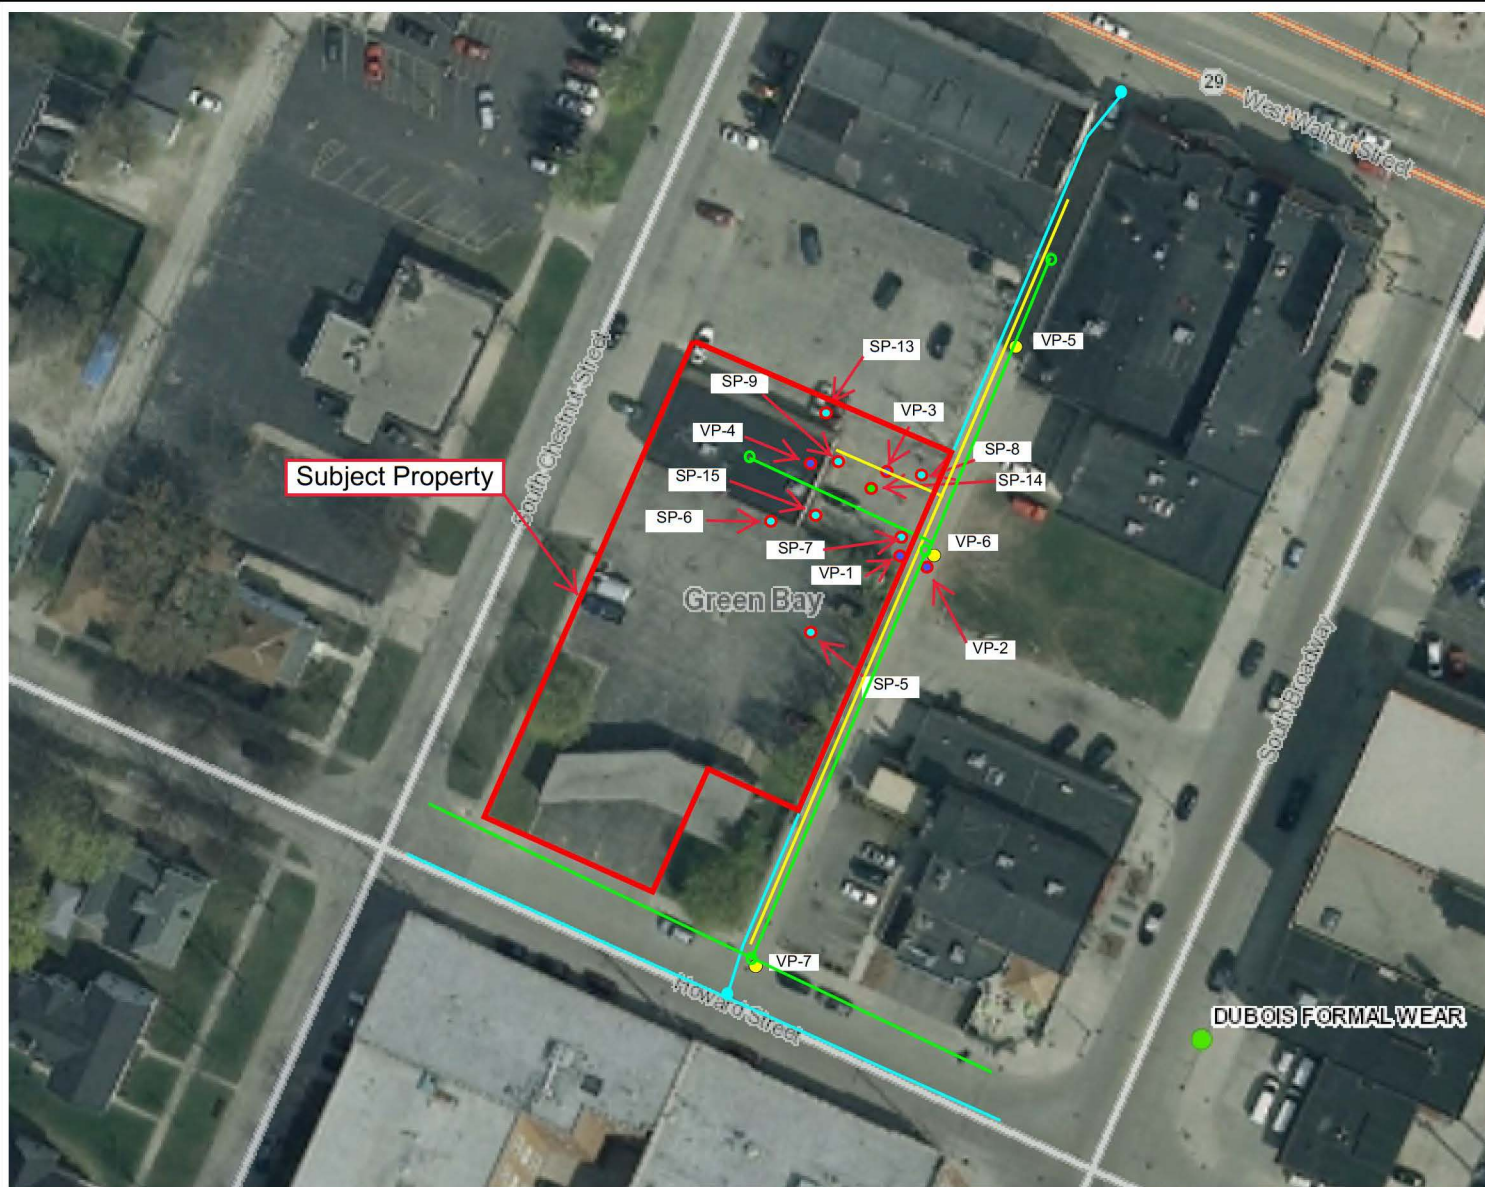
PROBE, VAPOR POINT AND VAPOR SAMPLE LOCATION DIAGRAM
BRRTS No. 02-05-585287

- Soil Probe Location
- Soil Vapor Point Location
- Vapor Sample Location
- Sanitary Line Location
- Stormwater Line Location
- Natural Gas Line Location

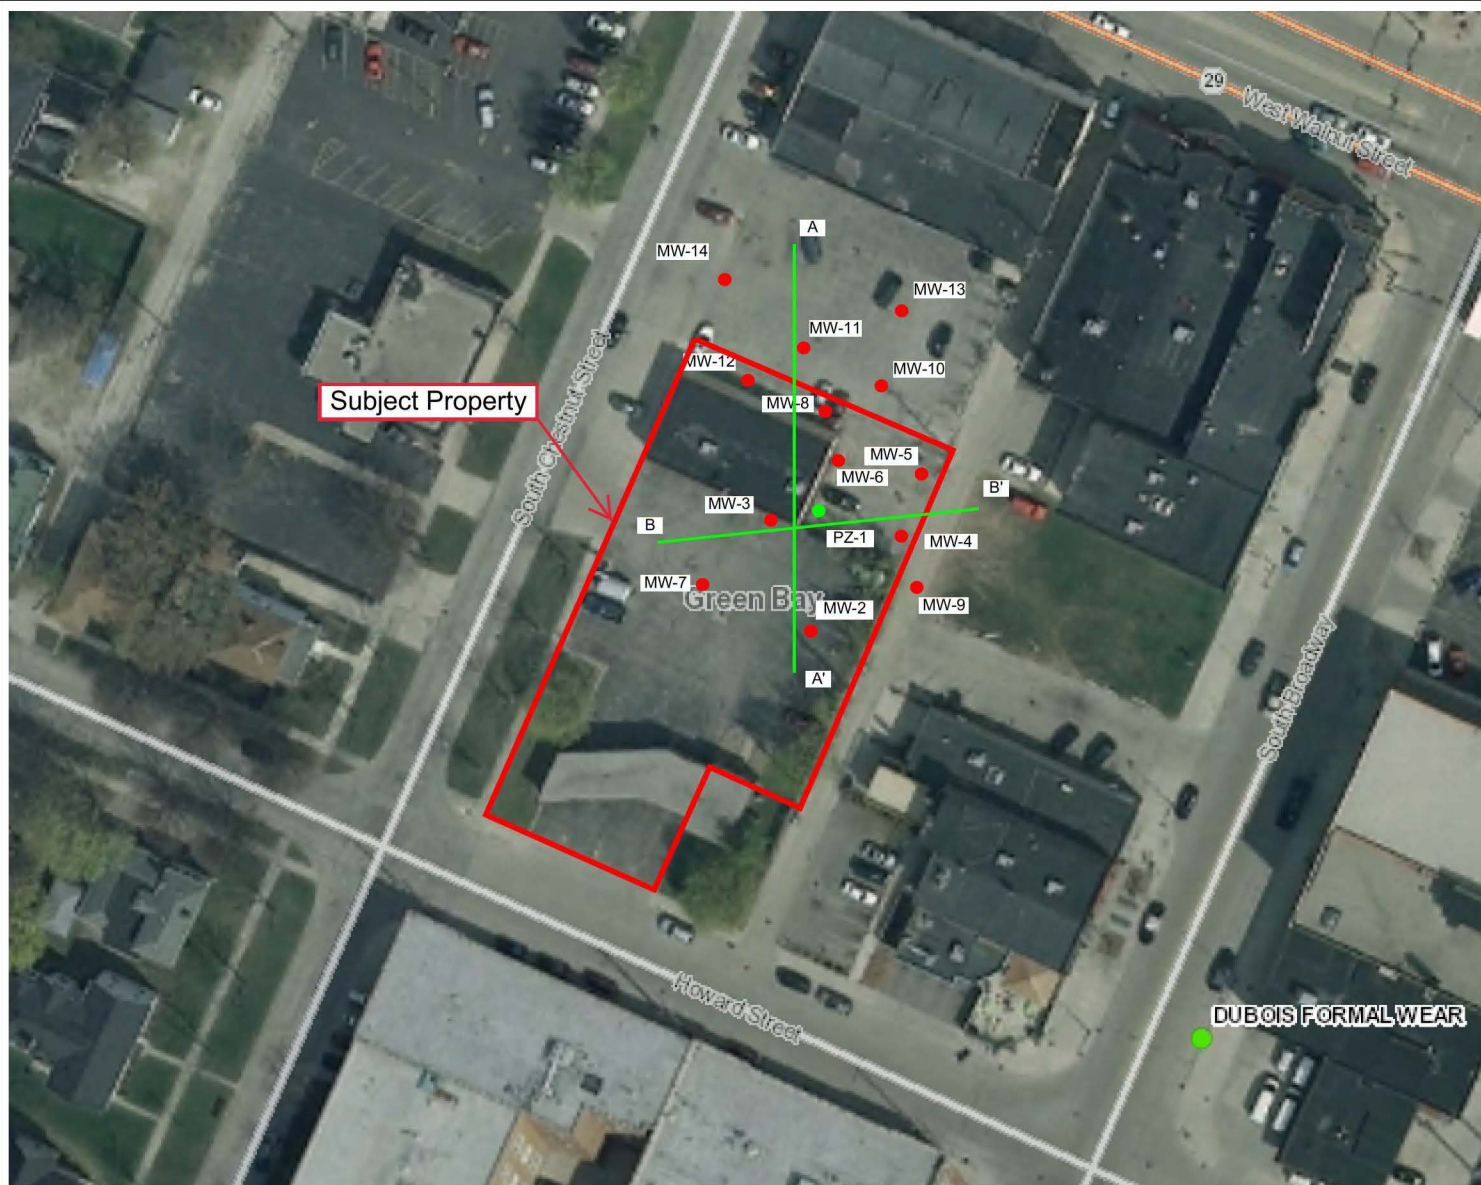
EXISTING WELL LOCATION DIAGRAM

- Monitoring Well Location
- Piezometer Location

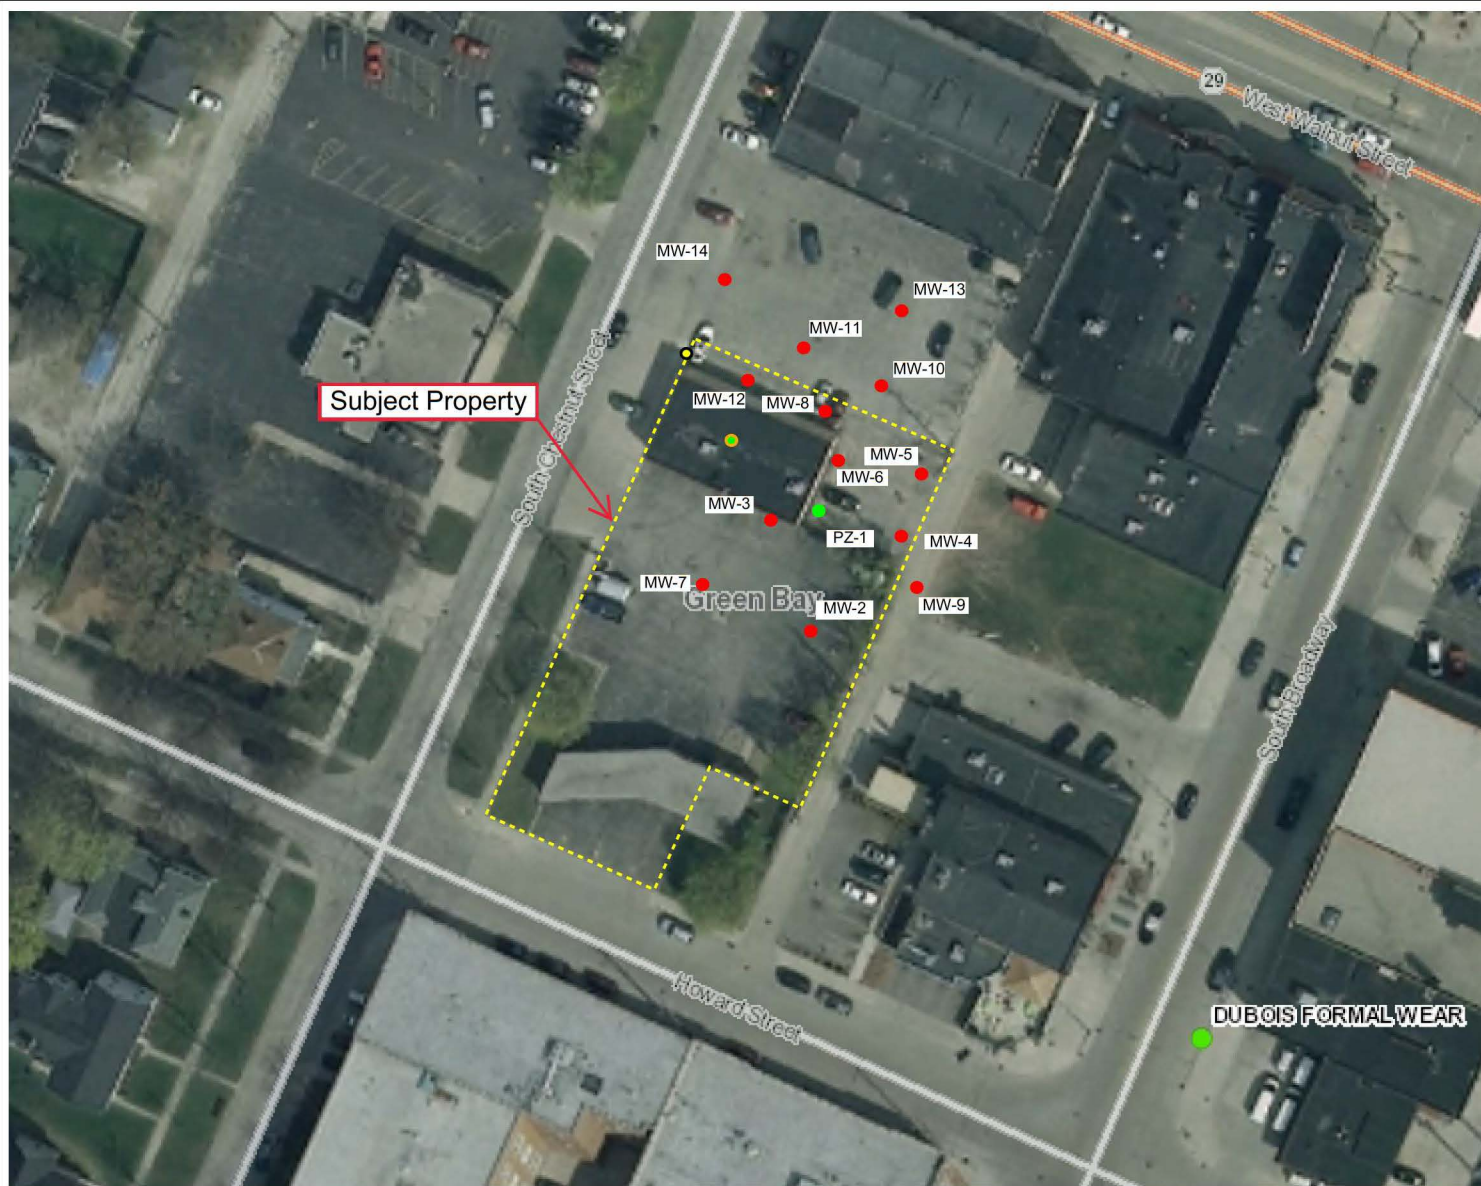
PROPOSED VAPOR POINT AND WELL LOCATION DIAGRAM
BRRTS No. 02-05-585287

- Existing Well Location
- Piezometer Location
- Proposed Well Location
- Proposed Sub-Slab Point Location

Because of the encountered soil contamination in the area of the southeast corner and near the northeast corner of the northern building and the presence of chlorinated compounds in the groundwater, it was recommended that additional investigative activities be performed to further evaluate the degree and extent of the PAH-impacted soils encountered in the northeast and the southeast corners of the Subject Property. It was also recommended that additional investigative activities be performed to further evaluate the degree and extent of the chlorinated-impacted groundwater contamination to the north of the northeast building corner of the northern building, within

the eastern alleyway, and to the south of the southeast building corner of the northern building. Further, due to the type of contamination, a piezometer is recommended to be installed near the southeast corner of the northern building to evaluate the deeper groundwater aquifer for the presence of chlorinated compounds.
