Rain Garden – Interim Investigation Report and Proposed Excavation Work Plan

November 2017

*Prepared For
Madison-Kipp Corporation
Madison, Wisconsin*

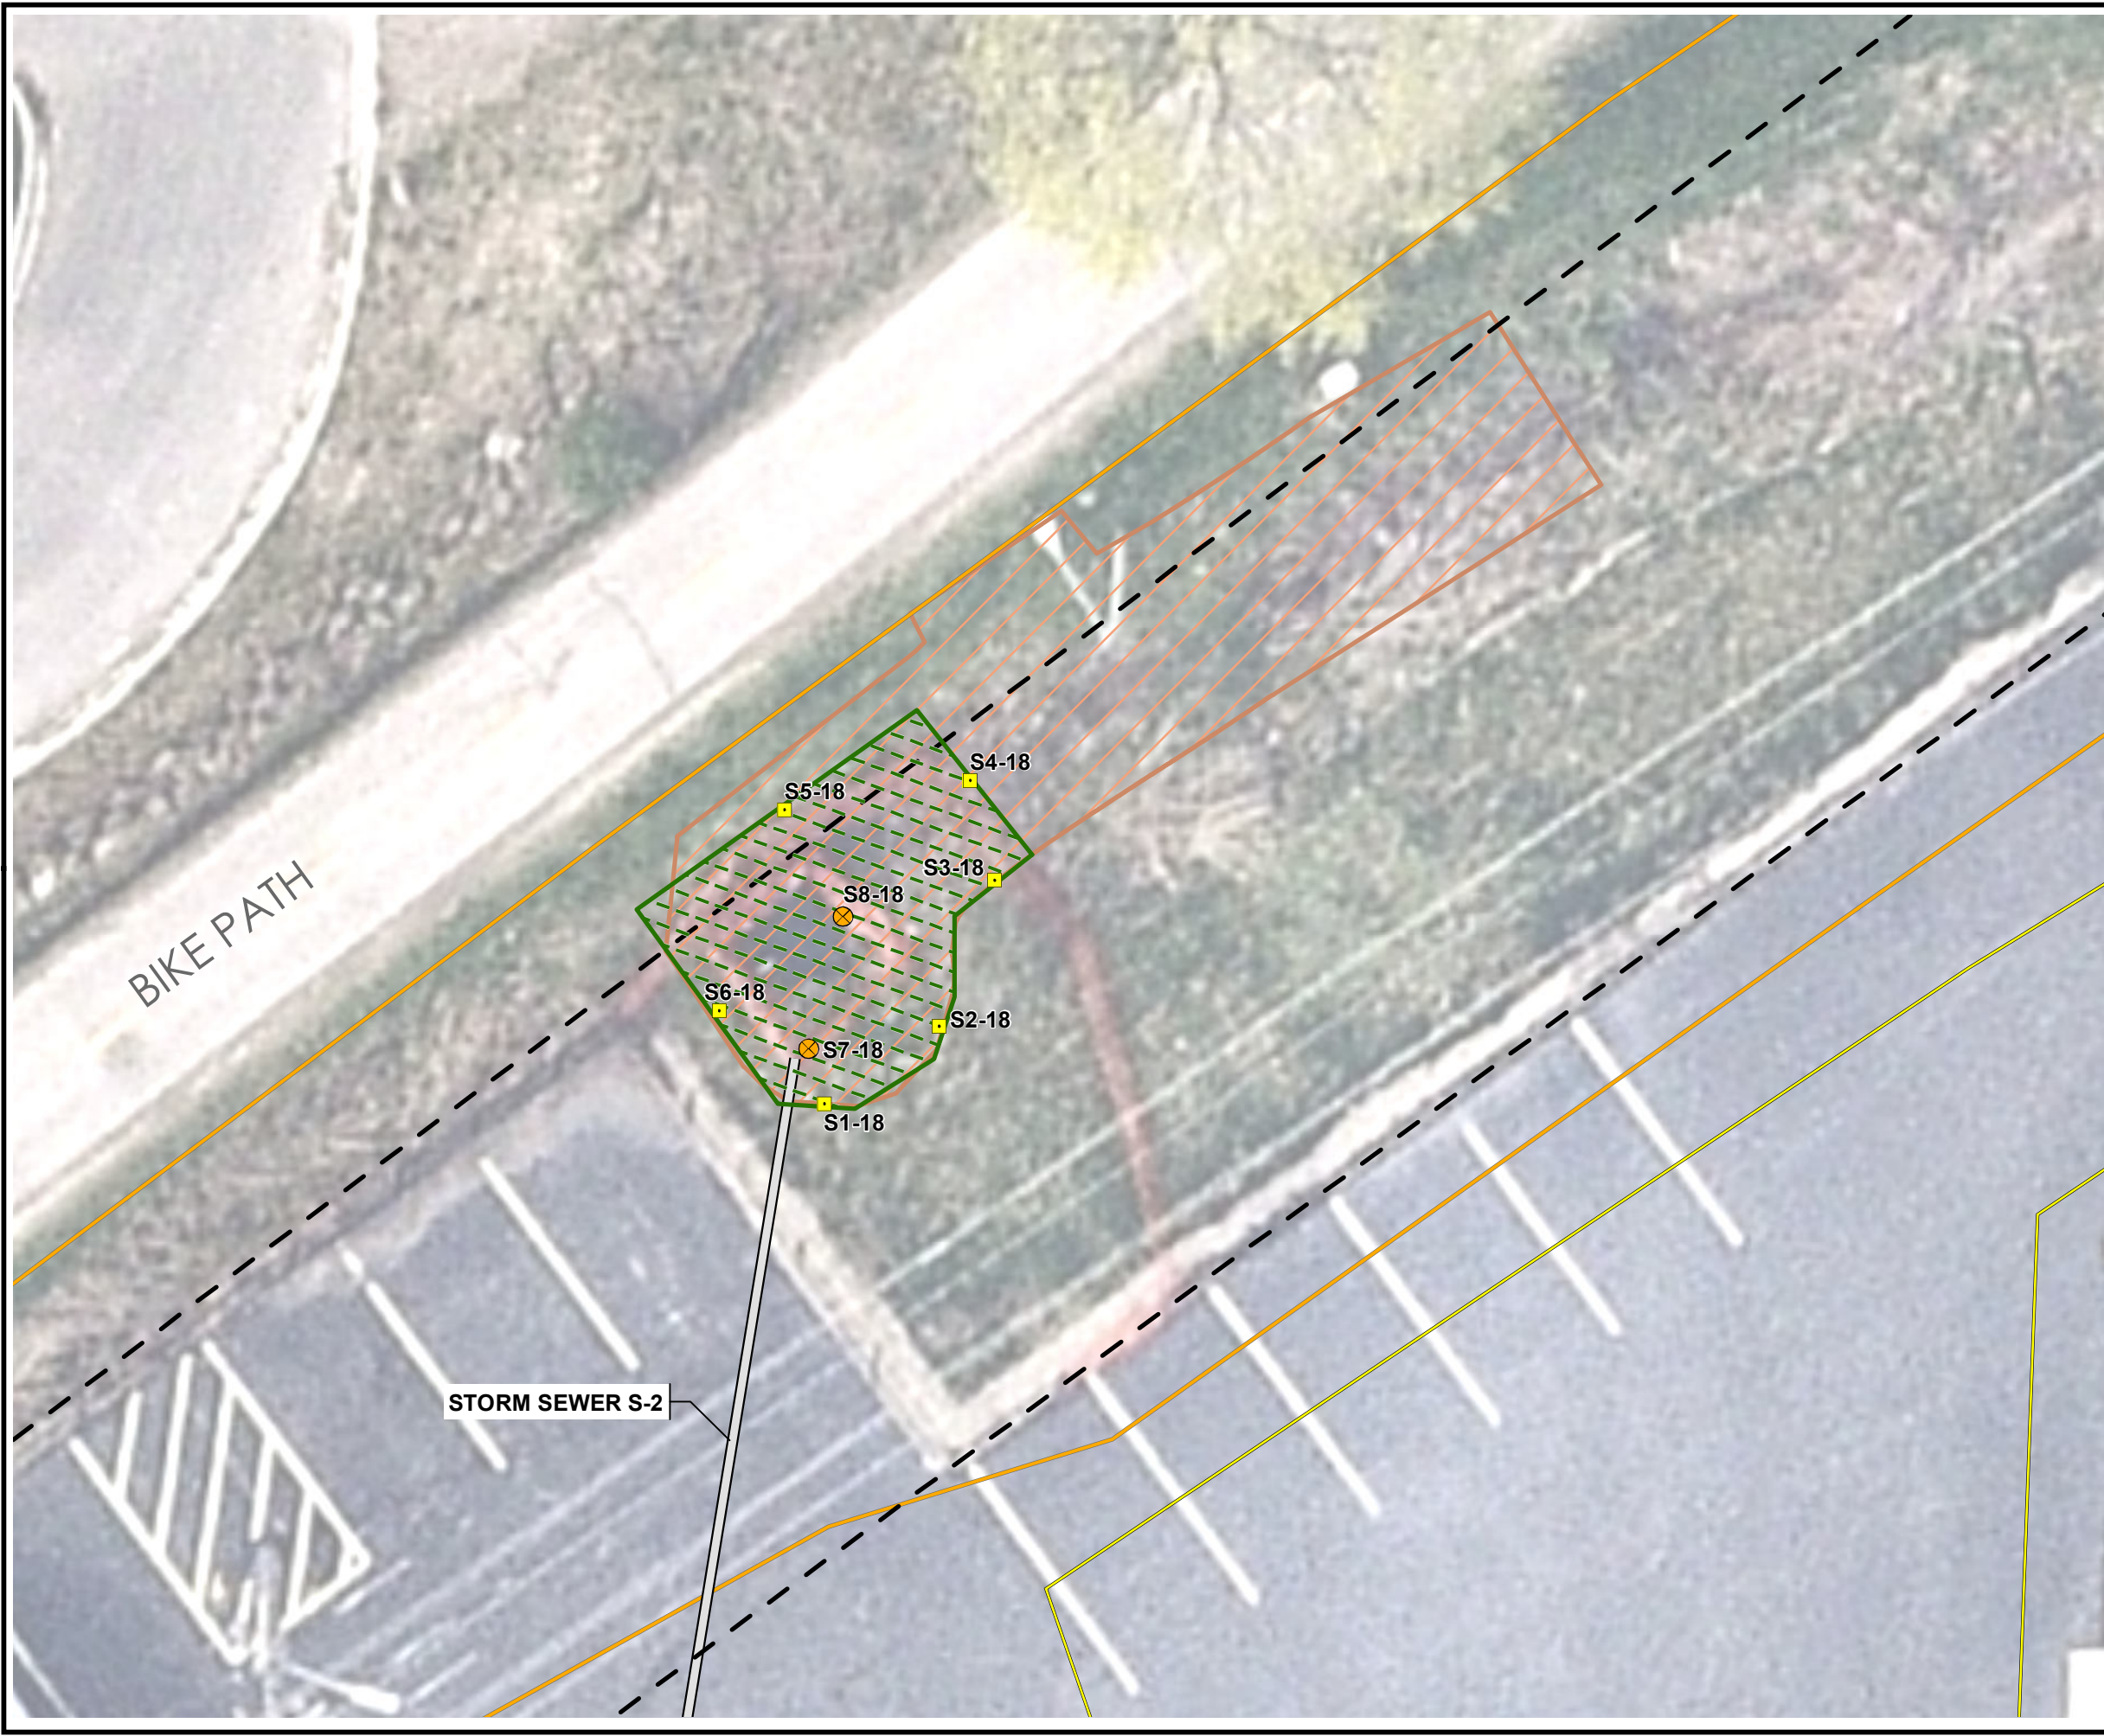
PROJECT:		MADISON-KIPP CORPORATION 201 WAUBESA STREET MADISON, WISCONSIN	
TITLE:		PROPOSED RAIN GARDEN EXCAVATION AND RESTORATION MAP	
DRAWN BY:	J. PAPEZ	PROJ NO.:	268304
CHECKED BY:	A. STEHN	FIGURE 1	
APPROVED BY:	K. VATER		
DATE:	NOVEMBER 2017

Table 1 includes a summary of the samples to be collected and analyzed and Figure 1 includes the proposed extent of the excavation and the approximate location of the confirmation samples.

outfall area into the rain garden. The limits will extend to the northwest, north, and east of the storm sewer discharge pipe into the rain garden. An approximate excavation area of twenty feet by twenty feet will be completed to an approximate depth of one foot below ground surface (bgs). The approximate extents of the excavation are shown on Figure 1. The planned extents of the excavation are beyond the limits of the known PCB-impacts. Following the removal of PCB-impacted soil, based on the slightly negative slope within the storm sewer pipe and immediate outfall area, the rain garden will be regraded to promote positive drainage. Based on the current grade, portions of the garden from the outfall area to the east-most discharge (approximately 225 feet in length by 2 feet in width) may require regrading to allow for proper drainage. Due to this activity, excavation work greater than one foot may be required in portions of the garden.

- (1) The approximate sample locations are included on Figure 1 of the Rain Garden Excavation and Restoration Work Plan.
- (2) The base samples may be collected between 0 and 2 feet below ground surface based on regarding work for the garden to promote positive drainage.
- (3) A soil sample will be collected over a 1 foot interval.
- (4) Samples will be analyzed for PCBs using U.S. EPA SW-846 Method 8082
