Impacts of Road Crossings on Streams

Dale Higgins, USDA Forest Service

Stream Crossing Perspectives

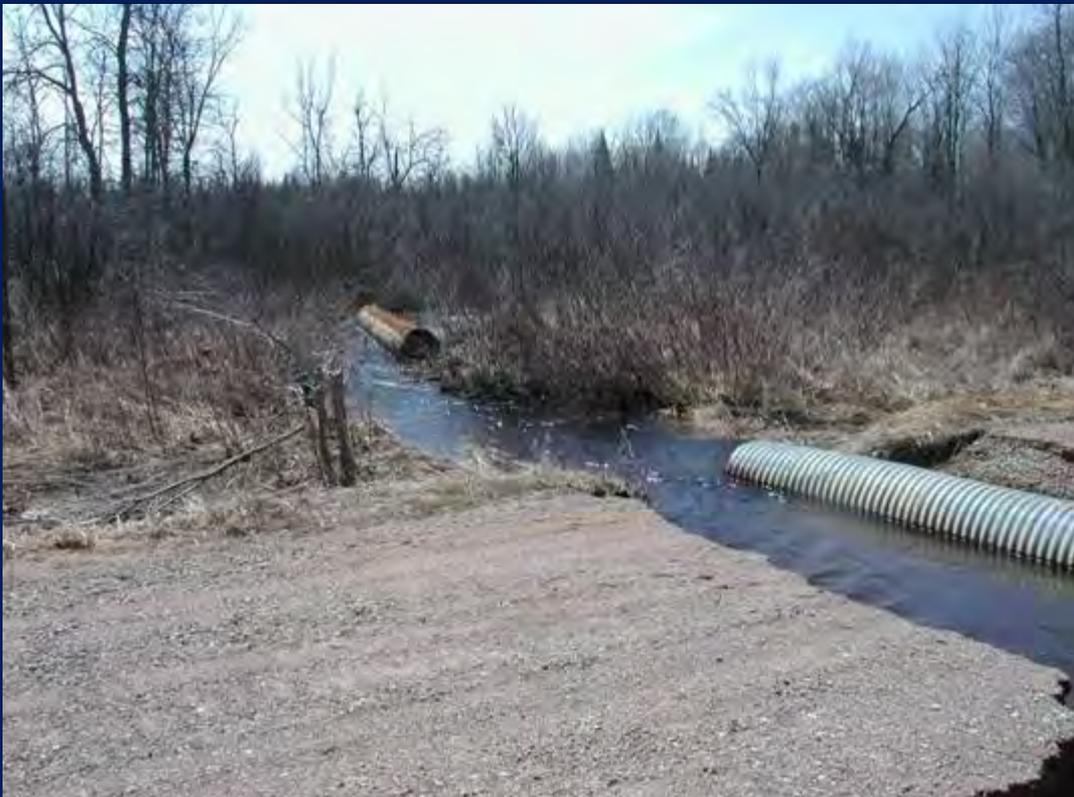
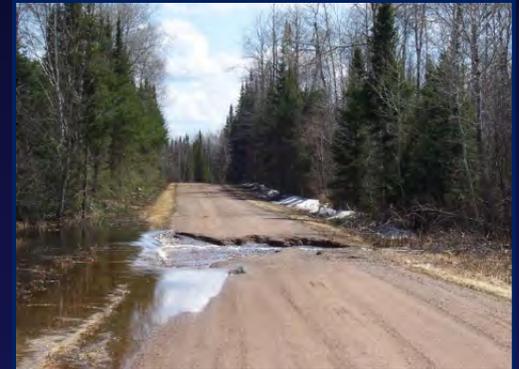
Frequent Washouts

Major source

- Sediment volume
- Sediment delivery

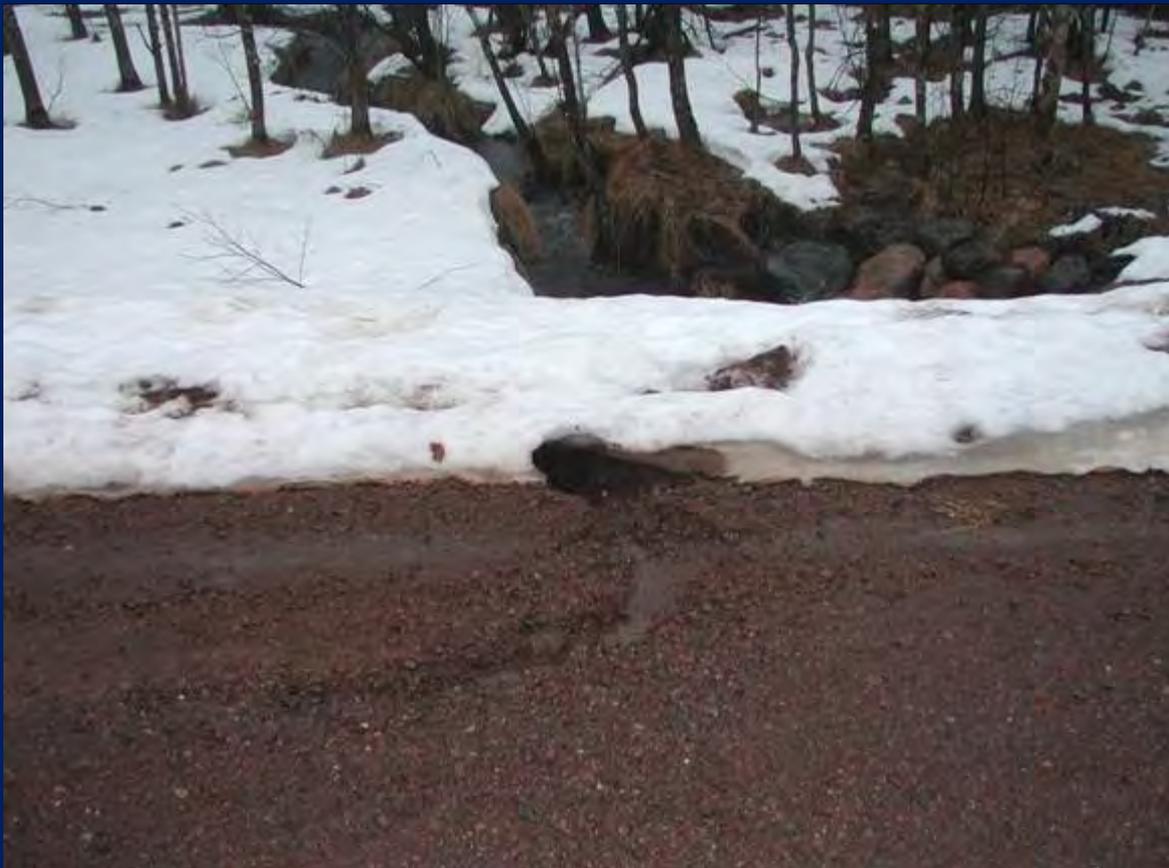
Road Surface and Ditch Erosion

- **Surface material**
- **Drainage**
- **Slope length**
- **Slope steepness**
- **Low point**

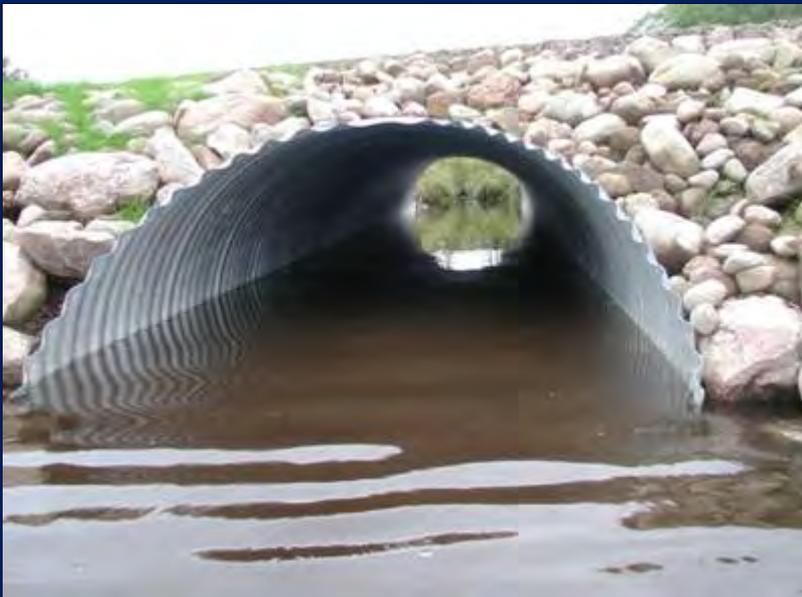
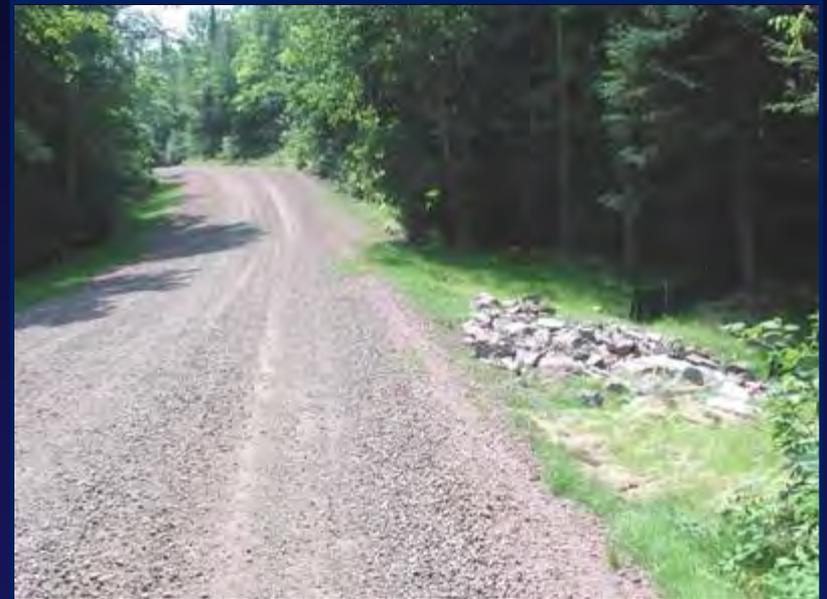
Embankment Erosion Solutions

Stable side-slopes 2:1 or less, adequate riprap, properly sized culvert with $HW/D < 1$ for 100-yr flow. Beveled culverts can reduce maintenance.

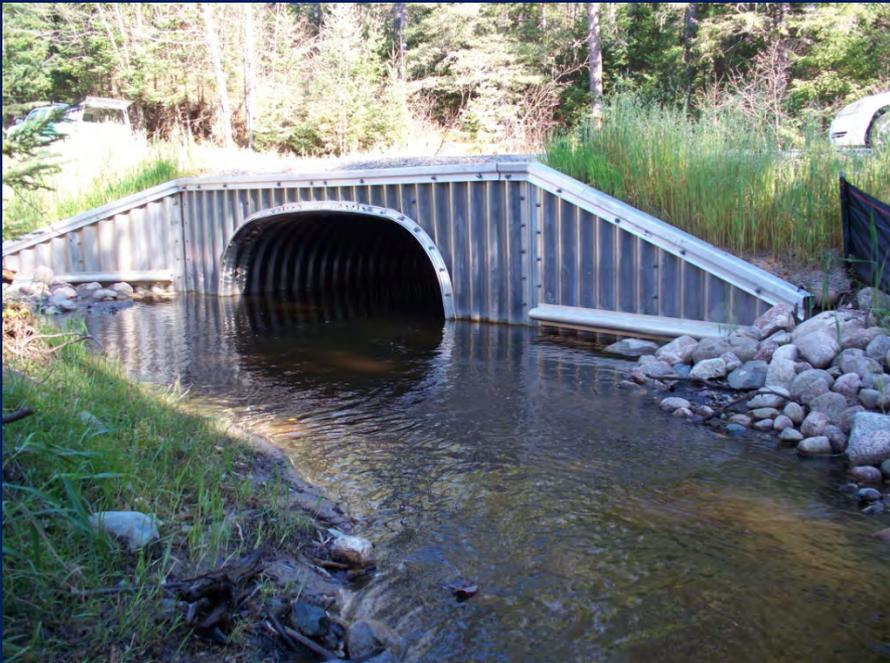
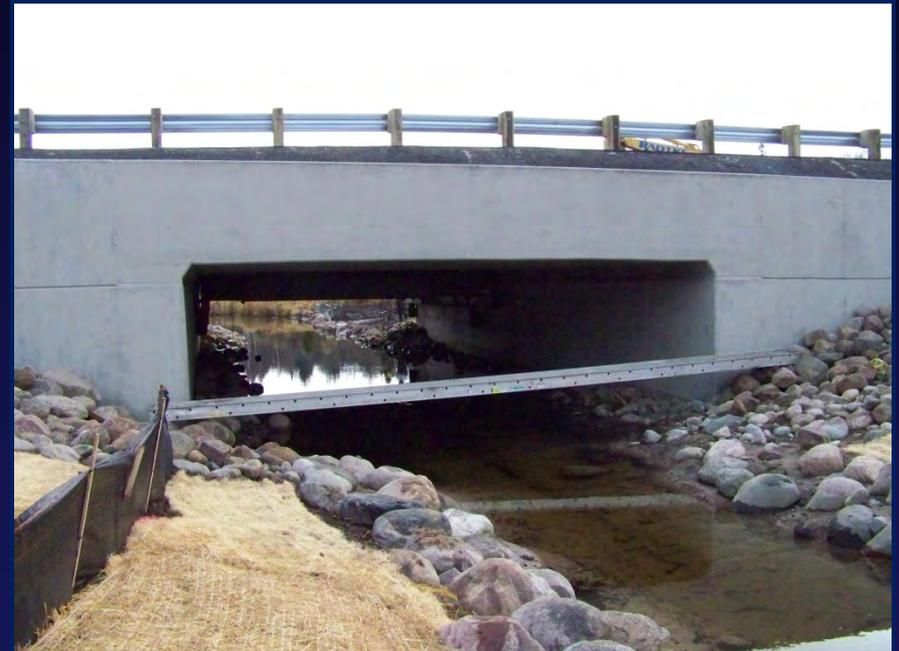
Embankment Erosion Solutions

Headwalls for embankment protection and to shorten culverts.

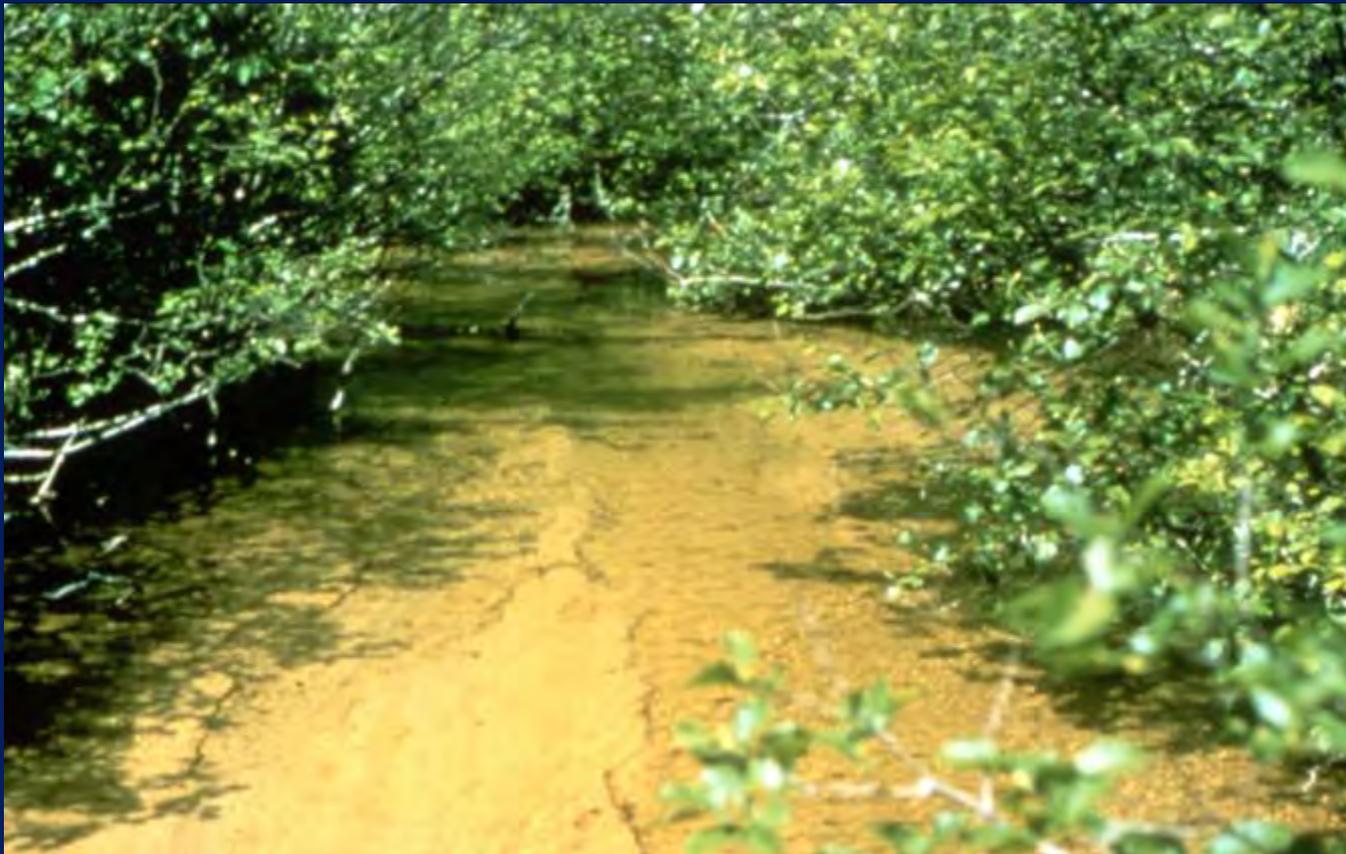
Downstream Sediment

Channel Morphology Impacts

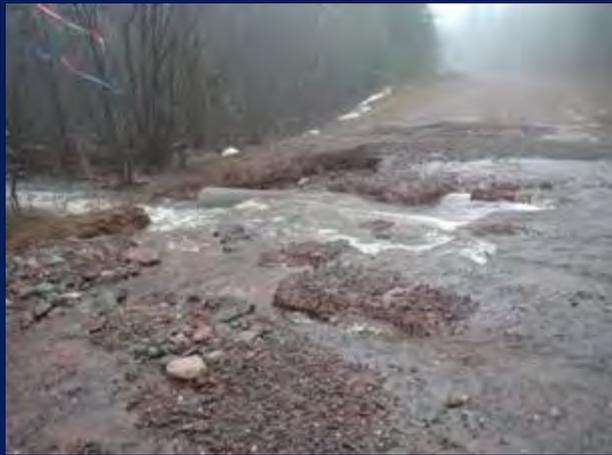
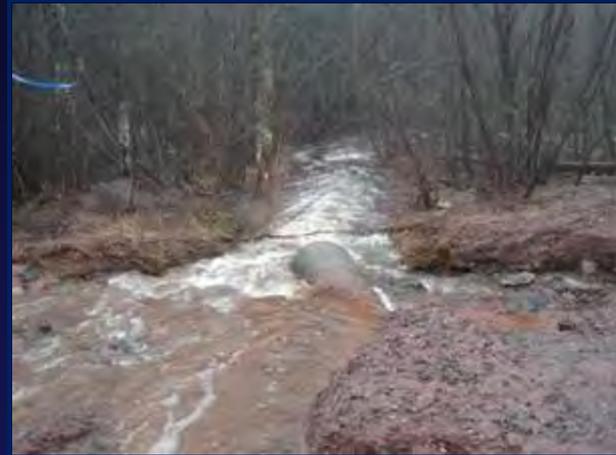
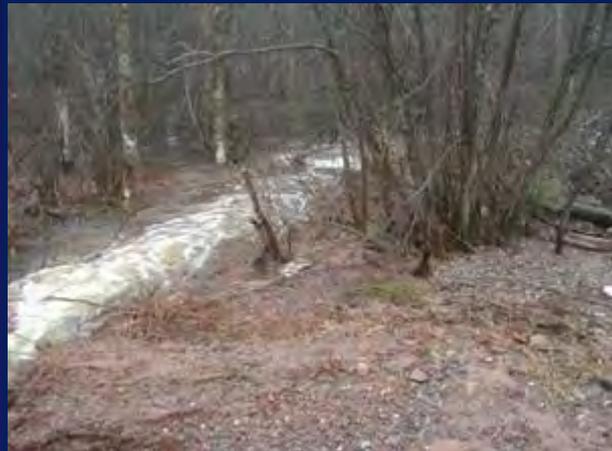
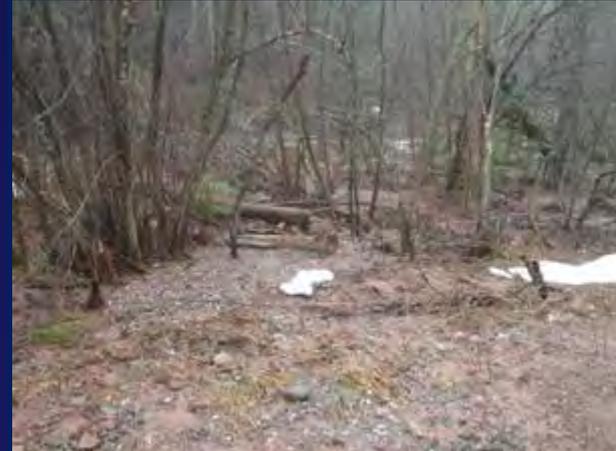
Downstream Sediment Channel Morphology Impacts

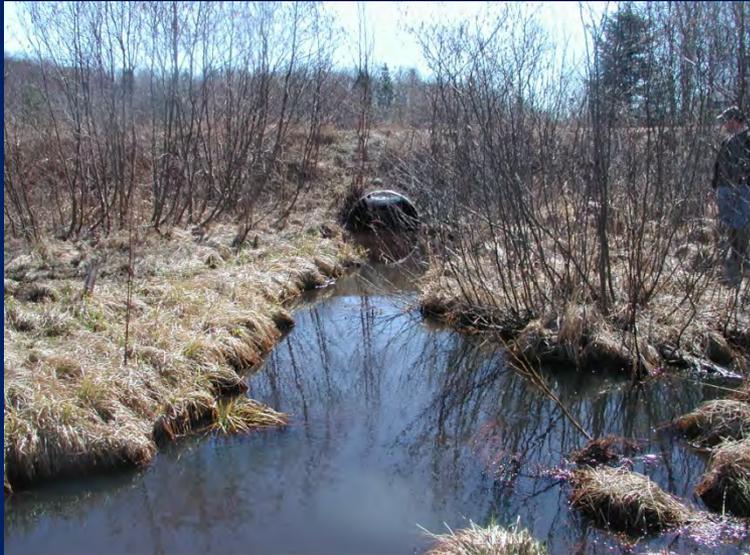
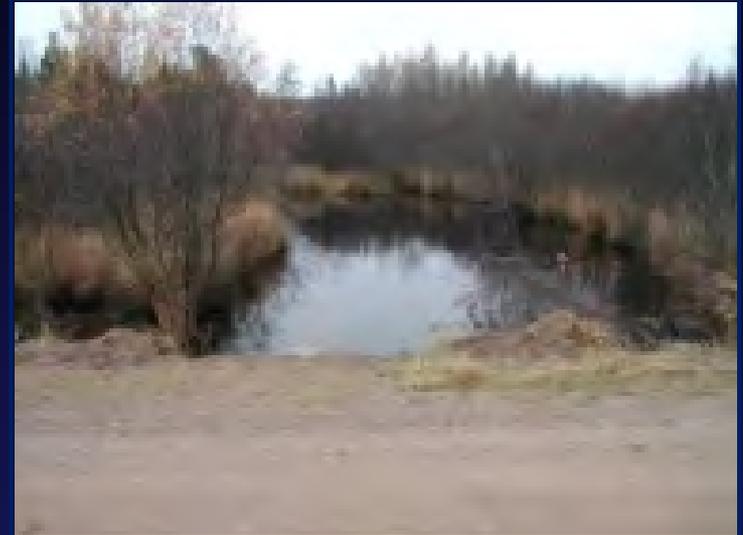
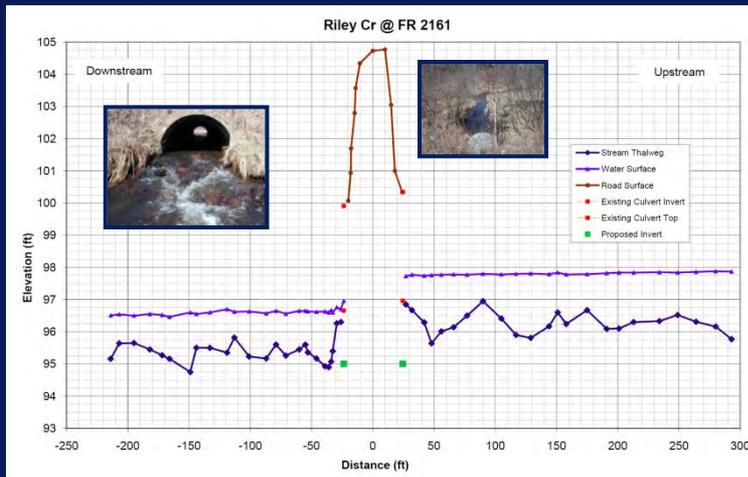
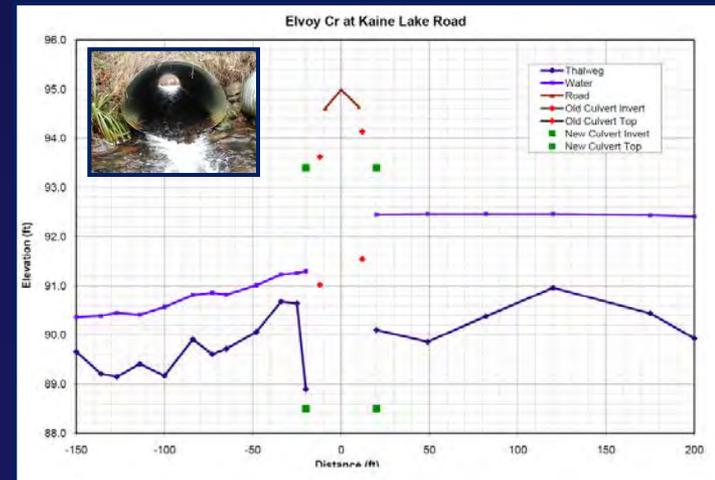
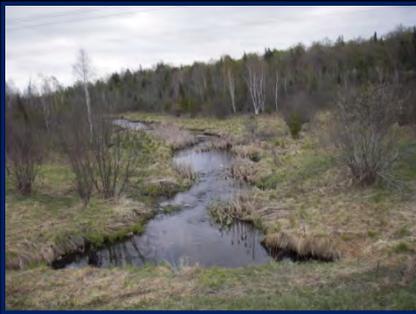
Upstream Ponding

Culvert Too High on Flat Streams, Channel Morphology Impacts

Culverts that constrict the channel to much can elevate the headwater and cause extreme velocities at high flows. This scours a large plunge pool with an elevated tailwater control that ponds water upstream. The lower upstream velocities can cause the channel to aggrade and allow vegetation to encroach.

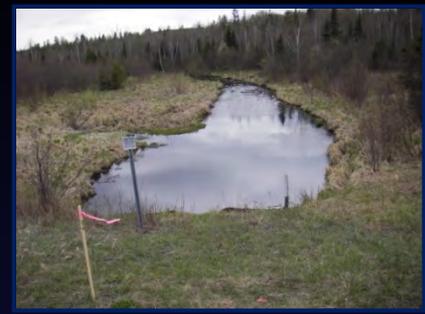
Upstream Ponding

Culvert Too High on Flat Streams
Channel Morphology Impacts

Torpee Cr at Hwy 32 Stream Profile

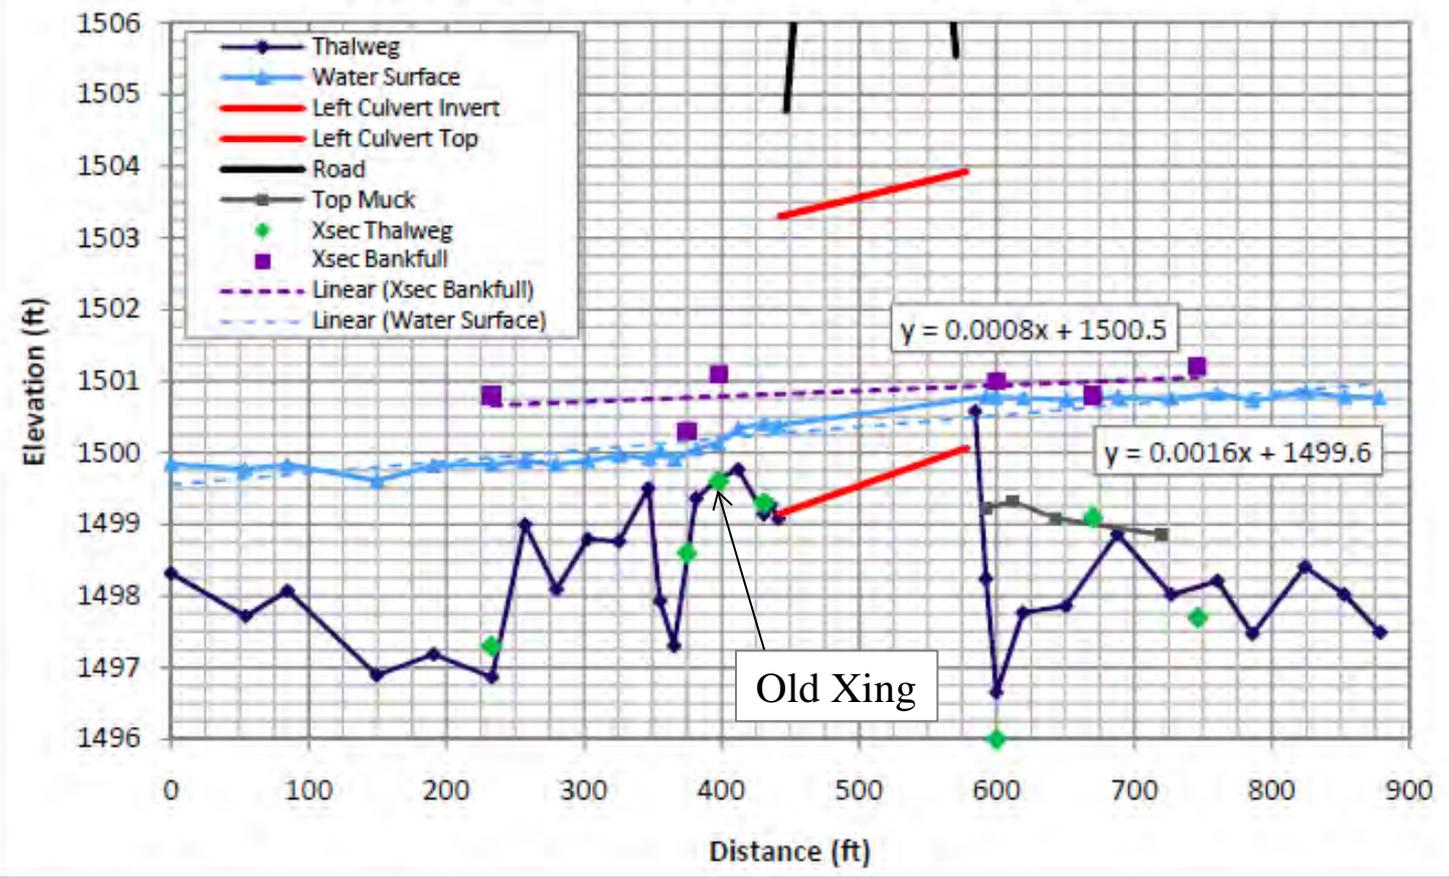
Upstream Ponding

Frequent Washouts on Flat Streams

Channel Morphology Impacts

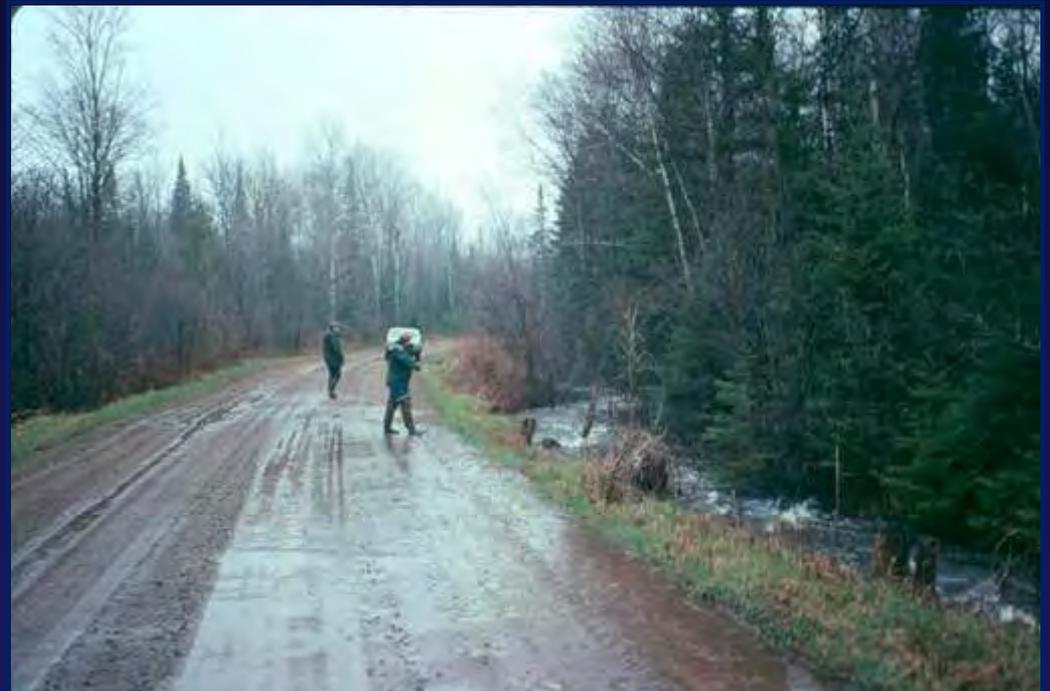
20 Mile Creek and Forest Road 378

Encroachment and Channelization

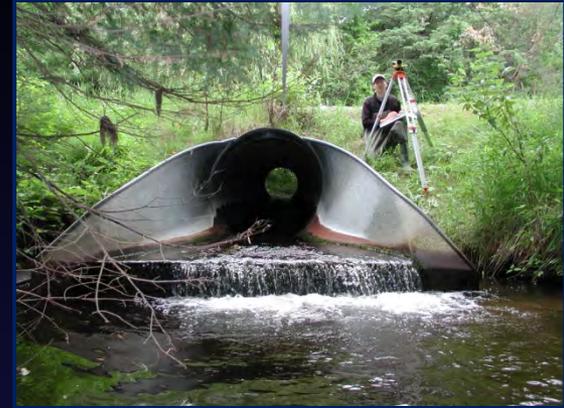
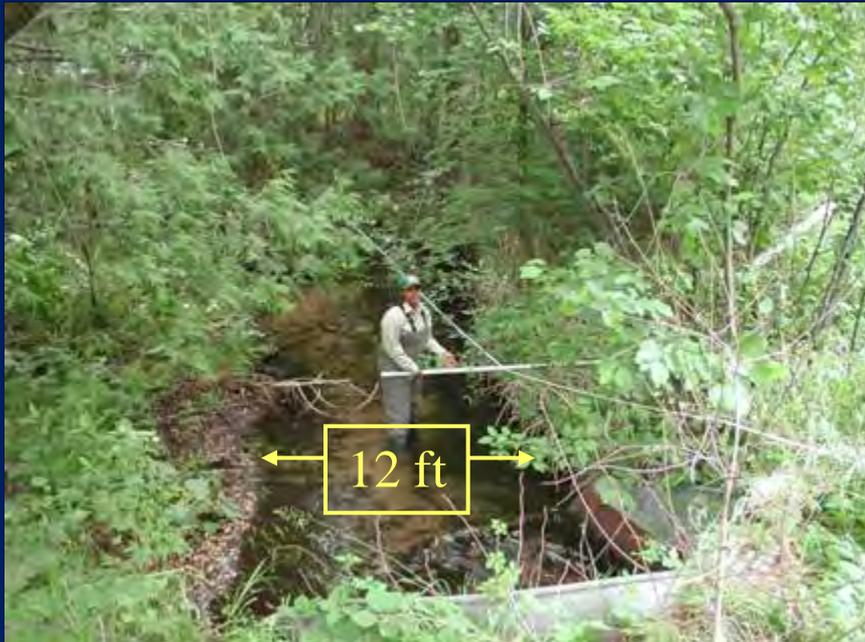
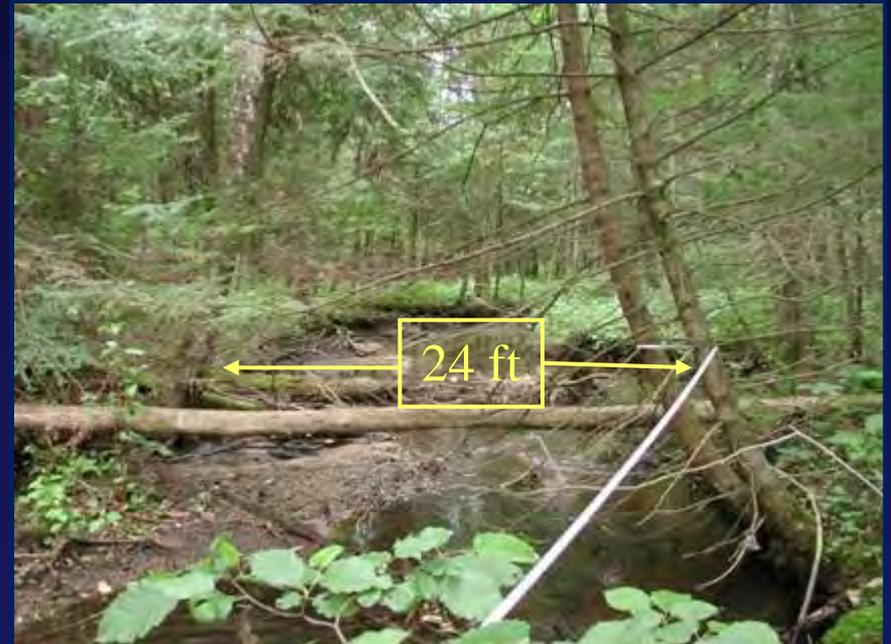
Downstream Scour

Upstream

Downstream

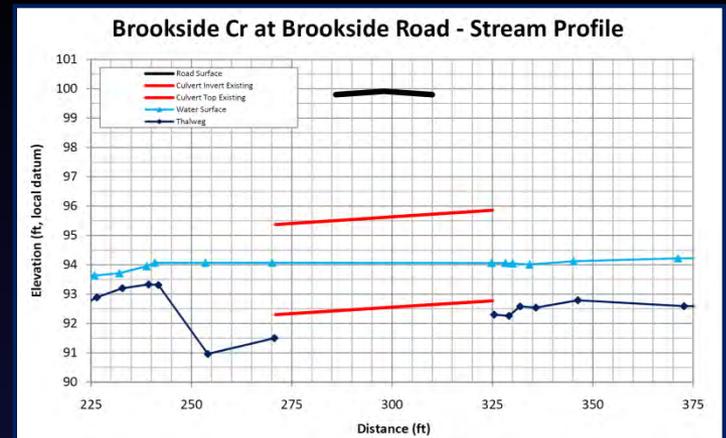
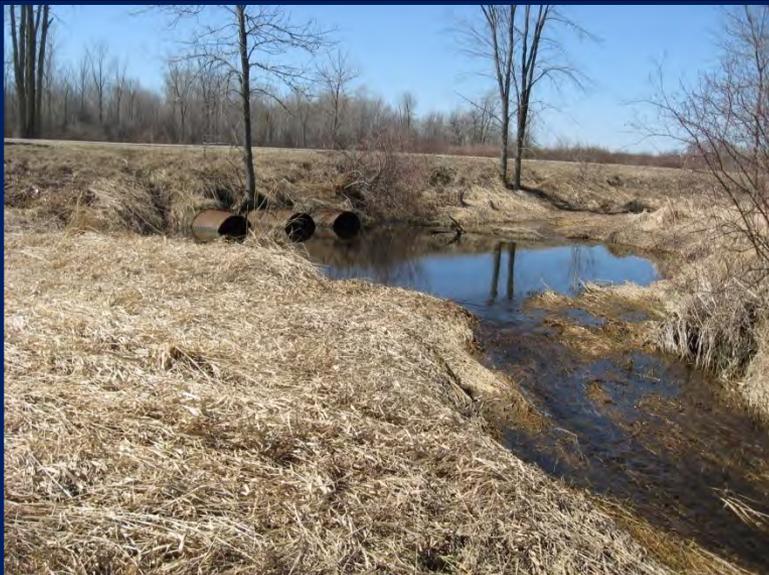
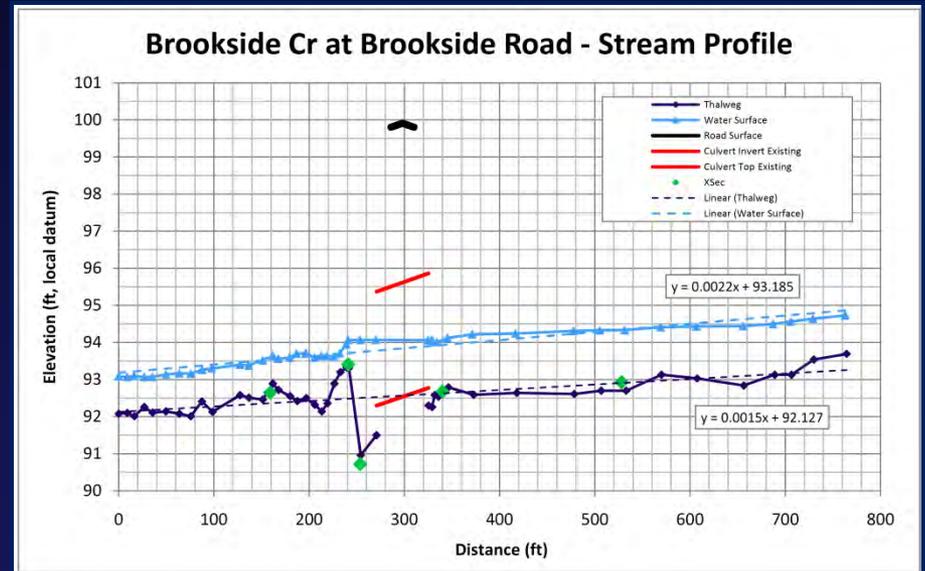
Plunge Pool

Downstream Scour

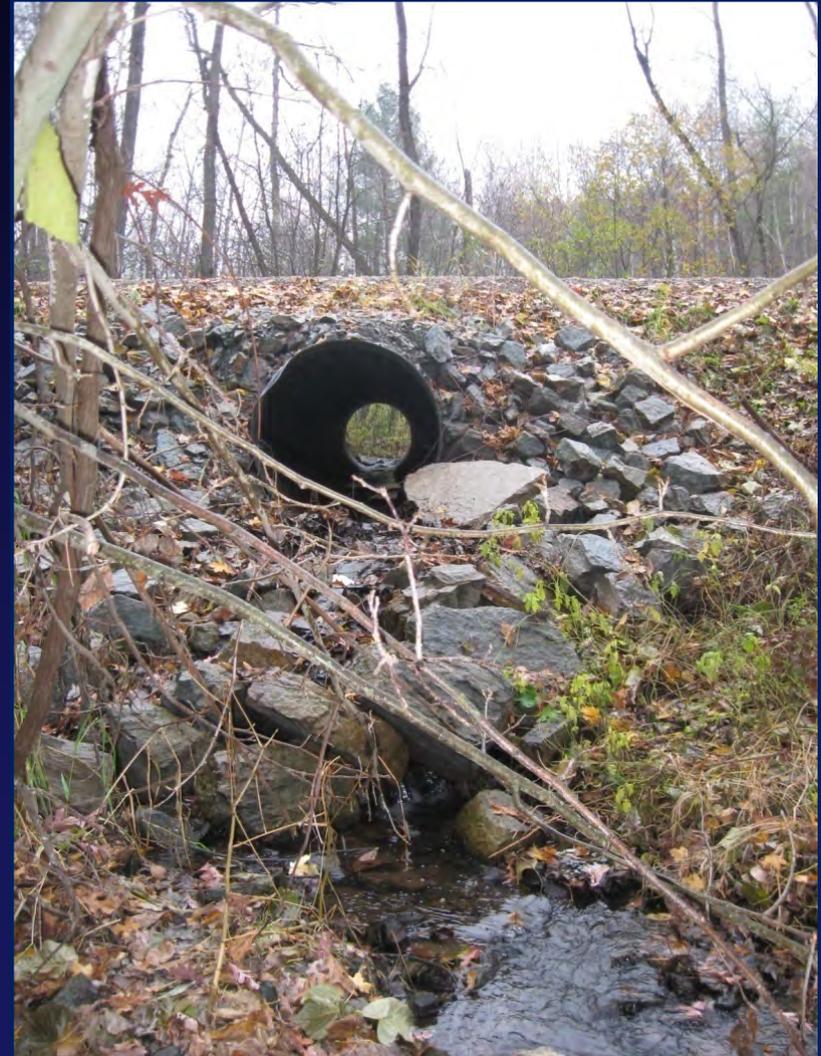
Headcuts and Culverts

In cases where a channel has degraded and a headcut has extended up to the culvert, grade controls may be necessary when replacing the culvert to ensure the headcut does not extend upstream.

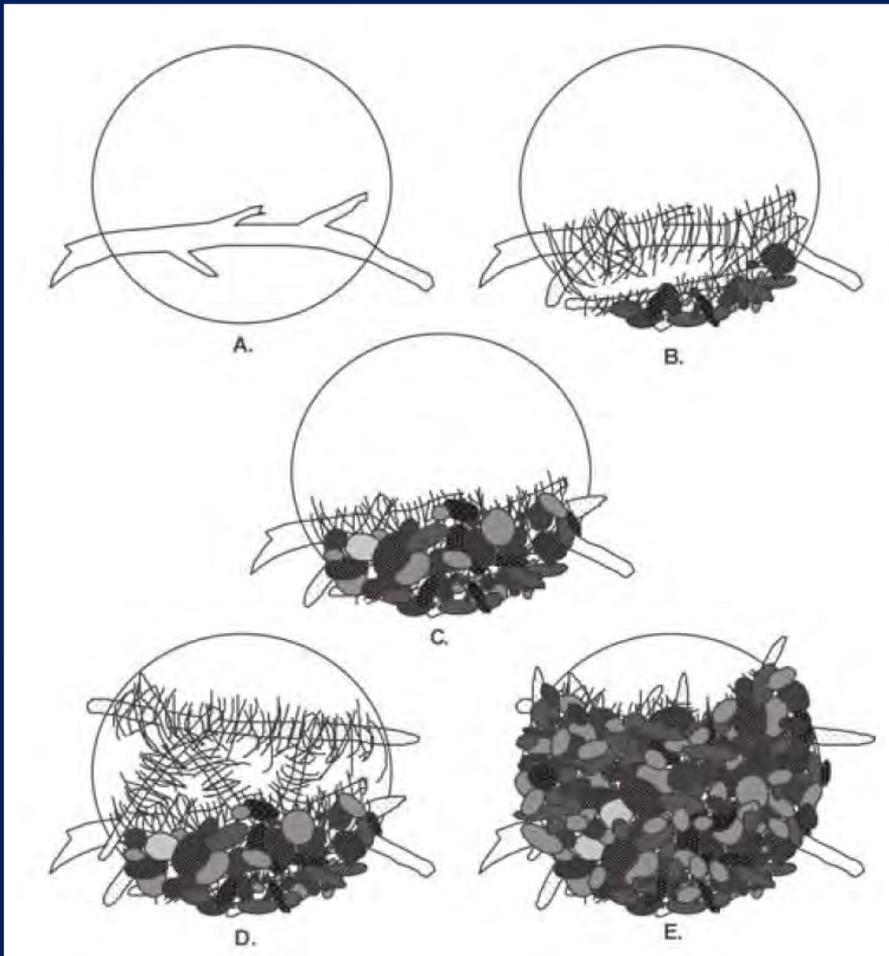
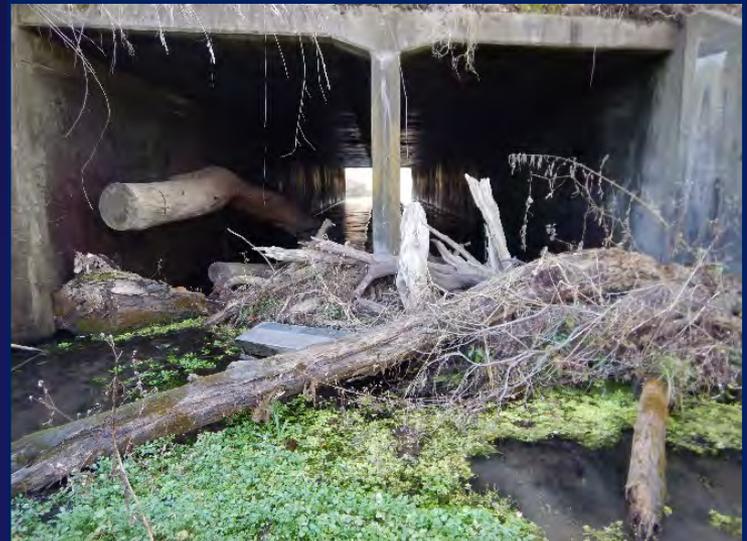
Study of woody debris transport at road-stream crossings in NW California study, 1993-95

- A. Initiator piece
- B. Sediment and detritus accumulation
- C. Debris consolidates
- D. Second initiator piece
- E. Plug grows upward

Flanagan, S.A. 2004. Woody Debris Transport through Low-order Stream Channels of Northwest California – Implications for Road-stream Crossing Failure. Arcata, CA: Humboldt State University. 114 p. M.S. Thesis Geology. Available online at: http://www.bof.fire.ca.gov/board/msg_supportedreports.html

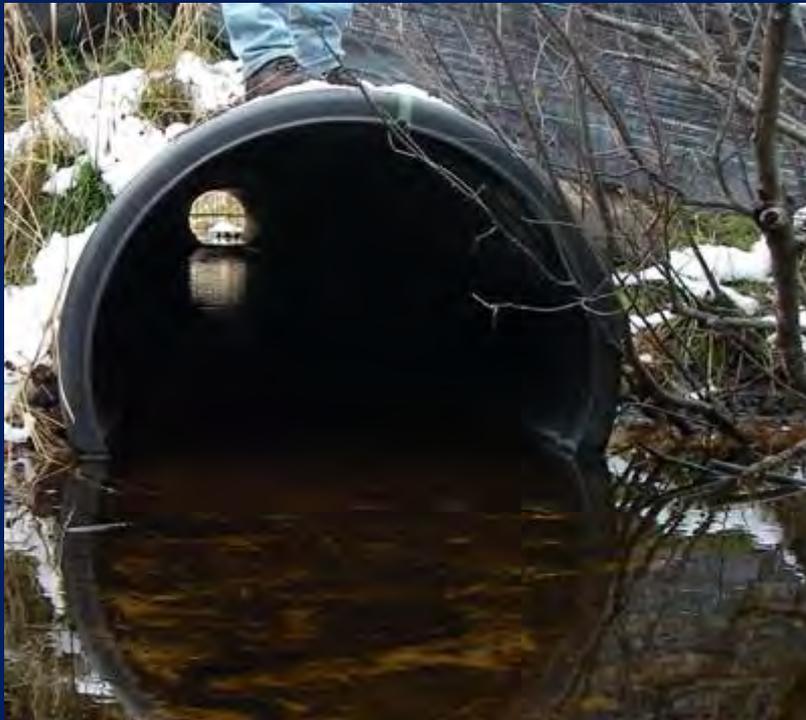
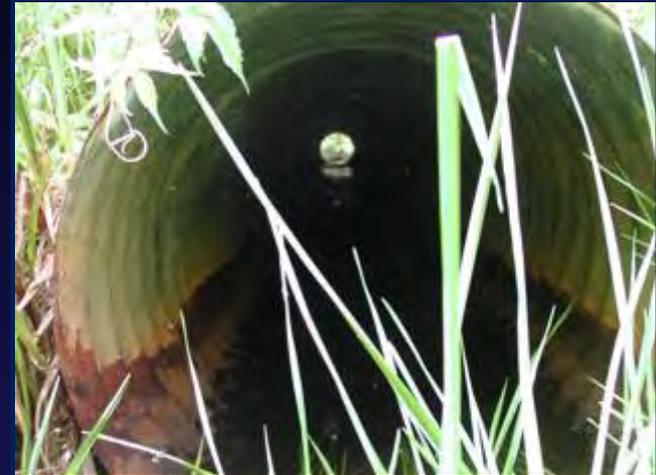
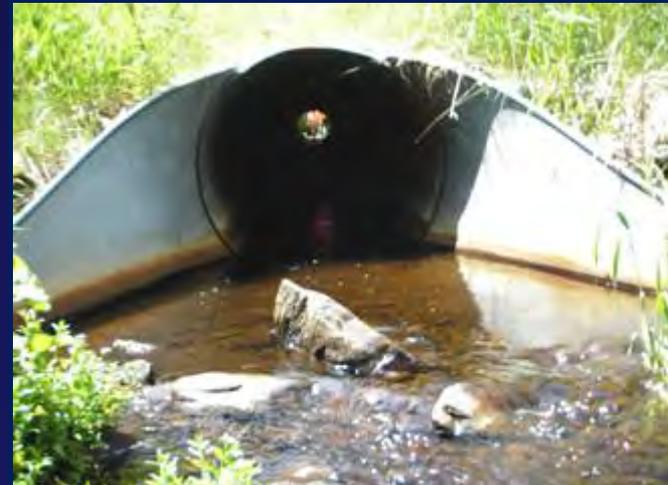
Openness Ratio - Behavioral Barriers

$X\text{-Sec Area (sq m) / Length (m)}$

(Reference: Scott Jackson)
