# Impacts of Road Crossings on Streams

Dale Higgins, retired hydrologist, USDA Forest Service

# Culvert and Road Impacts

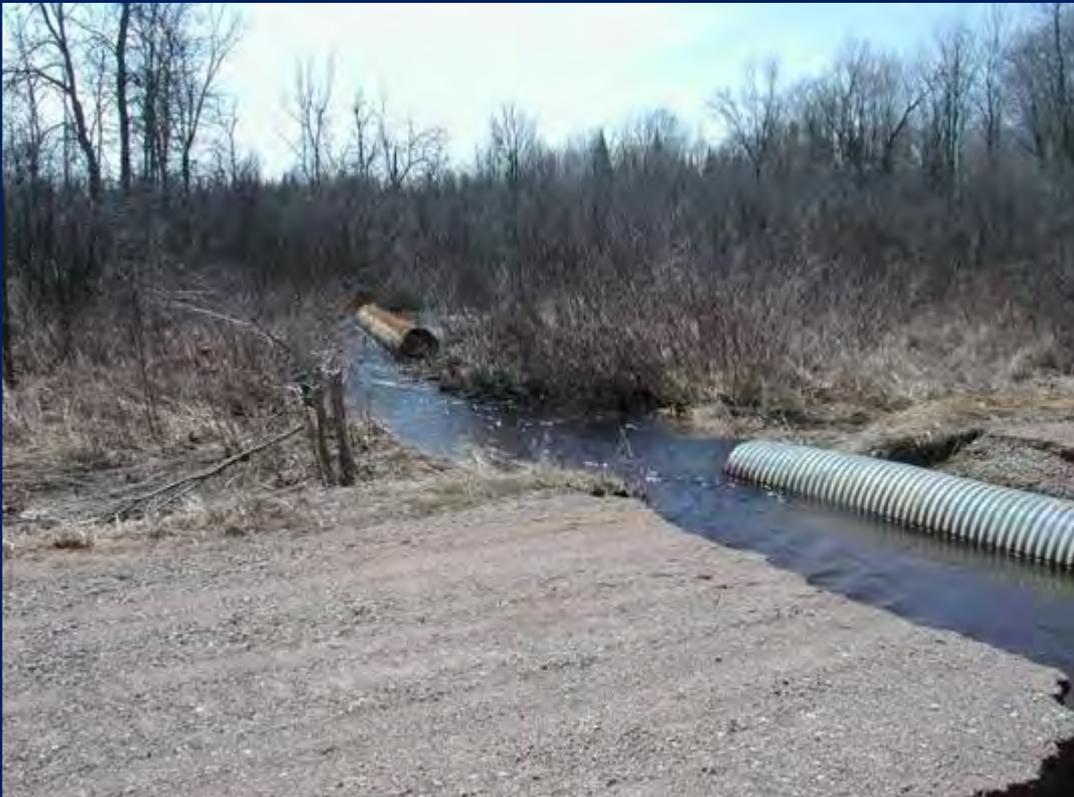
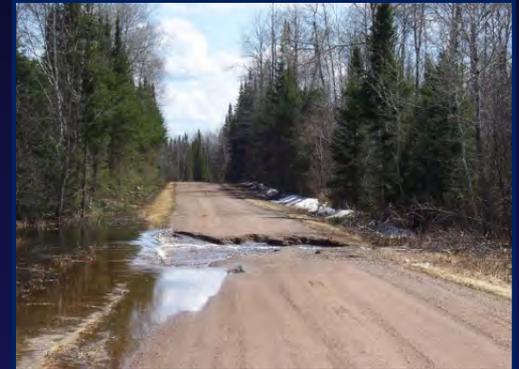
**Major source**

- Sediment volume
- Sediment delivery

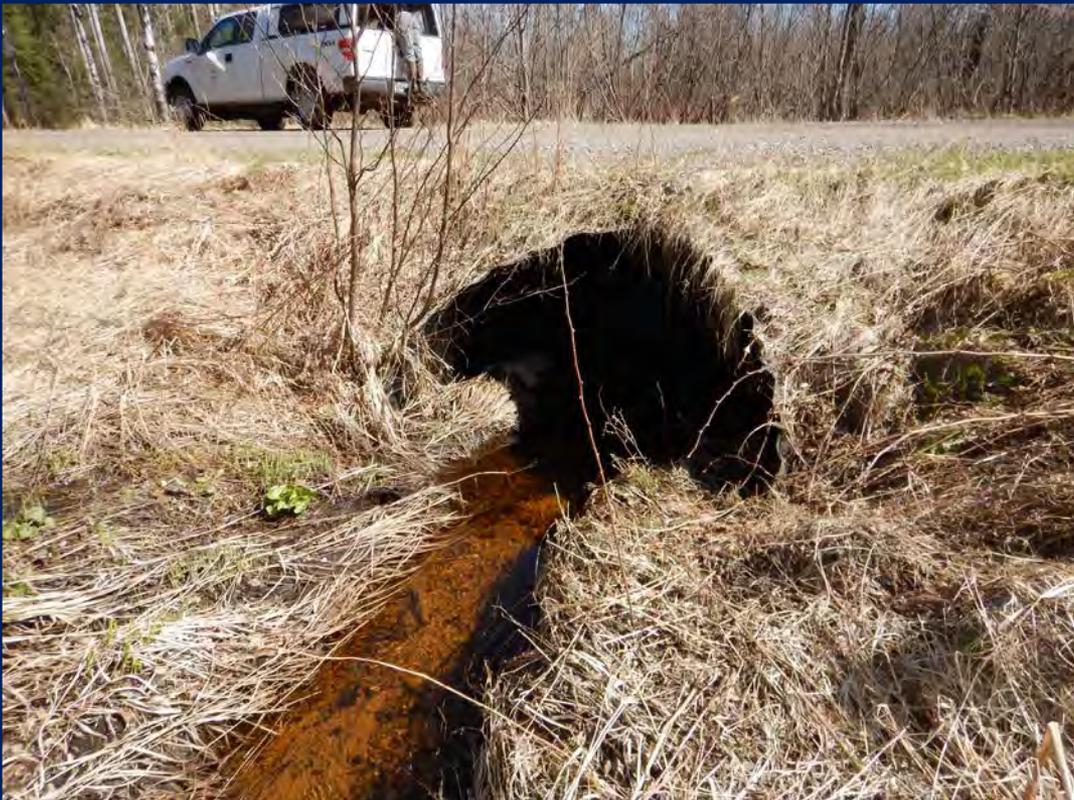
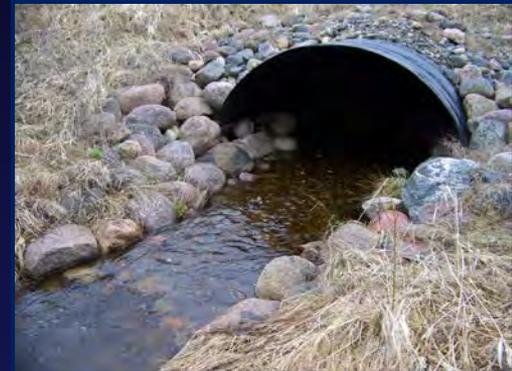
### Solutions:

- bankfull width
- $HW/D < 0.8$  at  $Q_{100}$
- proper construction

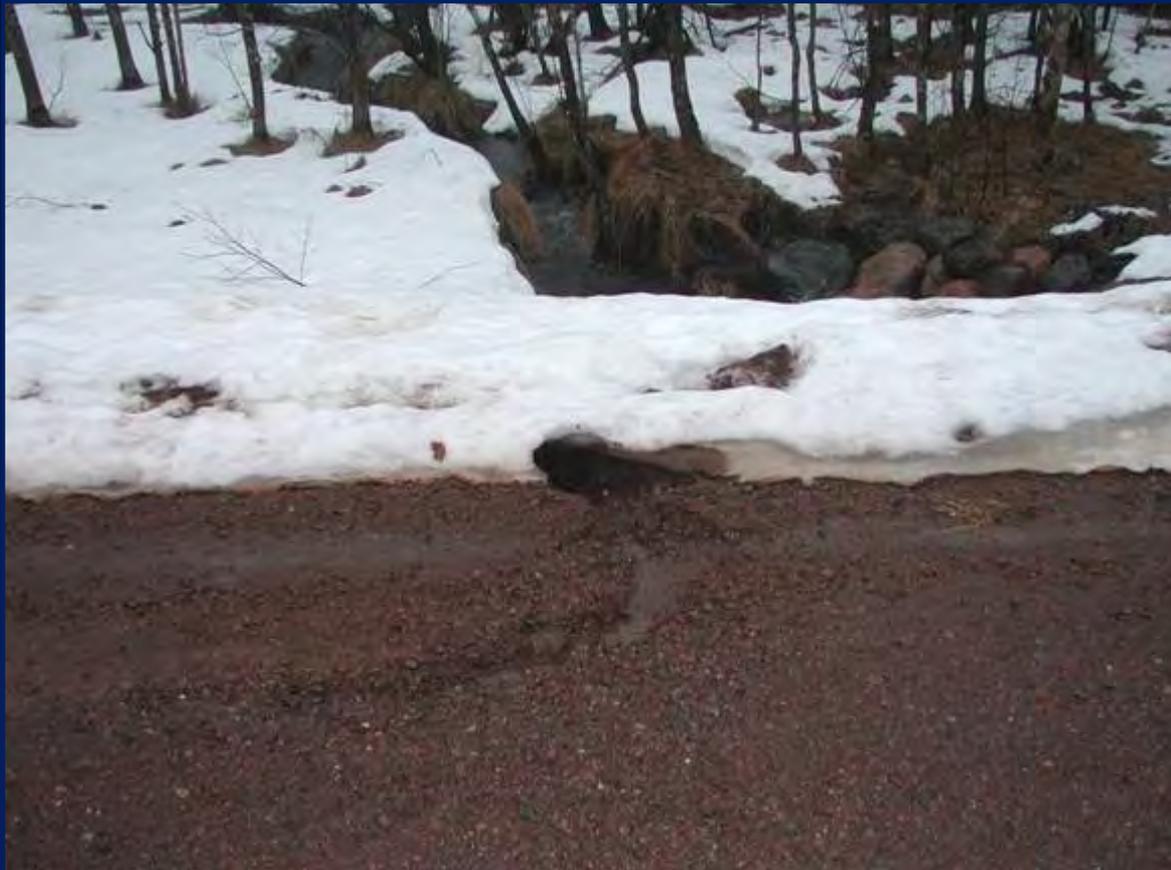
- **Surface material**
- **Drainage**
- **Slope length**
- **Slope steepness**
- **Low point**

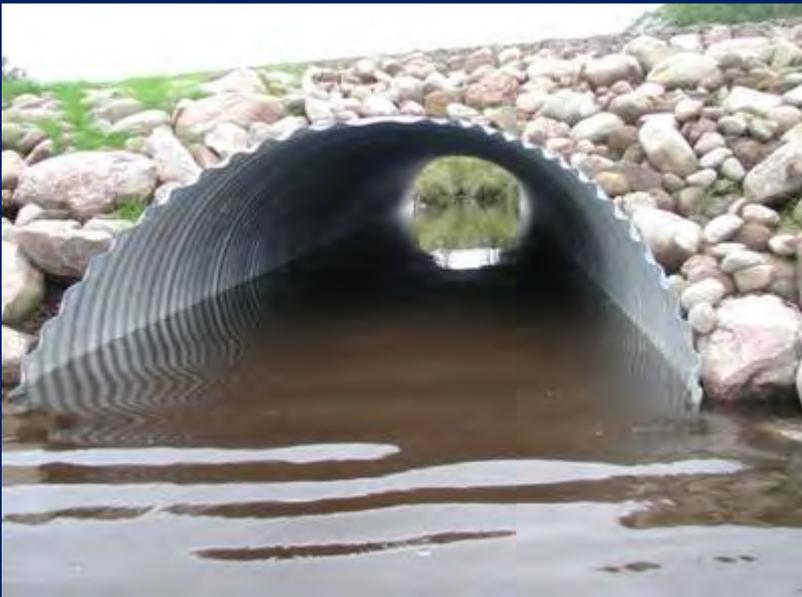
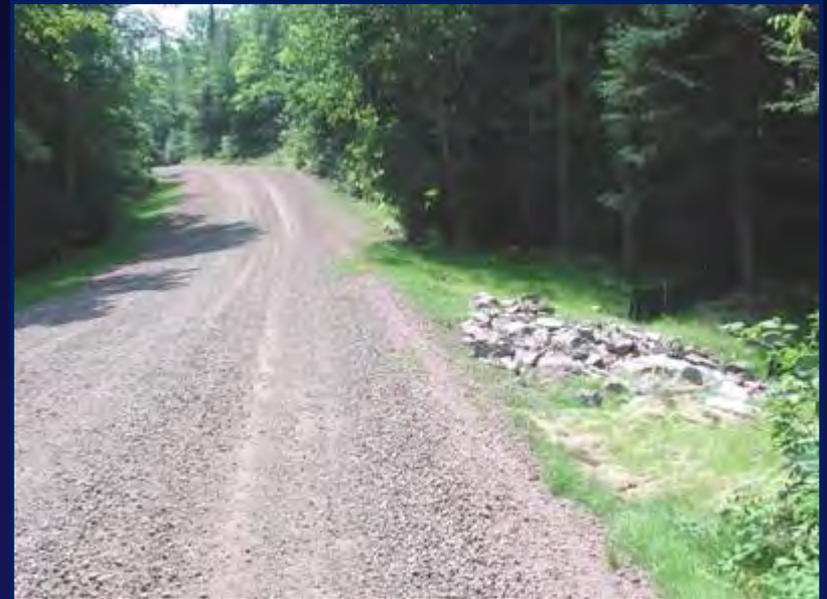
Stable side-slopes 2:1 or less, adequate riprap, properly sized culvert with  $HW/D < 0.8$  for 100-yr flow. Beveled culverts can reduce maintenance.

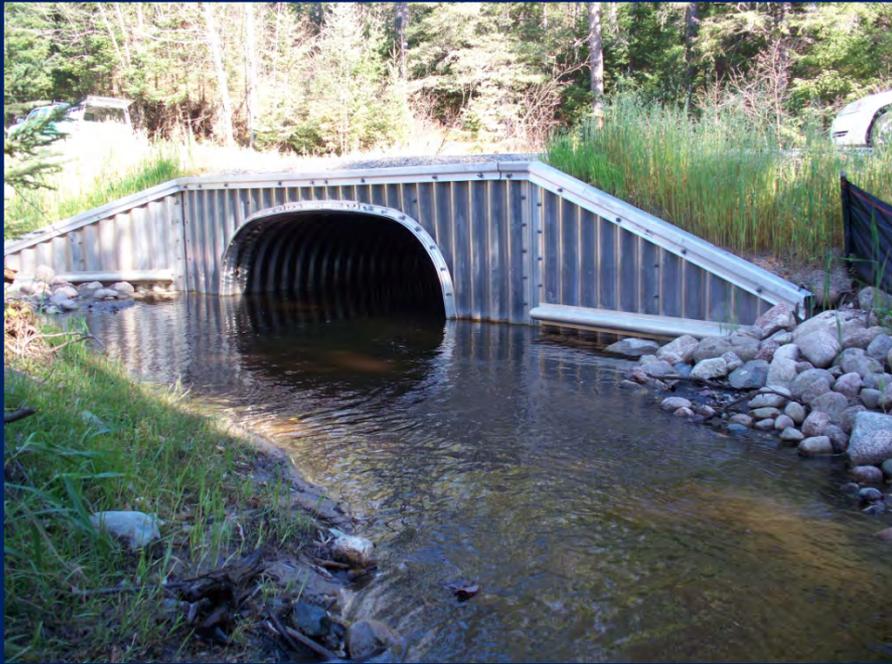
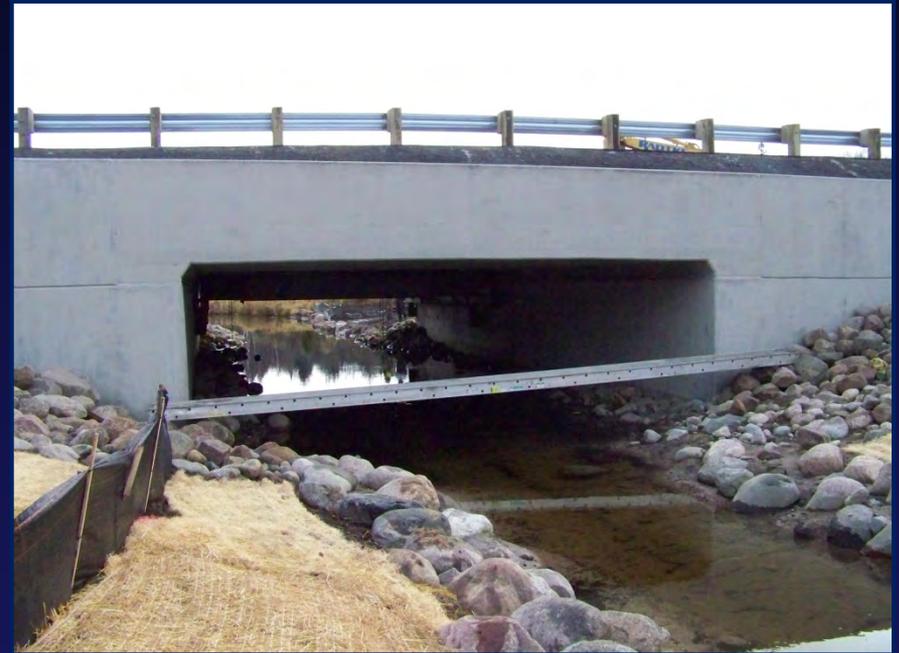
Headwalls for embankment protection and to shorten culverts.

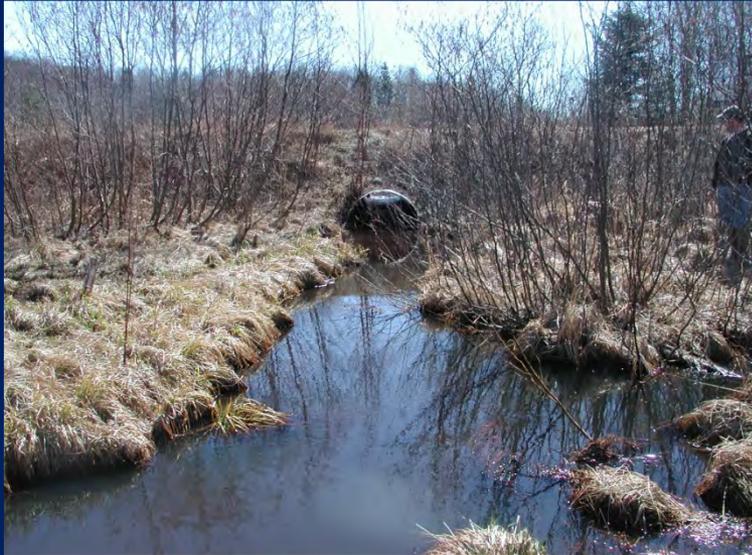
## Culvert Too High on Flat Streams, Channel Morphology Impacts

Culverts that constrict the channel too much can elevate the headwater and cause extreme velocities at high flows. This scours a large plunge pool with an elevated tailwater control that ponds water upstream. The lower upstream velocities can cause the channel to aggrade and allow vegetation to encroach.

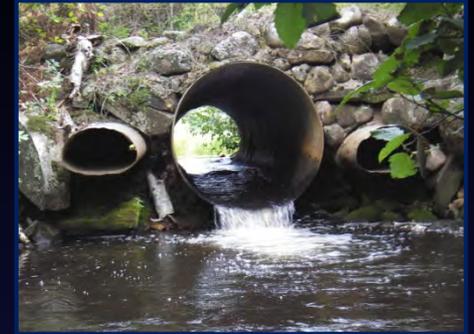
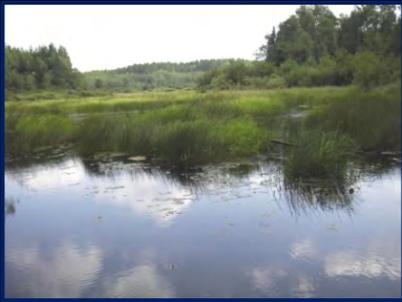
Simpson Creek at Forest Road 2386 (Site 62303)

# Upstream Ponding Water Temperature (and other) Impacts

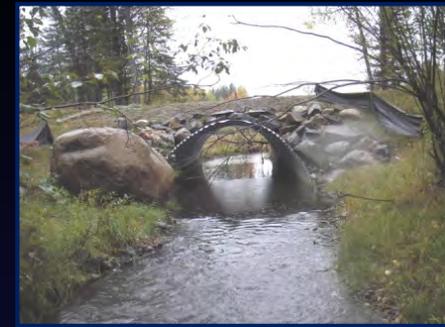
Simpson Creek After Culvert Replacement

# Upstream Ponding Water Temperatures Impacts

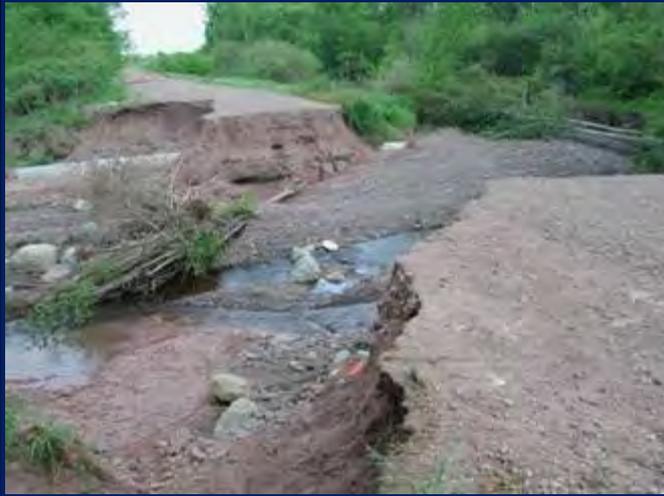
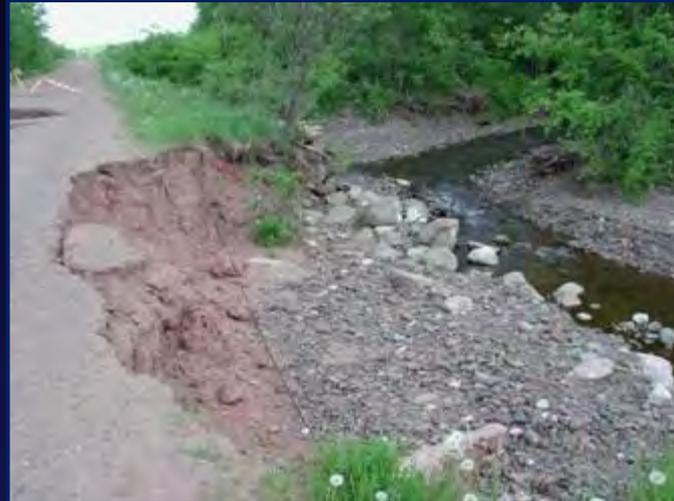
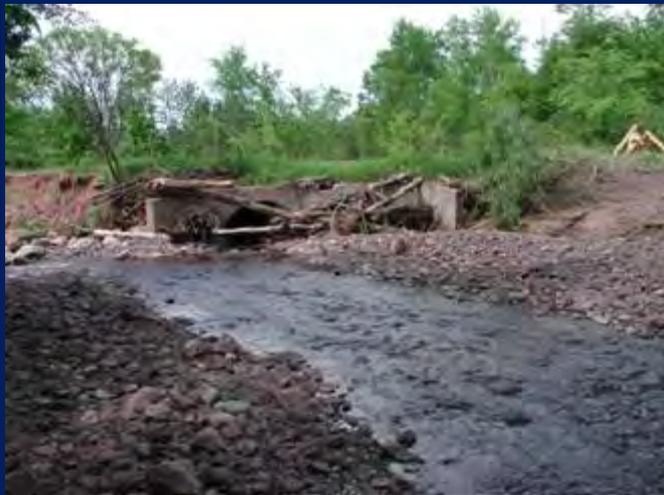
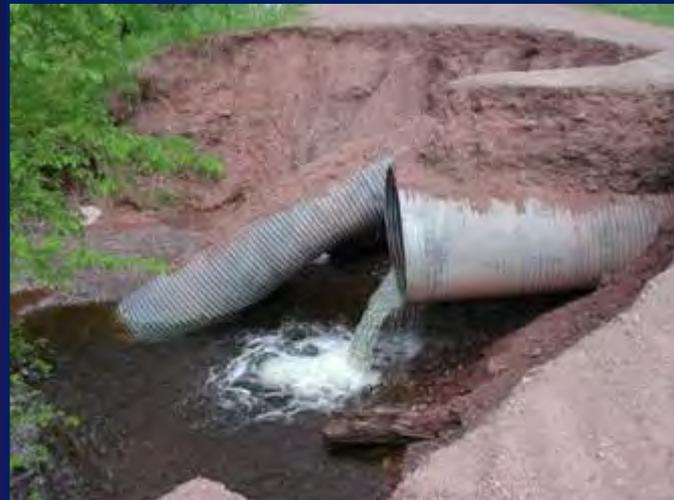
# Gravel Bed Accumulation on Steep Streams

## Channel Morphology Impacts

- Maintain transport of gravel and cobble sediment
- Stream simulation
- Bankfull width channel
- Natural bedforms and profile

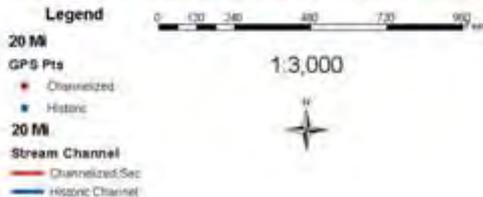
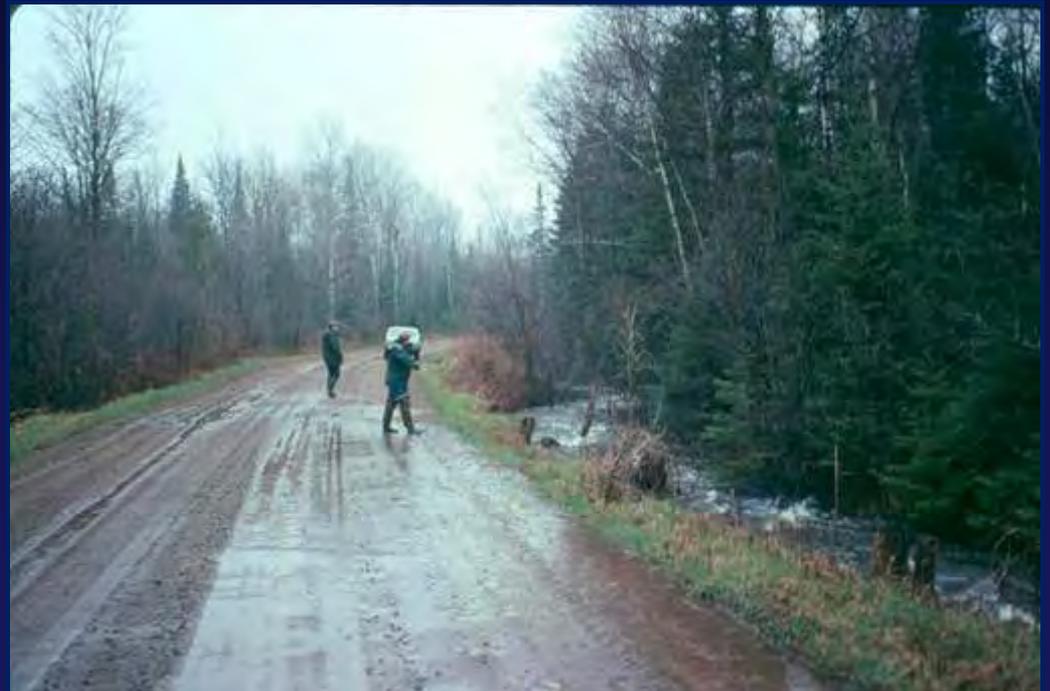
20 Mile Creek and Forest Road 378

# Encroachment and Channelization

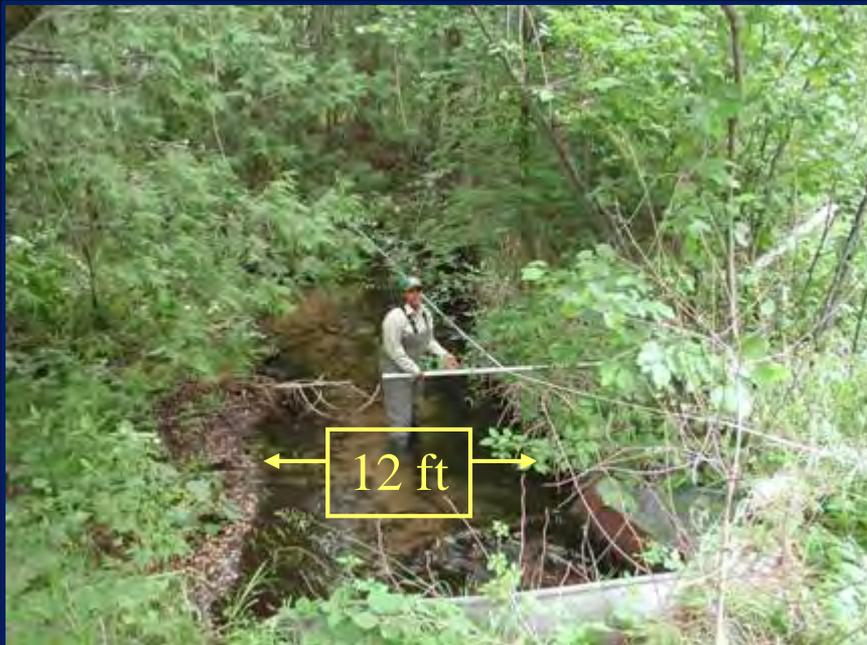
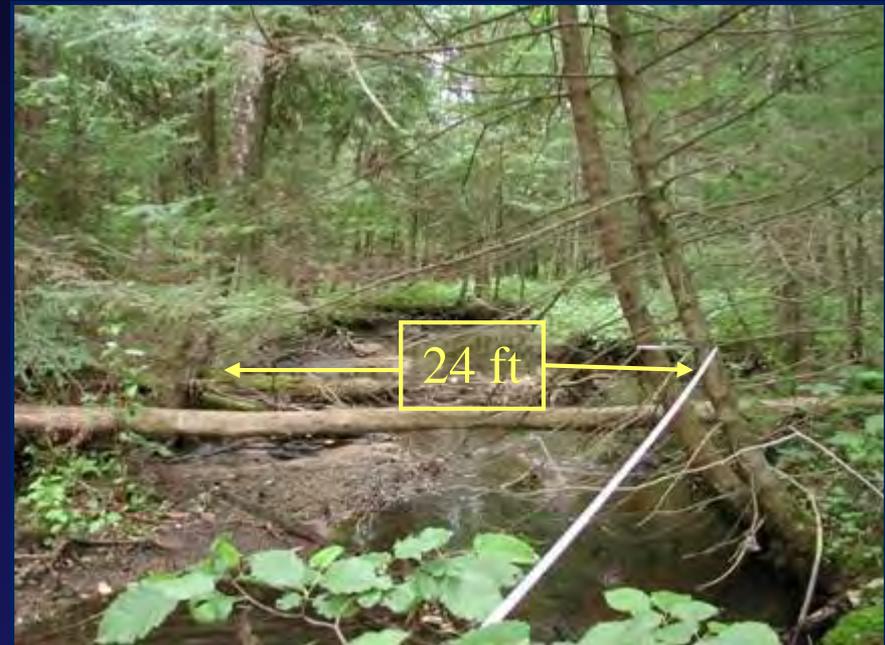
# Downstream Scour

Upstream

Downstream

Solution: bankfull width culvert set at the proper elevation

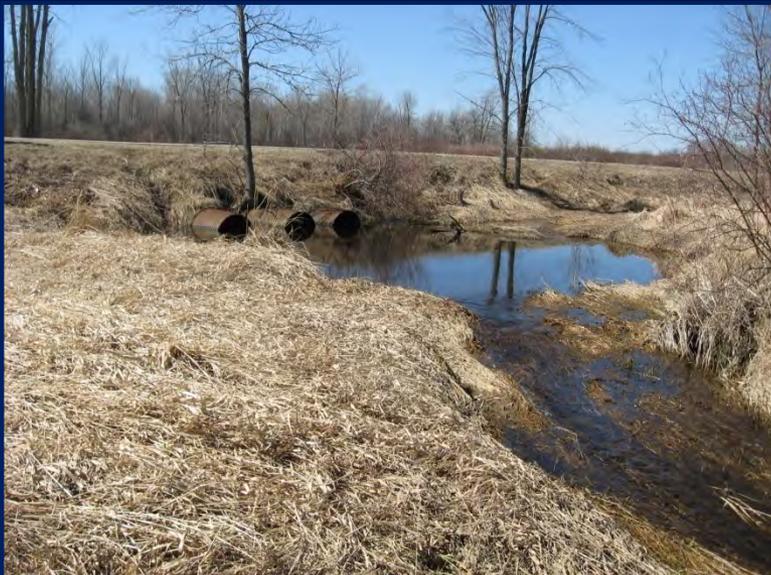
## Plunge Pool

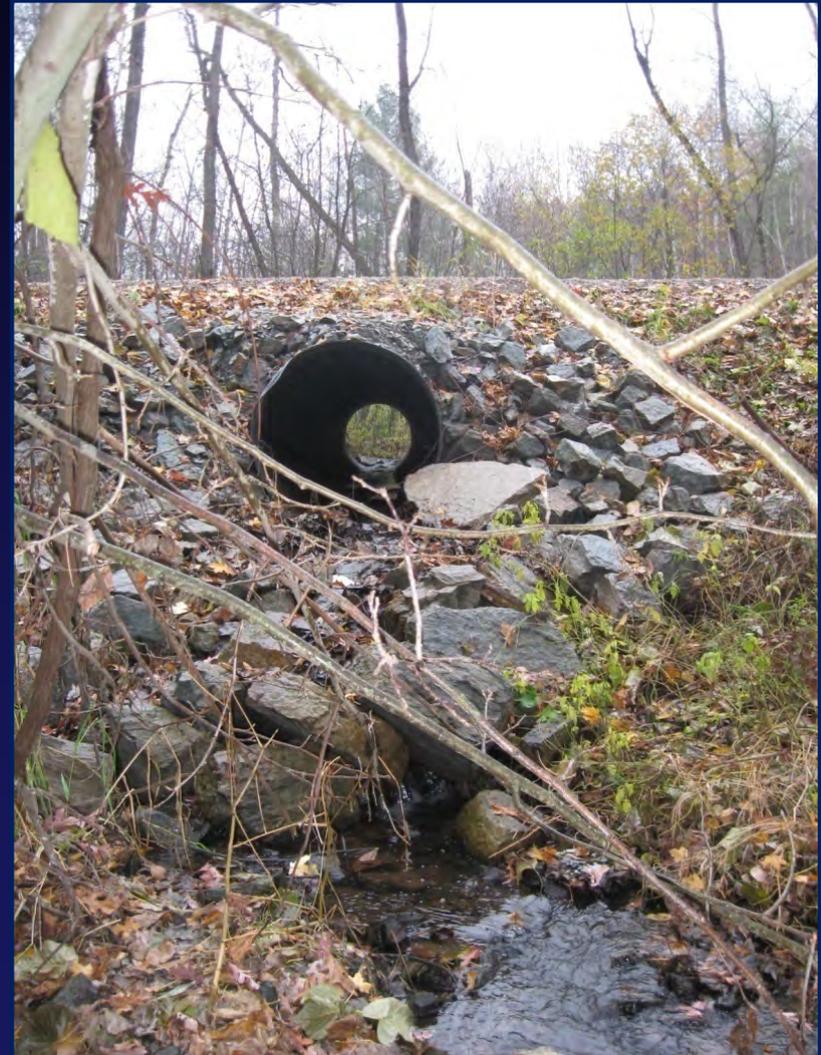
Trout Creek at Melanie Lane Profile

In cases where a channel has degraded and a headcut has extended up to the culvert, grade controls may be necessary when replacing the culvert to ensure the headcut does not extend upstream.

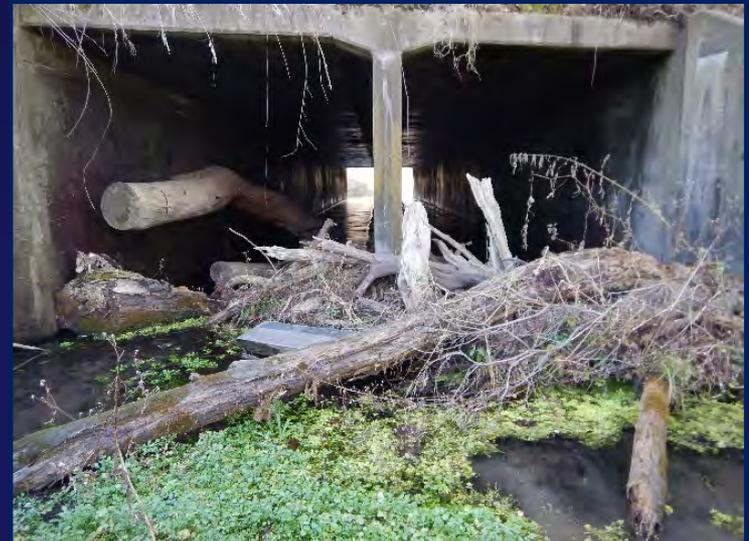
Study of woody debris transport at road-stream crossings in NW California study, 1993-95

- A. Initiator piece
- B. Sediment and detritus accumulation
- C. Debris consolidates
- D. Second initiator piece
- E. Plug grows upward
