Village of Centuria Long Lake Boat Landing

Stormwater Mitigation Options

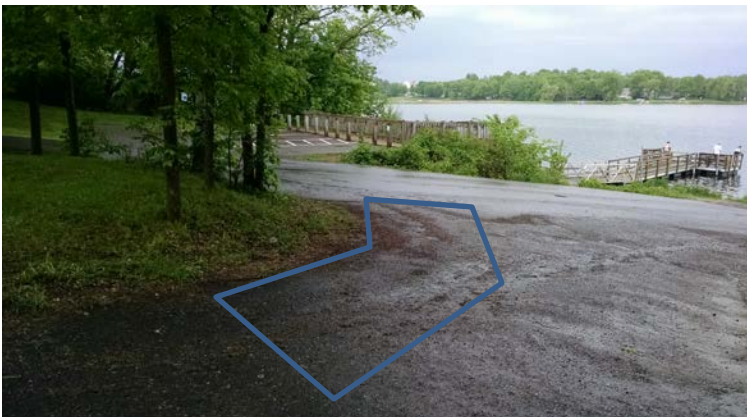
Here is another area where under-pavement infiltration could be installed. A diversion (trench or asphalt bump) would be needed to get water to this spot.
