**SANITARY SEWER REPORT
UPPER POST LAKE**

**Project #10432.SS
July 1994**

**Mid-State Associates, Inc.
1230 South Boulevard
Baraboo, Wisconsin 53913**

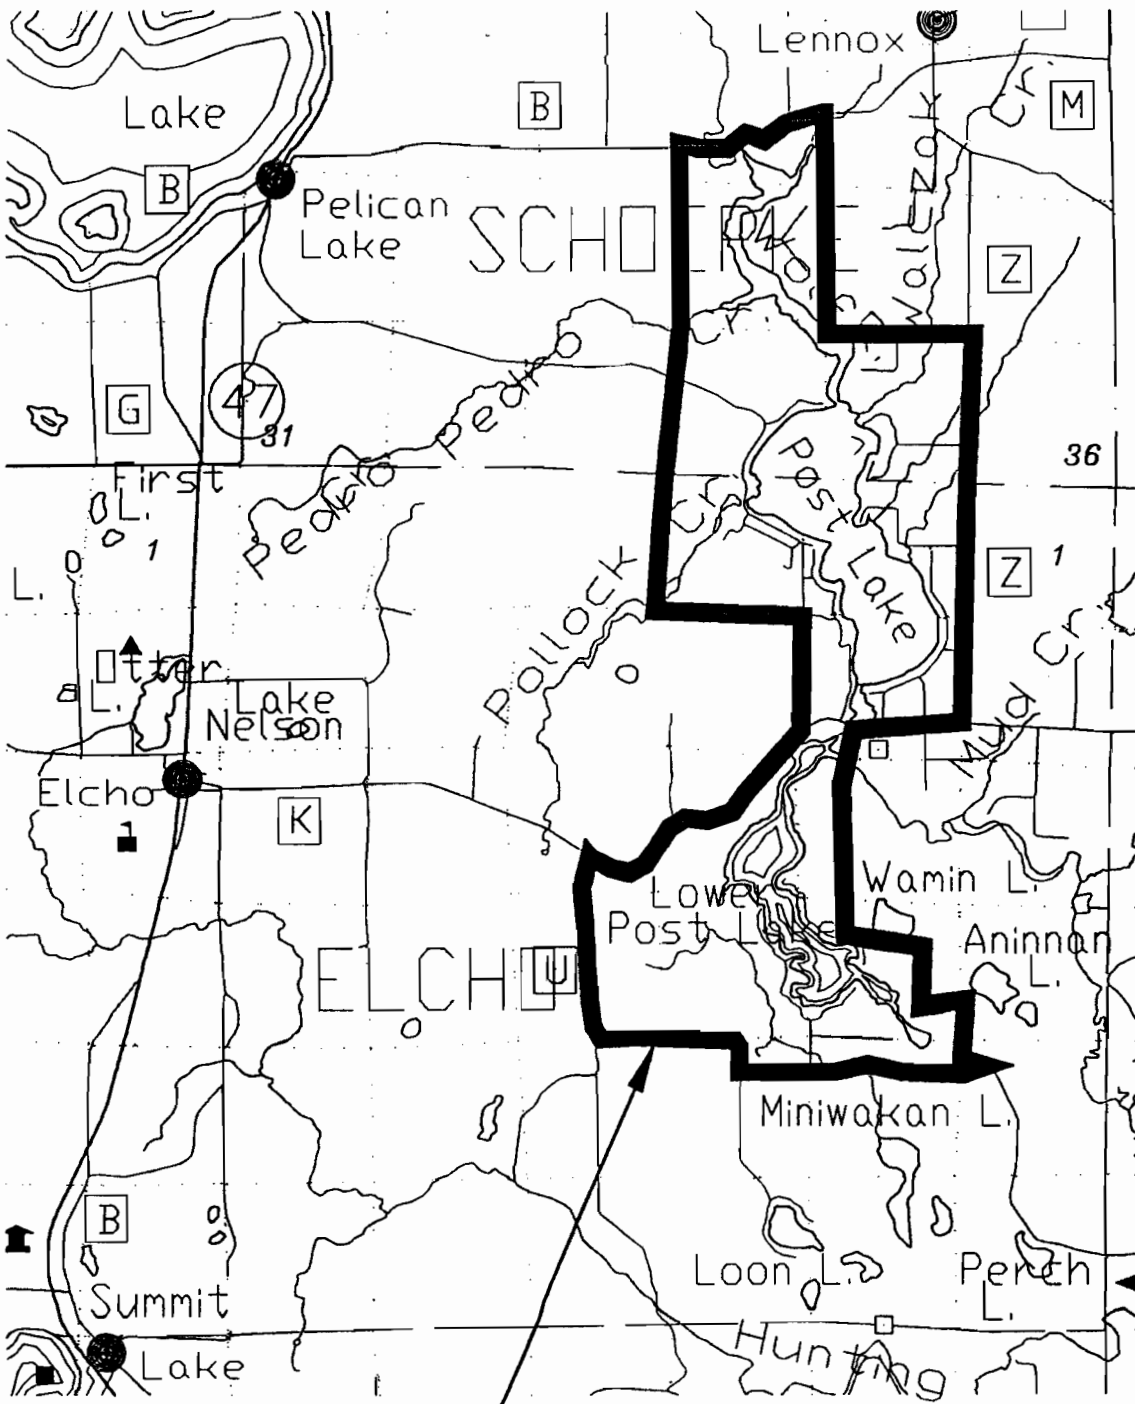
FIGURE 1

POST LAKE
REHABILITATION
AND PROTECTION
DISTRICT BOUNDARY

PLATE 1	
POST LAKE

Figure 1	Plate 1
Figure 2	Owner's Questionnaire
Figure 3	Inspection Report
