**SANITARY SEWER REPORT
LOWER POST LAKE
PHASE II**

**Project #259603.SSR
June 1996**

**Mid-State Associates, Inc.
1230 South Boulevard
Baraboo, Wisconsin 53913**

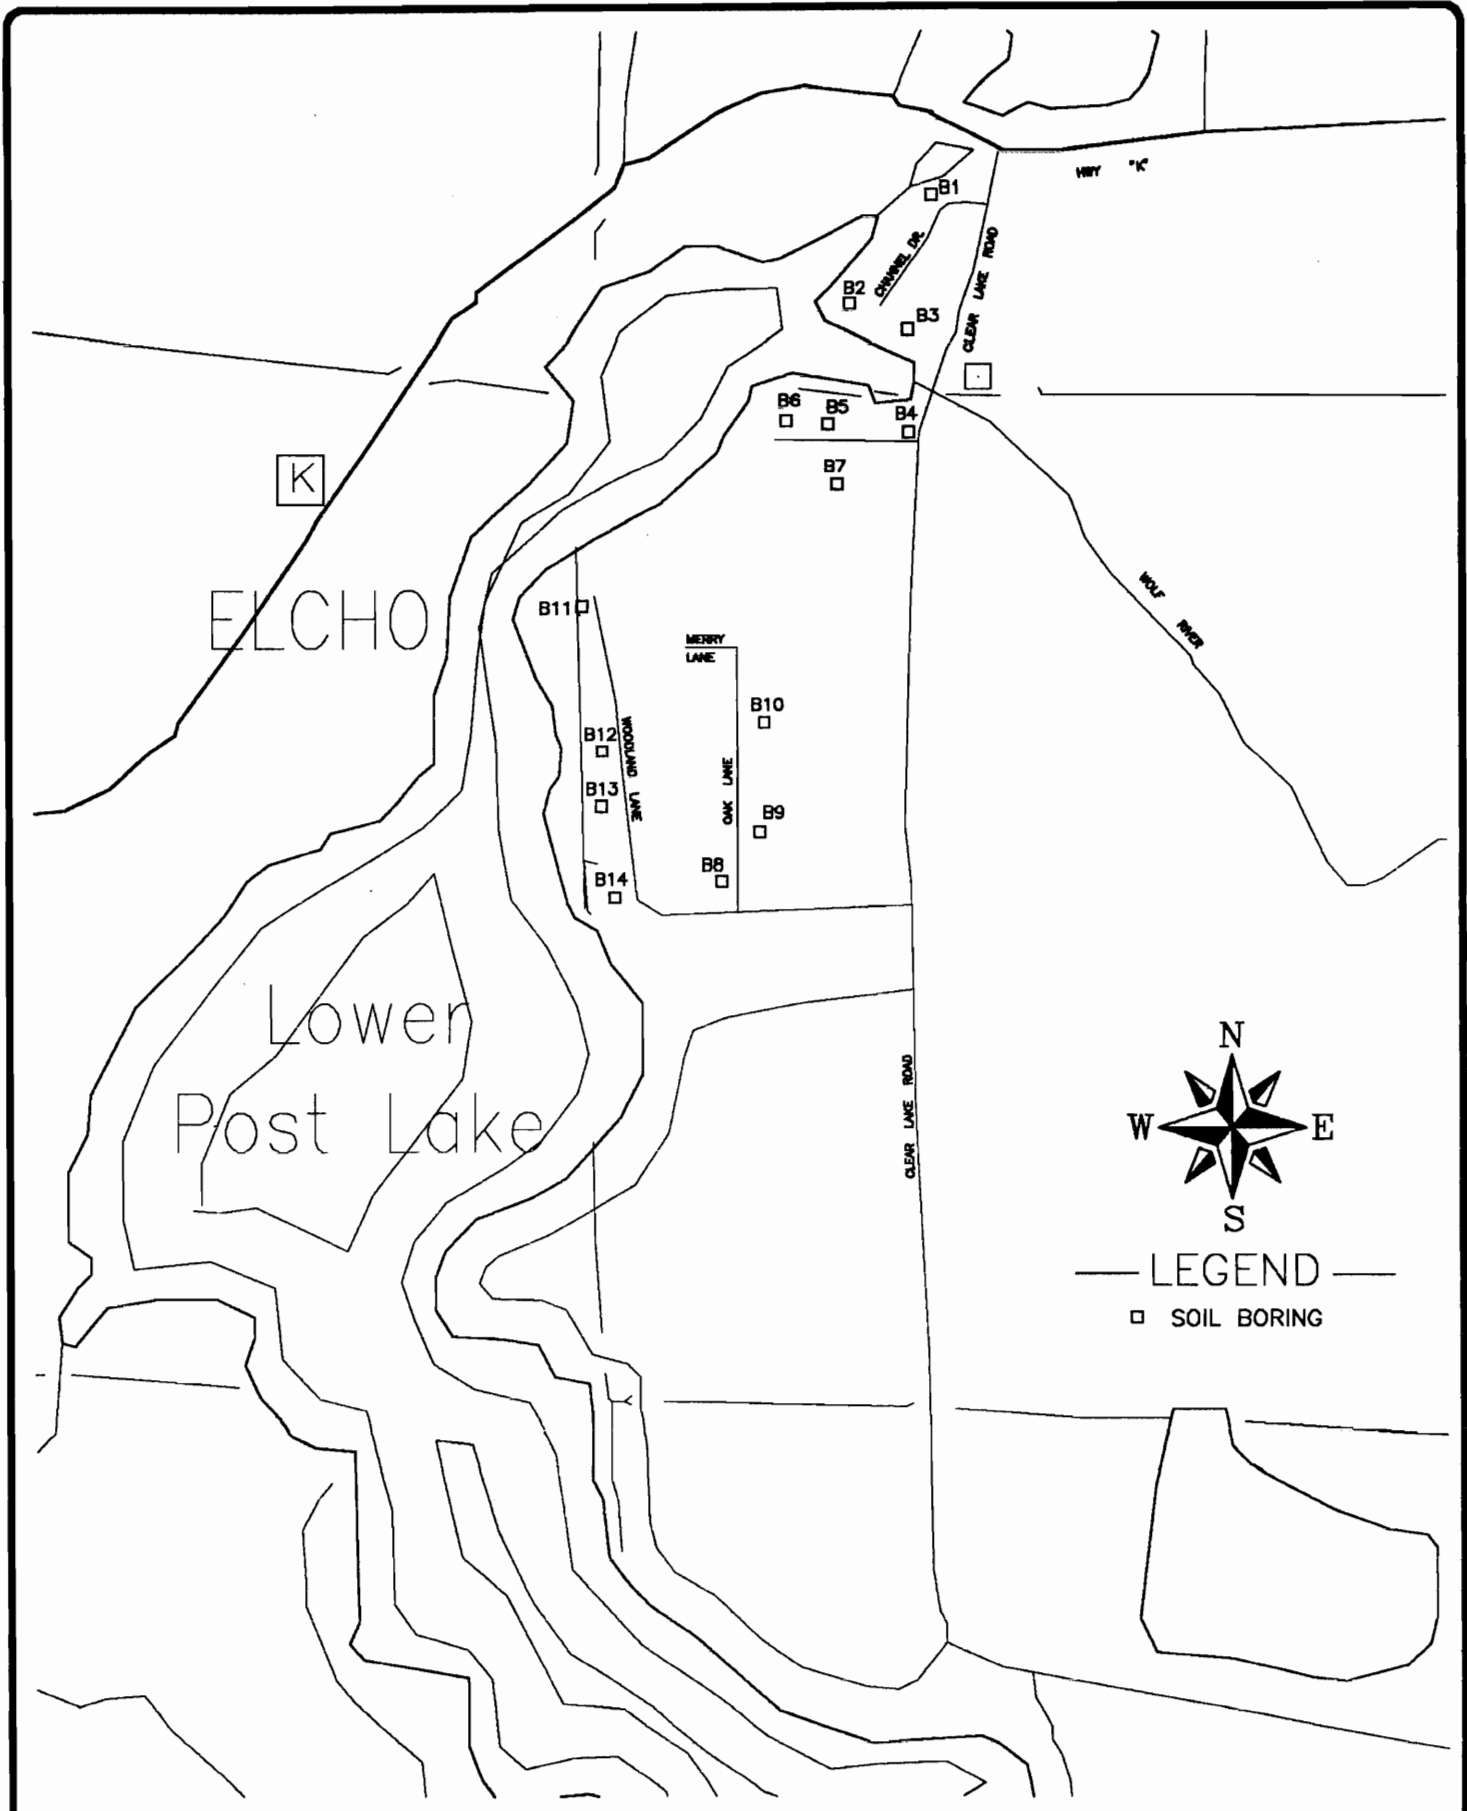
**PHASE II
SOIL BORINGS**

SCALE: AS SHOWN	DATE: JUNE, 1996
FIELD BOOK: N/A	MSA PROJECT #: 259803
DRAWN BY: DAW	MSA FILE #: 259803B.DWG
CHECKED BY:	SHEET #: FIGURE 4

- Figure 1 Location Map
- Figure 2 Owner's Questionnaire
- Figure 3 Inspection Report
- Figure 4 Soil Boring Map
