RE: Serial Letter #61
Sheboygan River and Harbor Superfund Site – EPA Review of Remedial
Action Plan for Tecumseh Falls and Maryland Avenue Sites
SME Project No. 069638.00.051.000

Pursuant to your request, SME has reviewed readily available historical information and historical assessment reports for the former Tecumseh Products Company Site (Site, Figure 1). The objective of our review was to evaluate the completeness of the historical investigations in assessing soil on the Site with a primary focus on the presence of polychlorinated biphenyls (PCBs). Your request was initiated by SME's discovery of PCB-impacted soil located north, east and northeast of the foundation slab of the former manufacturing building.

FIGURE No.	SHEET TITLE
1.	Cover Sheet
2A.	September 1978 Assessment Sample Locations
2B.	December 1978 Assessment Sample Locations
3A.	1999 Site and Riverbank Assessment Sample Locations
3B.	1999 Site Composite Assessment Sample Locations
4A.	2004 Plant Source (PS) Confirmatory Sample Locations with Remediation Area Boundary
4B.	2004 Riverbank (RB) Confirmatory Sample Locations with Remedial Area Boundary
4C.	2004 Preferential Pathway (PP) Confirmatory Sample Locations wi

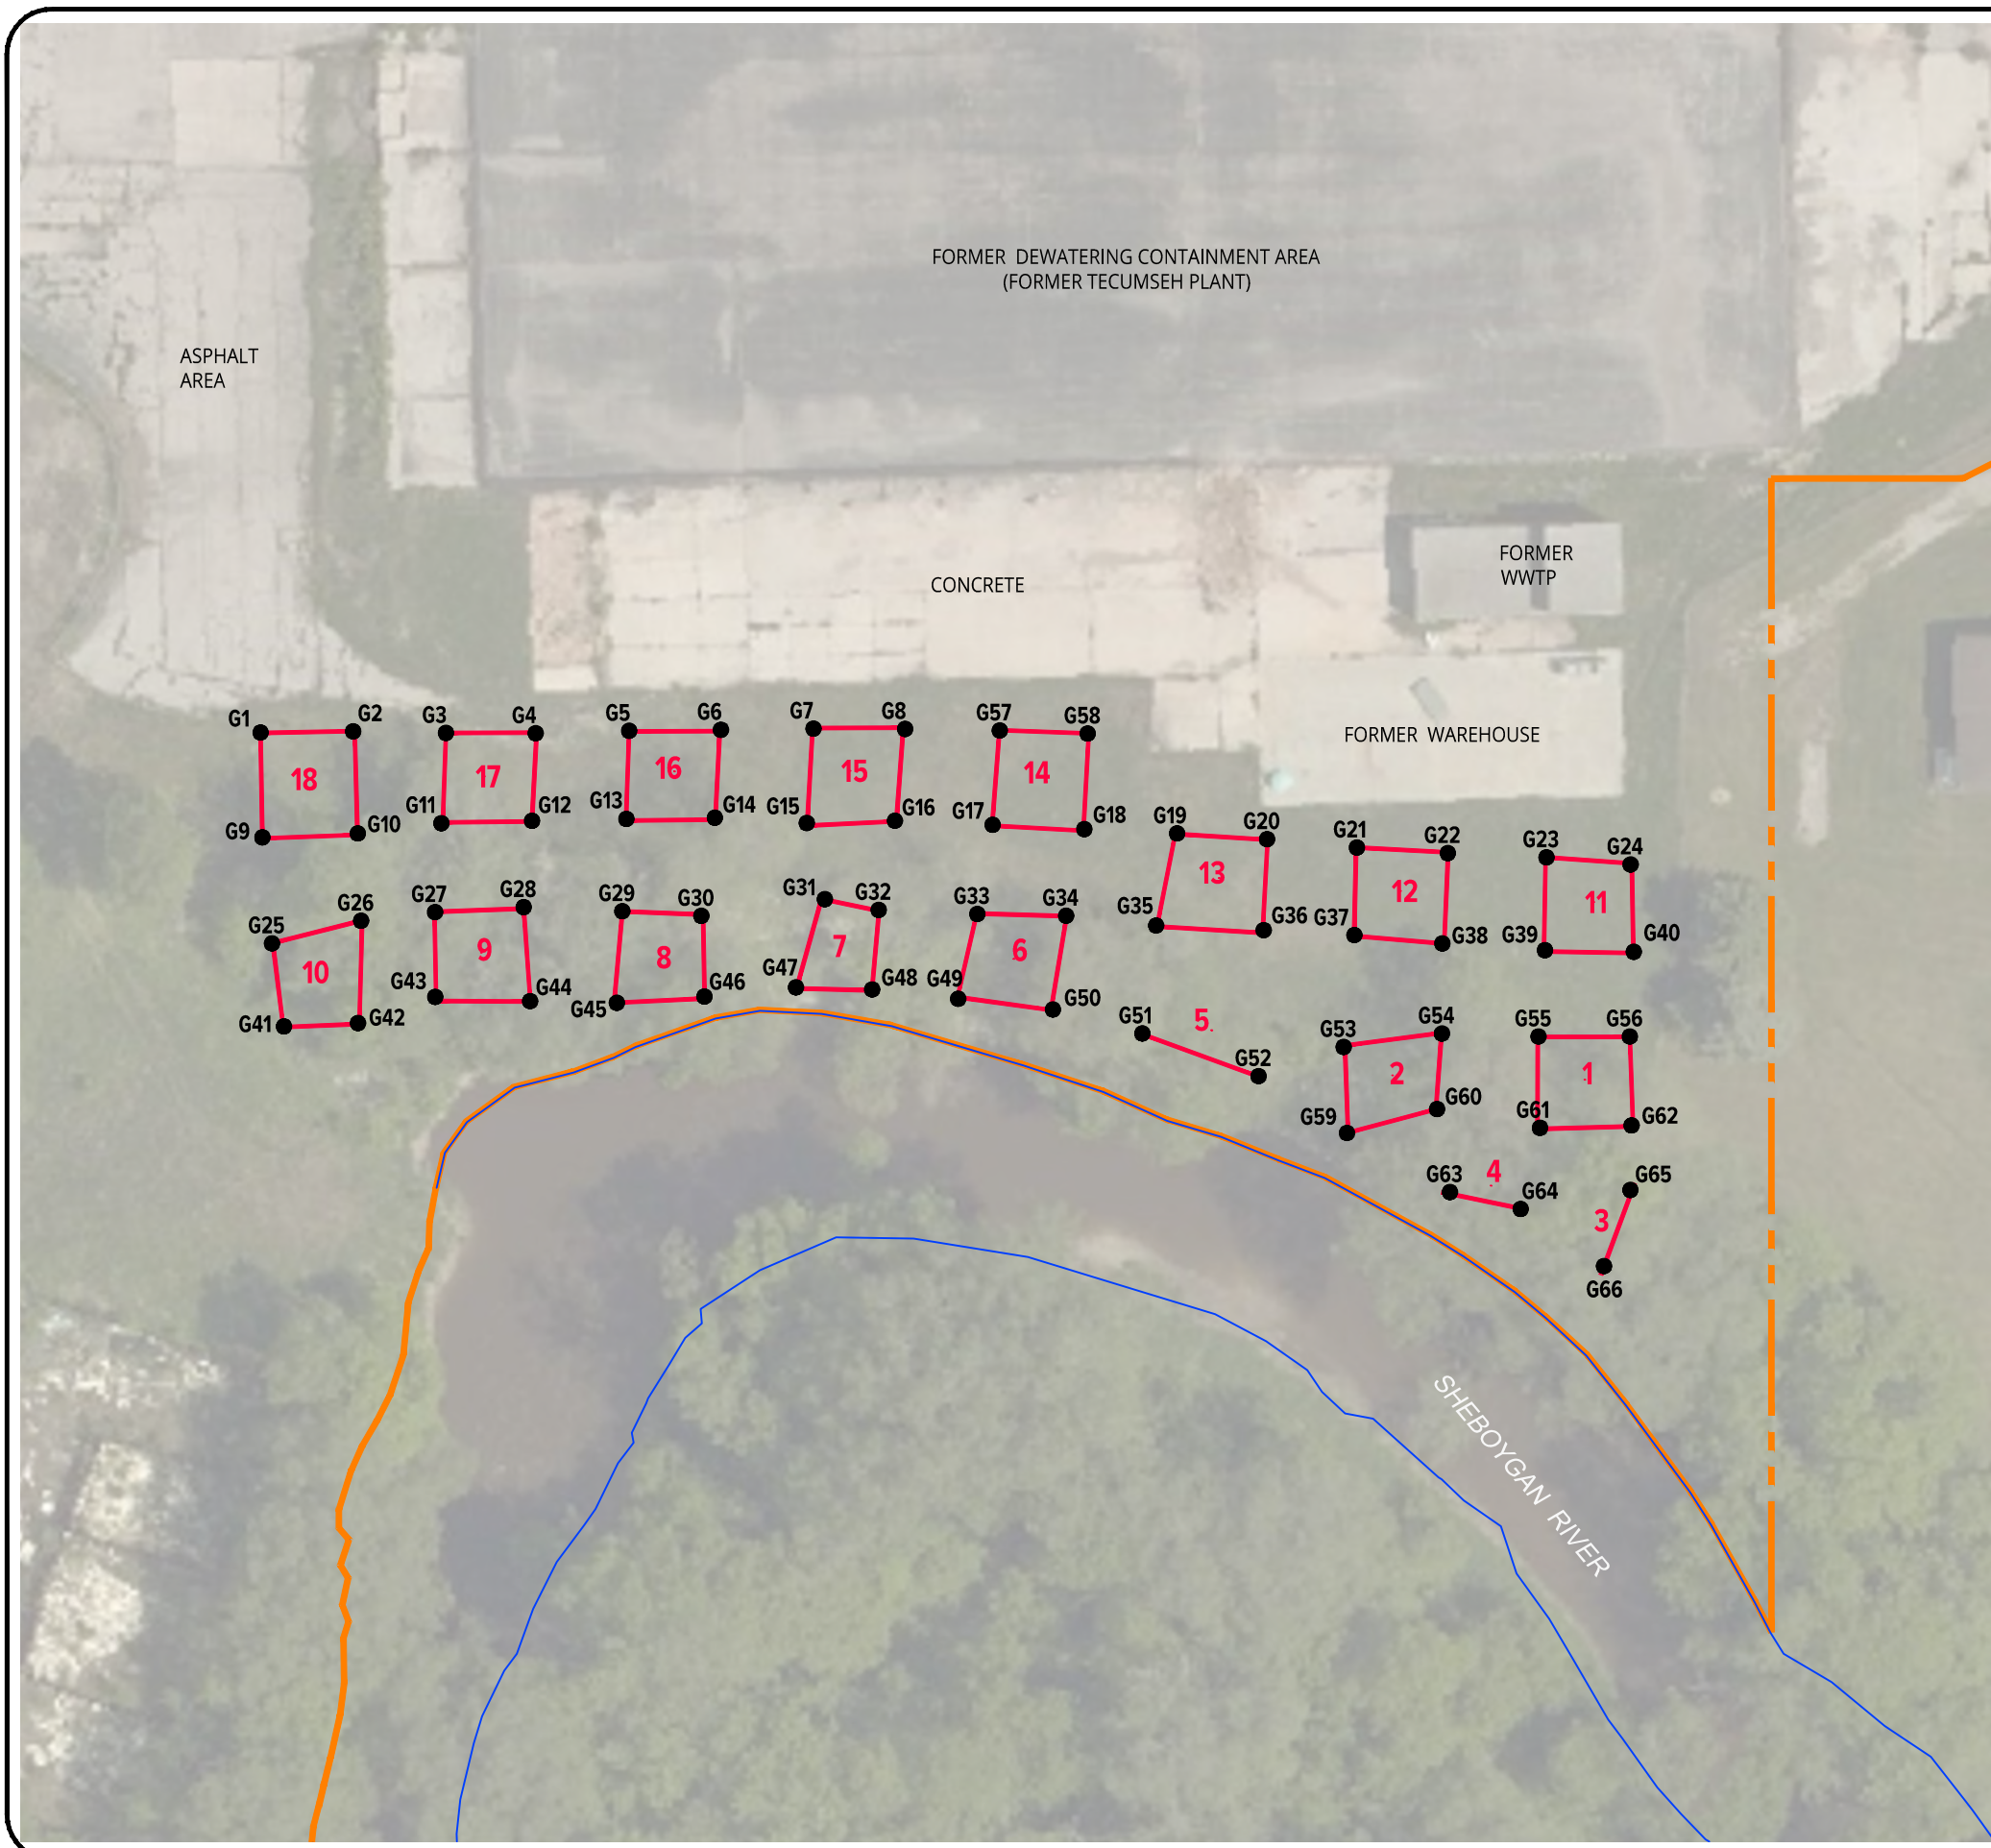
Date	4-16-2020
CADD	JAB
Designer	KE/AJL
Scale	AS NOTED
Project	069638.00.051
Figure No.	3B

- - - APPROXIMATE SITE BOUNDARY
- 1999 COMPOSITE SOIL SAMPLE
- 1 1999 SOIL SAMPLE COMPOSITE LOCATION WITH SAMPLES
