Thank you for providing Citizens for a Clean Wausau (CCW) with the opportunity to submit comments on the Site Investigation Work Plans (SIWPs) for both 1300 Cleveland Avenue and the Former CN/WCL Railroad Track in Wausau, portions of which reside in very close proximity to one another.

COMMENTS RELEVANT TO BOTH THE GEI SIWP AND ARCADIS SIWP

COMMENTS ON THE GEI SITE INVESTIGATION WORK PLAN FOR 1300 CLEVELAND AVENUE

COMMENTS ON ARCADIS SITE INVESTIGATION WORK PLAN FOR THE FORMER CN/WCL RAILROAD TRACK

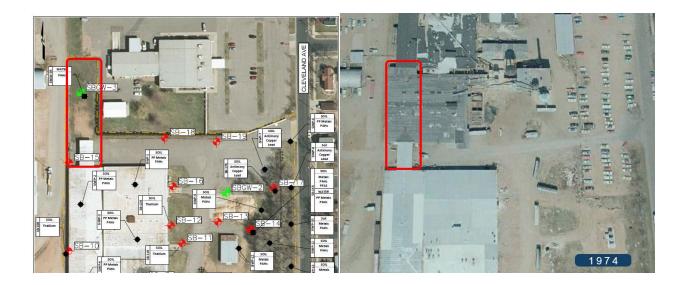
Figure 2.1 - 3M Wausau Maximum Plan for Locomotive Rail and Storage Property

Sampling and proposed sampling in the northwest corner of the site are extremely limited, especially given 1) it is one of the few areas on the property where there had historically been a

manufacturing structure present and 2) should zoning and land use change in the future (e.g., 3M's proposal for rail operations), there is an extremely high chance of soil disturbance and disruption. Therefore, we feel that this portion of the property should undergo – at the very least – an equal level of sampling and investigation as the rest of the property, particularly in light of the bis(2-ethylhexyl) phthalate recently identified in nearby soil on the adjacent property – a phthalate with strong, documented associations with the lacquer/varnish products used by Connor Forest Industries.
