EQUIPMENT SONAR MAPPED APRIL 1966
 MO. YR.

Source: Wisconsin Department of Natural Resources 608-266-2621
Kilby Lake – Marquette County, Wisconsin DNR Lake Map
Date – Apr 1966- Historical Lake Map - Not for Navigation
A Public Document - Please Identify the Source when using it.

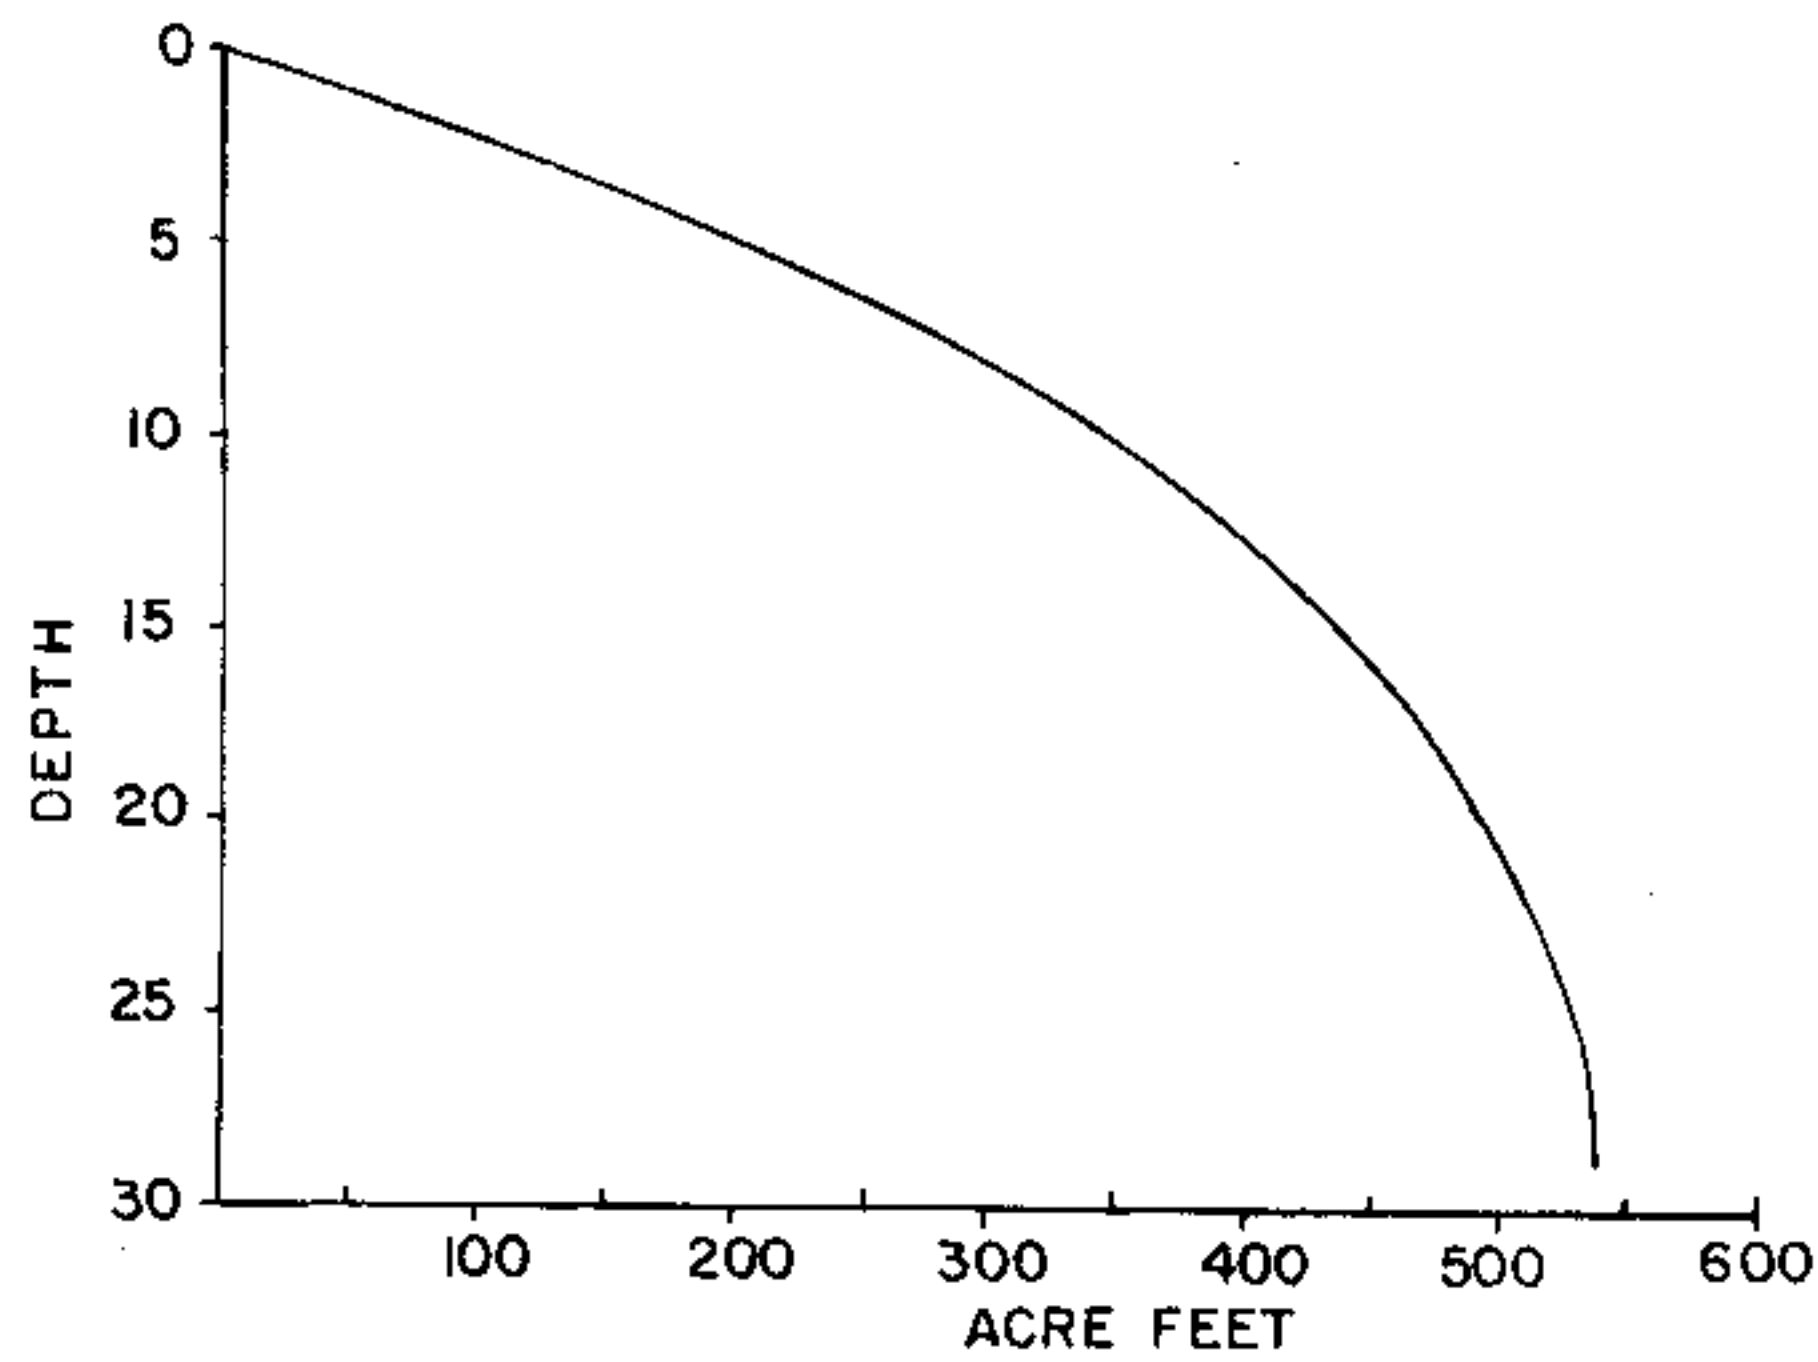
B.M. 'X' white post on W. side of P.A. on high water mark.
 Assumed elev. 100.0
 Water elev. 96.4

WATER ELEV. 96.4

AREA 45.6 ACRES
 UNDER 3 FT. 14.1 %
 OVER 20 FT. 23.4 %
 VOLUME 539.1 ACRE FT.
 TOTAL ALK. 121 P.P.M.
 SHORELINE 1.1 MILES
 MAX. DEPTH 29 FEET
