AREA 155.3 ACRES
 UNDER 3FT. 30 %
 OVER 20FT. 5 %
 VOLUME 1,075.4 ACRE FT.
 TOTAL ALK. 100 P.P.M.
 SHORELINE 2.1 MILES
 MAX. DEPTH 33 FEET

Source: Wisconsin Department of Natural Resources 608-266-2621
Tuttle Lake – Marquette County, Wisconsin DNR Lake Map
Date – Jun 1964 - Historical Lake Map - Not for Navigation
A Public Document - Please Identify the Source when using it.

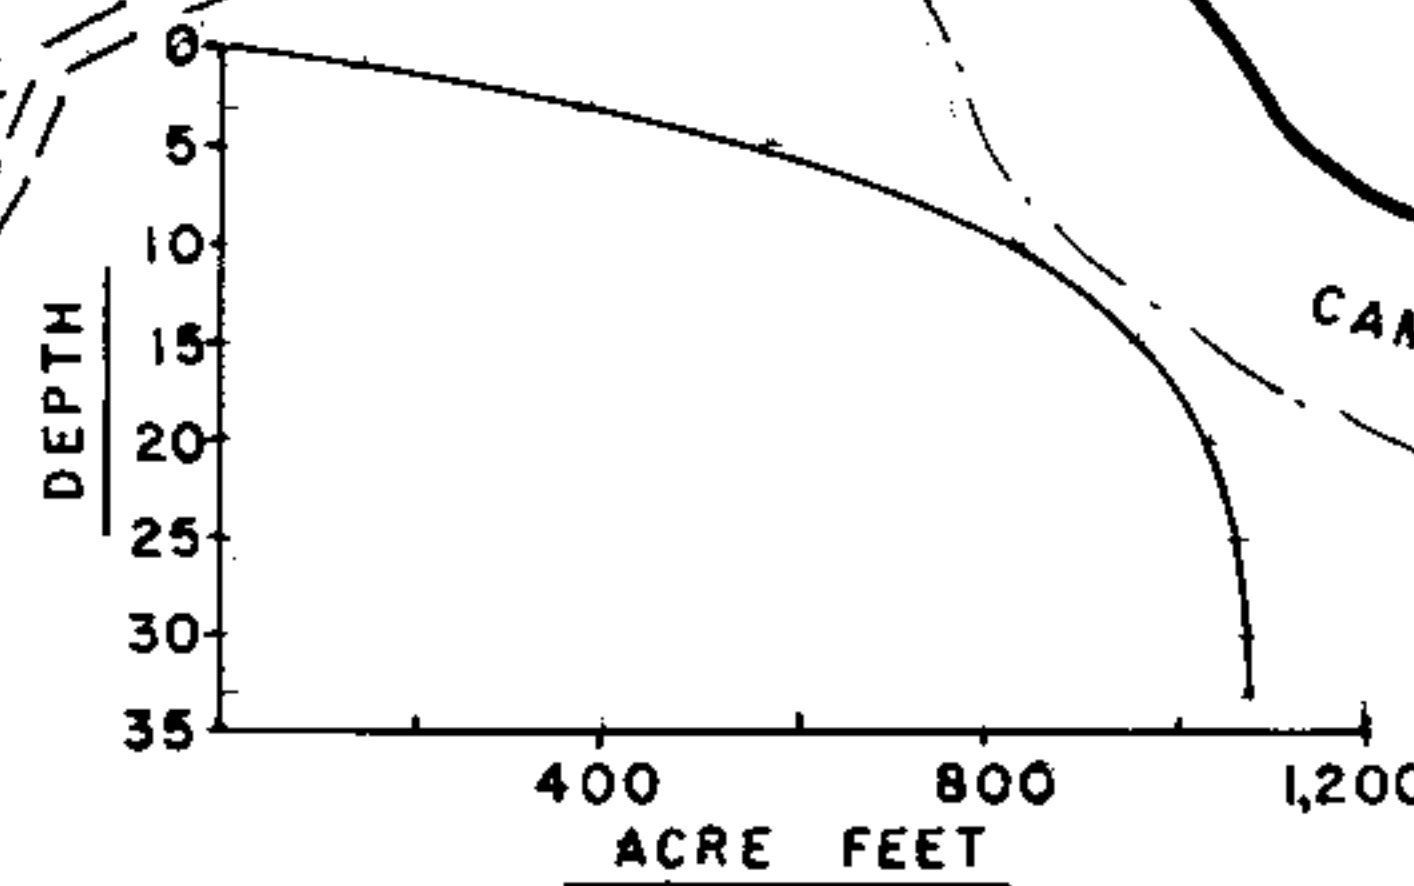
EQUIPMENT SONAR MAPPED JUNE 1964
 MO. YR.
 WATER ELEV. 95.9'
