VILLAGE OF WILD ROSE

Source: Wisconsin Department of Natural Resources 608-266-2621
Wild Rose Pond – Waushara County, Wisconsin DNR Lake Map
Date – May 1964 - Historical Lake Map - Not for Navigation
A Public Document - Please Identify the Source when using it.

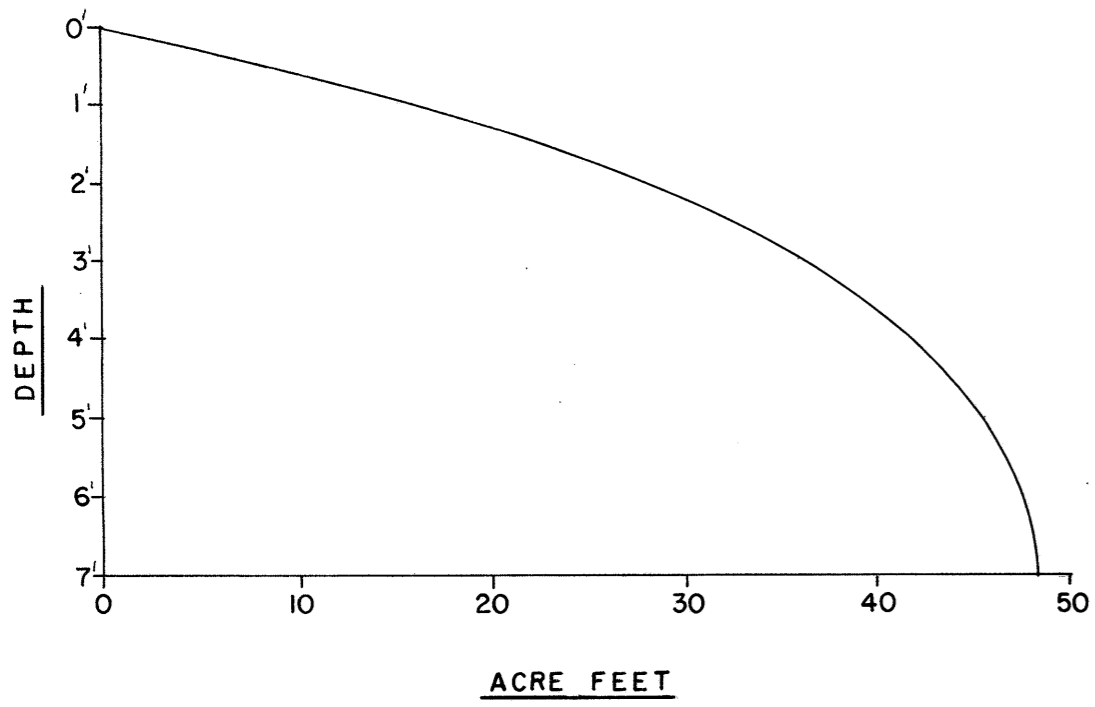
B.M. 'X' Top of S.E. dam gate
 angle iron.
 Assumed Elev. 100.00
 Water Elev. 93.30

EQUIPMENT SONAR MAPPED MAY 1964
 MO. YR.
 WATER ELEV. 93.30

AREA 16.71 ACRES
 UNDER 3FT. 58 %
 OVER 20FT. 0 %
 VOLUME 48.5 ACRE FT.
 TOTAL ALK. 140 P.P.M.
 SHORELINE 0.89 MILES
 MAX. DEPTH 7 FEET
