CITY OF WAUPACA

EQUIPMENT RECORDING SONAR MAPPED APRIL 1966
MO. YR.

Source: Wisconsin Department of Natural Resources 608-266-2621
Cary Pond – Waupaca County, Wisconsin DNR Lake Map
Date – Apr 1966 - Historical Lake Map - Not for Navigation
A Public Document - Please Identify the Source when using it.

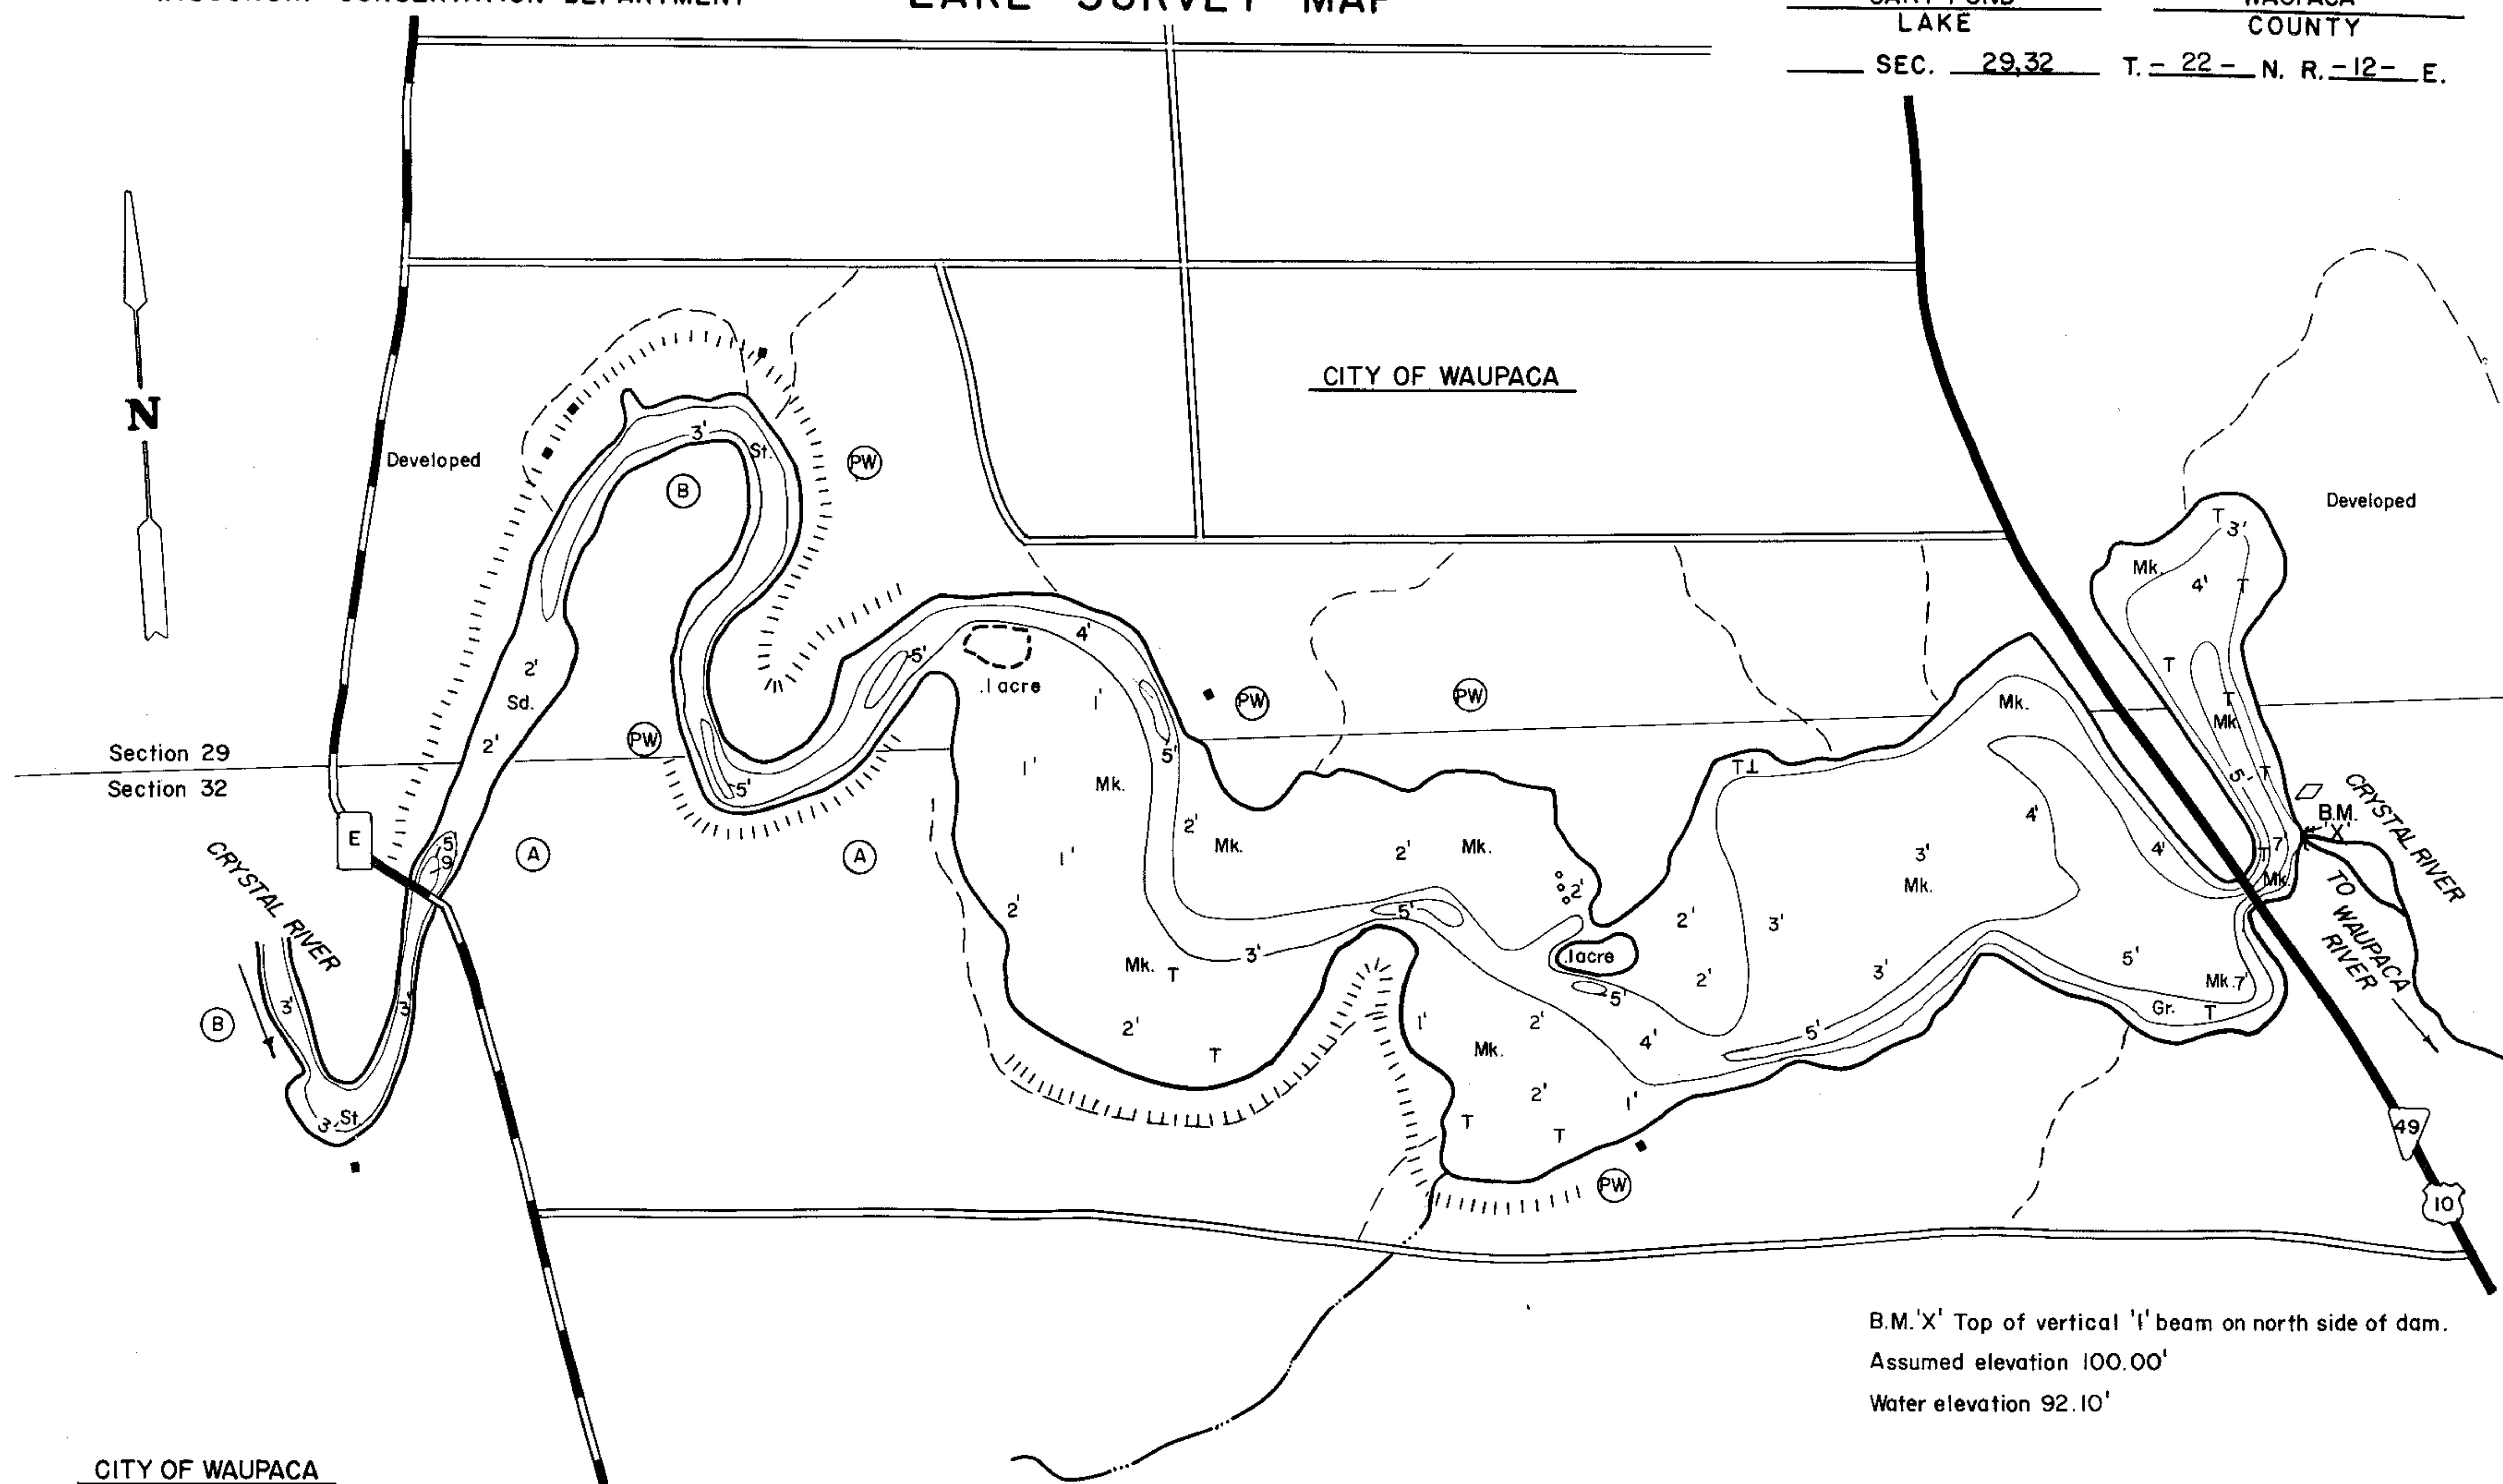
B.M. 'X' Top of vertical 'I' beam on north side of dam.
Assumed elevation 100.00'
Water elevation 92.10'

26.6 ACRES WITH ISLANDS
AREA 26.4 ACRES
UNDER 3 FT. 44 %
OVER 20 FT. 0.0 %
VOLUME 75.2 ACRE FT.
TOTAL ALK. 163 P.P.M.
SHORELINE 2.6 MILES
MAX. DEPTH 9 FEET
