EQUIPMENT \_\_\_\_\_ SONAR \_\_\_\_\_ MAPPED APRIL 1966  
MO. YR.

Source: Wisconsin Department of Natural Resources 608-266-2621  
Ogdensburg Pond – Waupaca County, Wisconsin DNR Lake Map  
Date – Apr 1966 - Historical Lake Map - Not for Navigation  
A Public Document - Please Identify the Source when using it.

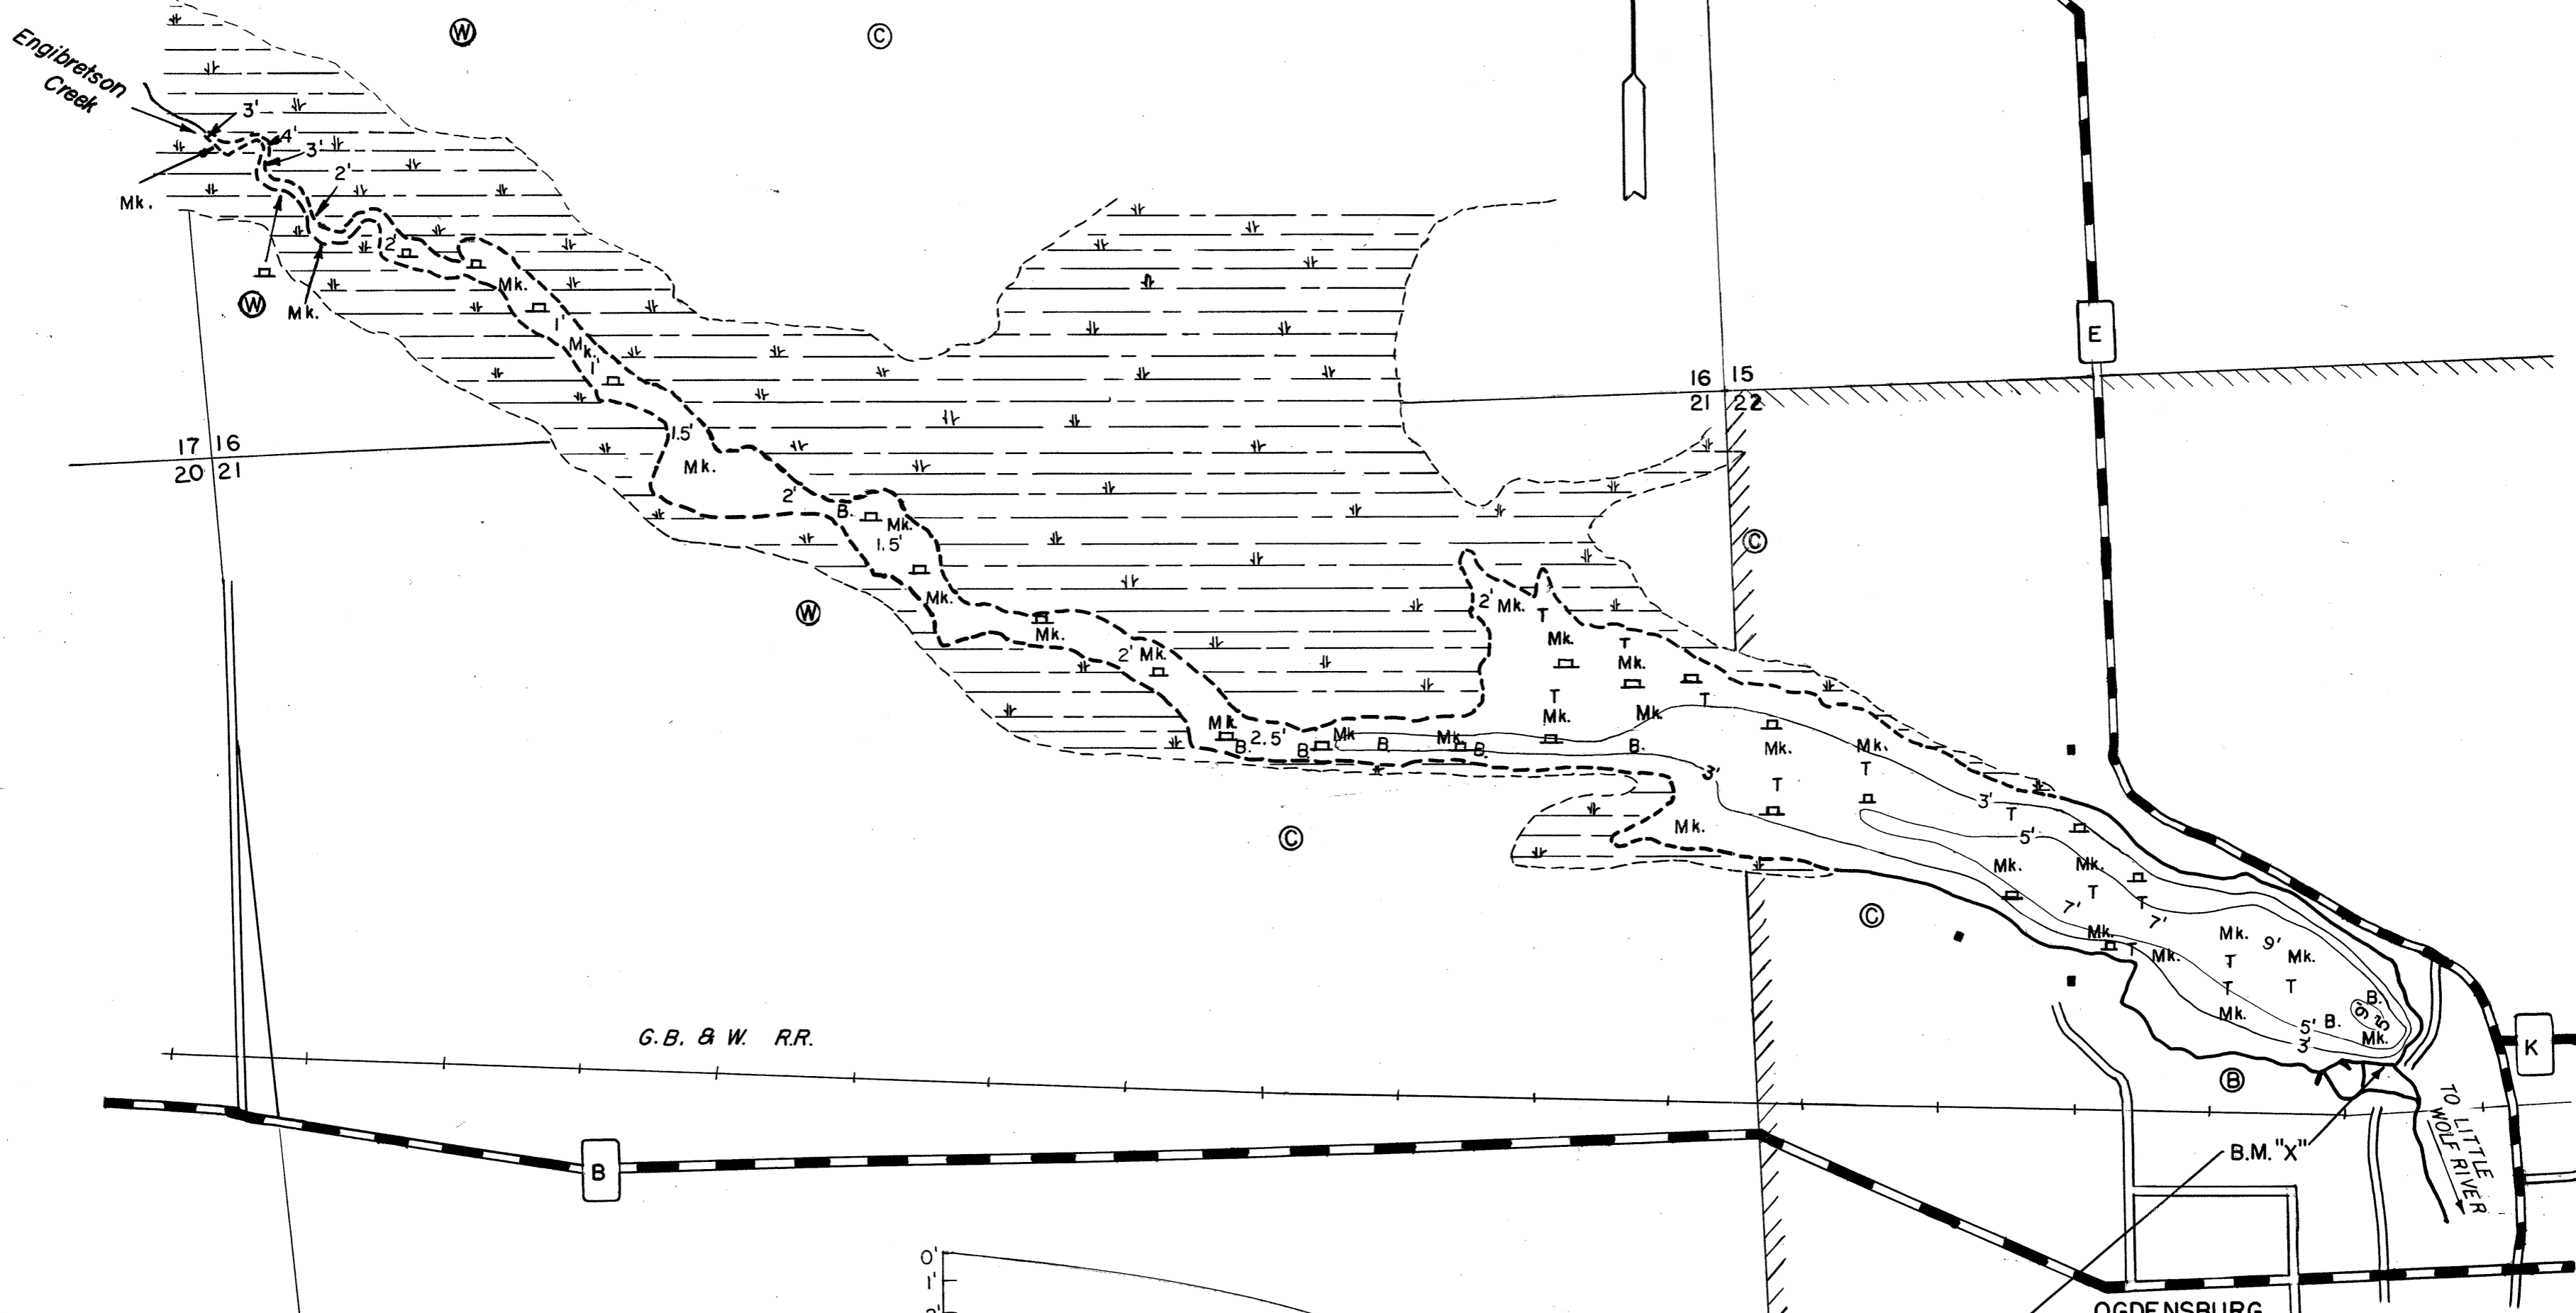
B.M. "X" - Top of south flume wall, square in concrete.  
Assumed elev. 100'  
Water elev. 99.3'

- TOPOGRAPHIC SYMBOLS
- (B) Brush
  - (PW) Partially wooded
  - (W) Wooded
  - (C) Cleared
  - (P) Pastured
  - (A) Agricultural
  - B.M. Bench Mark
  - Dwelling
  - Resort
- LAKE BOTTOM SYMBOLS
- P. Peat
  - Mk. Muck
  - C. Clay
  - M. Marl
  - Sd. Sand
  - St. Silt
  - Gr. Gravel
  - R. Rubble
  - Br. Bedrock
  - T Submergent vegetation
  - ↓ Emergent vegetation
  - ⊢ Floating vegetation
  - ⊙ Stumps & Snags

AREA 61.9 ACRES  
UNDER 3FT. 66.1 %  
OVER 20FT. 0.0 %  
VOLUME 184.98 ACRE FT.  
TOTAL ALK. 178.0 P.P.M.  
SHORELINE 4.09 MILES  
MAX. DEPTH 9 FEET
