EQUIPMENT RECORDING SONAR MAPPED JUNE 1975
MONTH YEAR
LAKE BOTTOM SYMBOLS

Source: Wisconsin Department of Natural Resources 608-266-2621
John's Lake – Oconto County, Wisconsin DNR Lake Map
Date - Jun 1975 - Historical Lake Map - Not for Navigation
A Public Document - Please Identify the Source when using it.

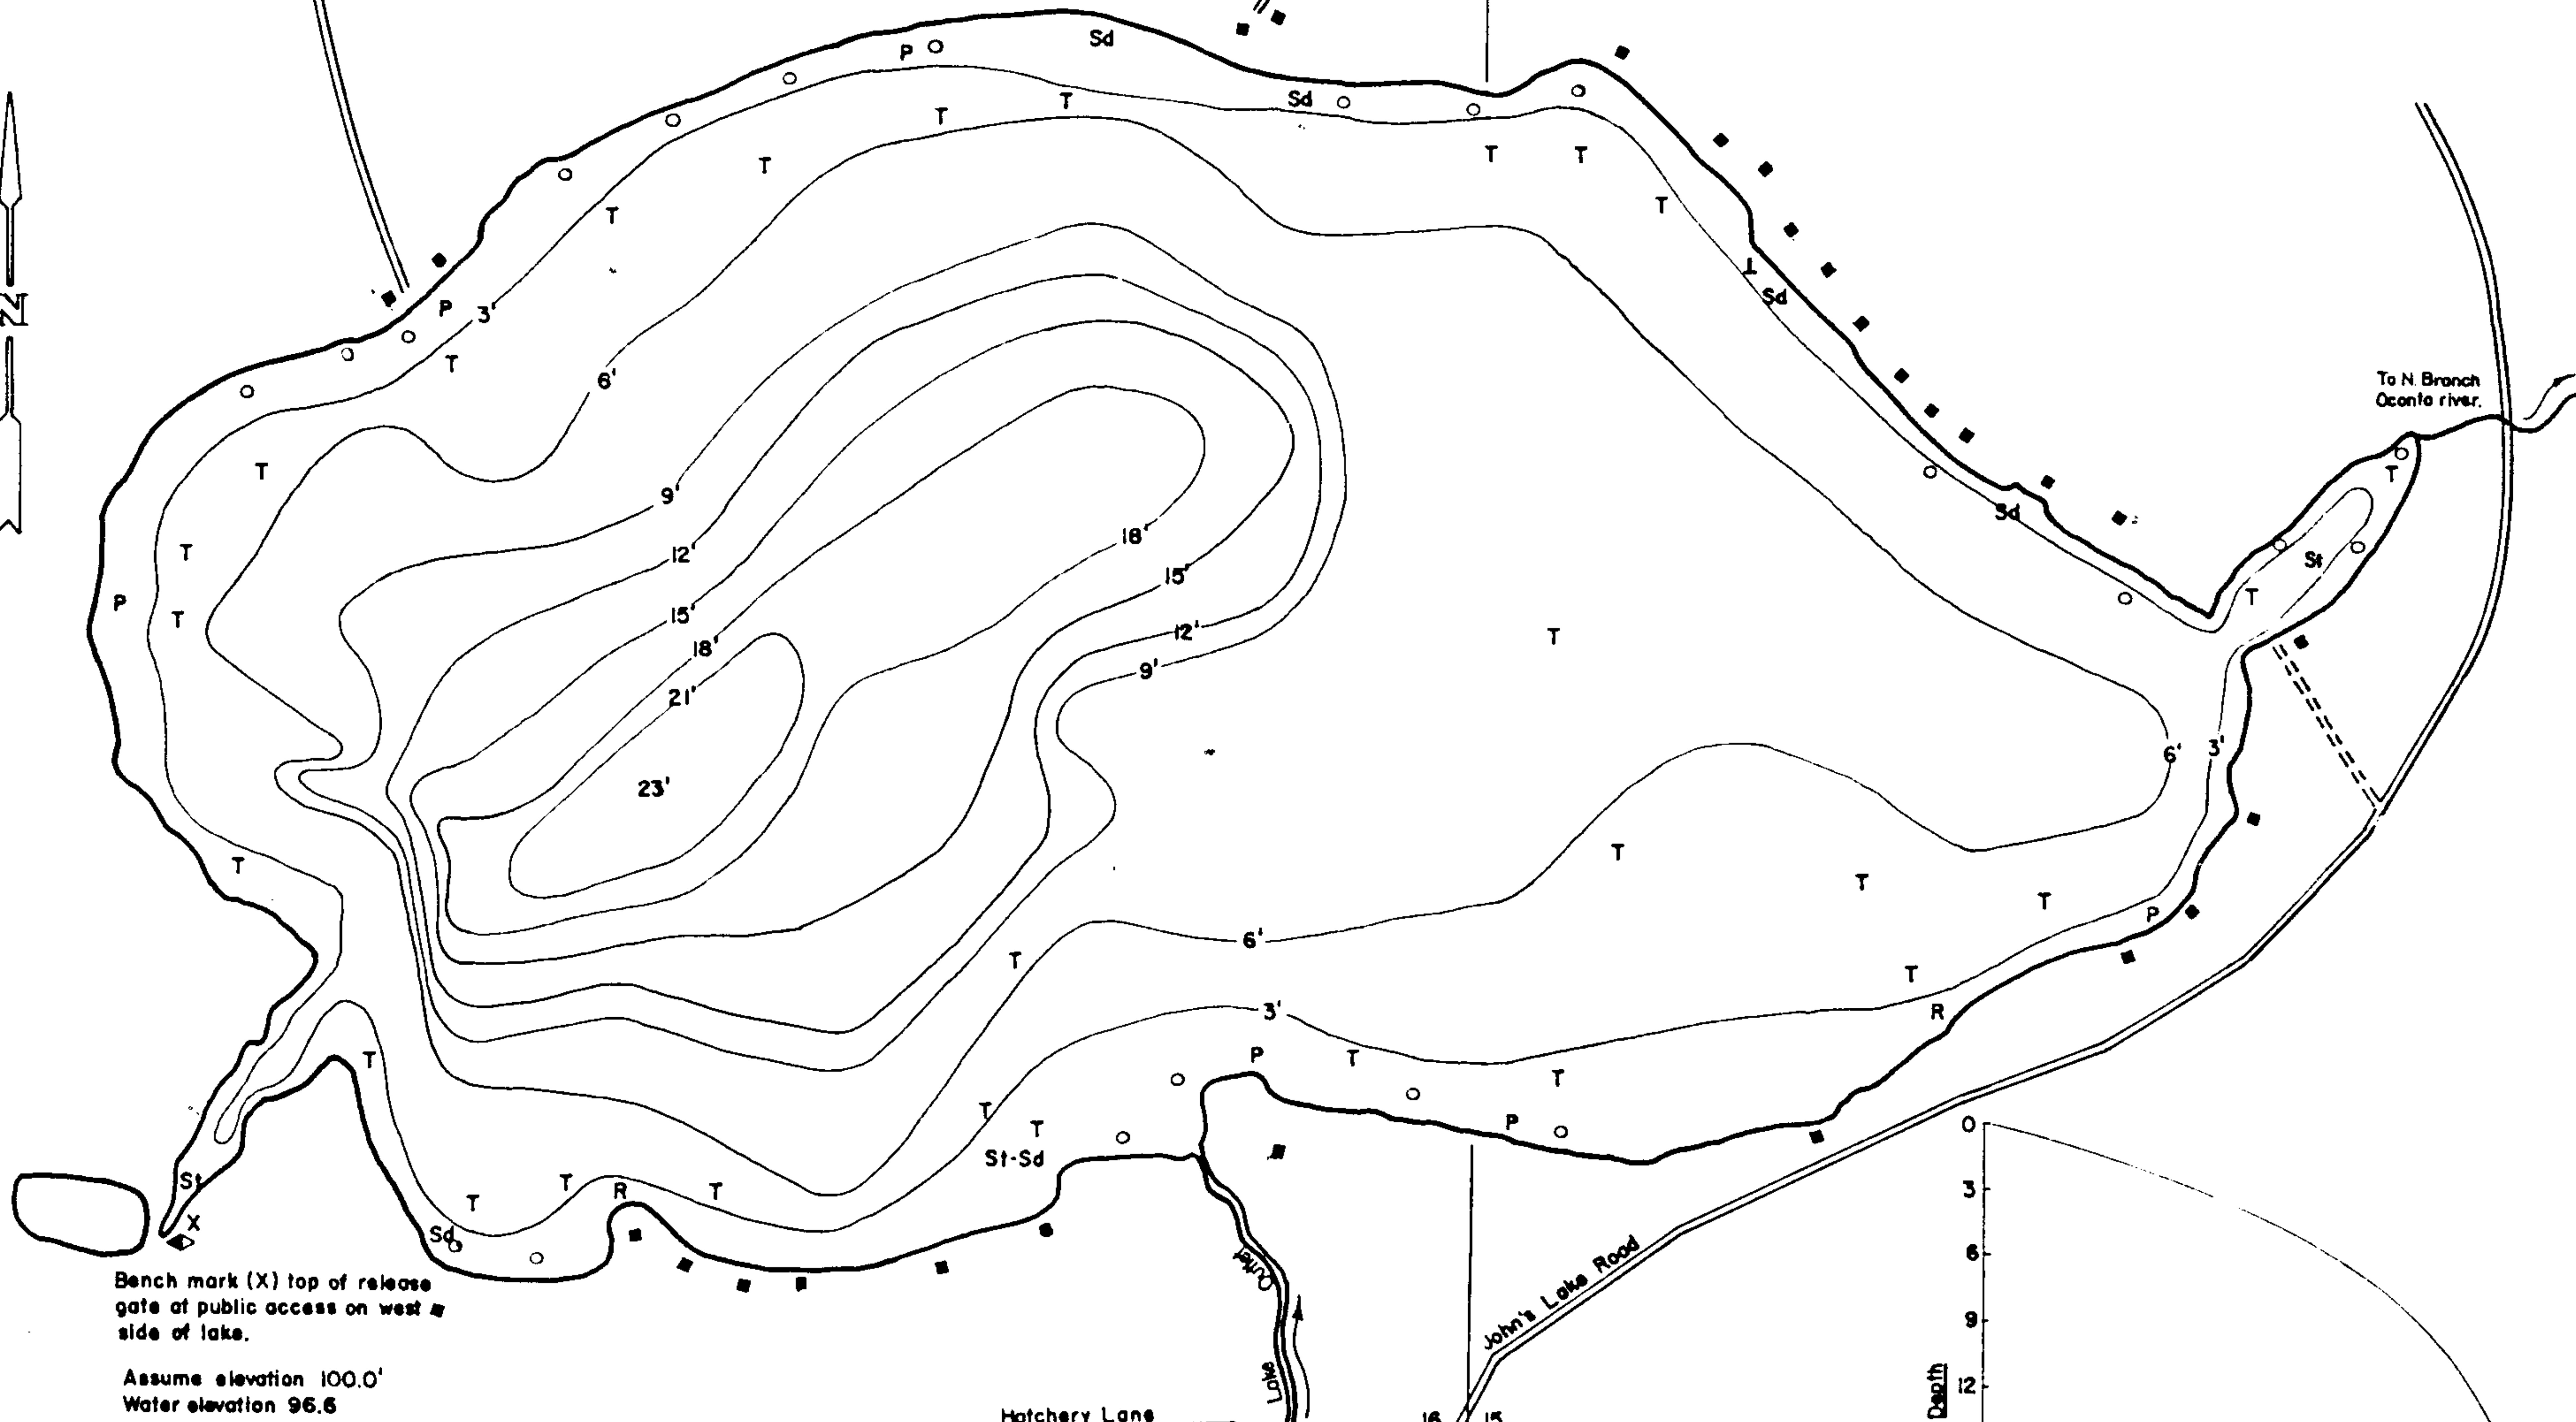
Bench mark (X) top of release gate at public access on west side of lake.

Assume elevation 100.0'
Water elevation 96.6

Acres feet in hundreds
WATER AREA 104 ACRES
UNDER 3 FT. 36 %
OVER 20 FT. 1 %
MAX. DEPTH 23 FEET.
TOTAL ALK. 103 P.P.M.
VOLUME 651.5 ACRE FT.
MAIN SHORELINE 1.67 MI.
ISLAND SHORELINE MI.
