LAKE SURVEY MAP

Source: Wisconsin Department of Natural Resources 608-266-2621  
Kingsford Flowage 2 of 3 - Florence County, Wisconsin DNR Lake Map  
Date: Aug. 1977 - Historical Lake Map - Not for Navigation  
A Public Document - Please Identify the Source when using it.

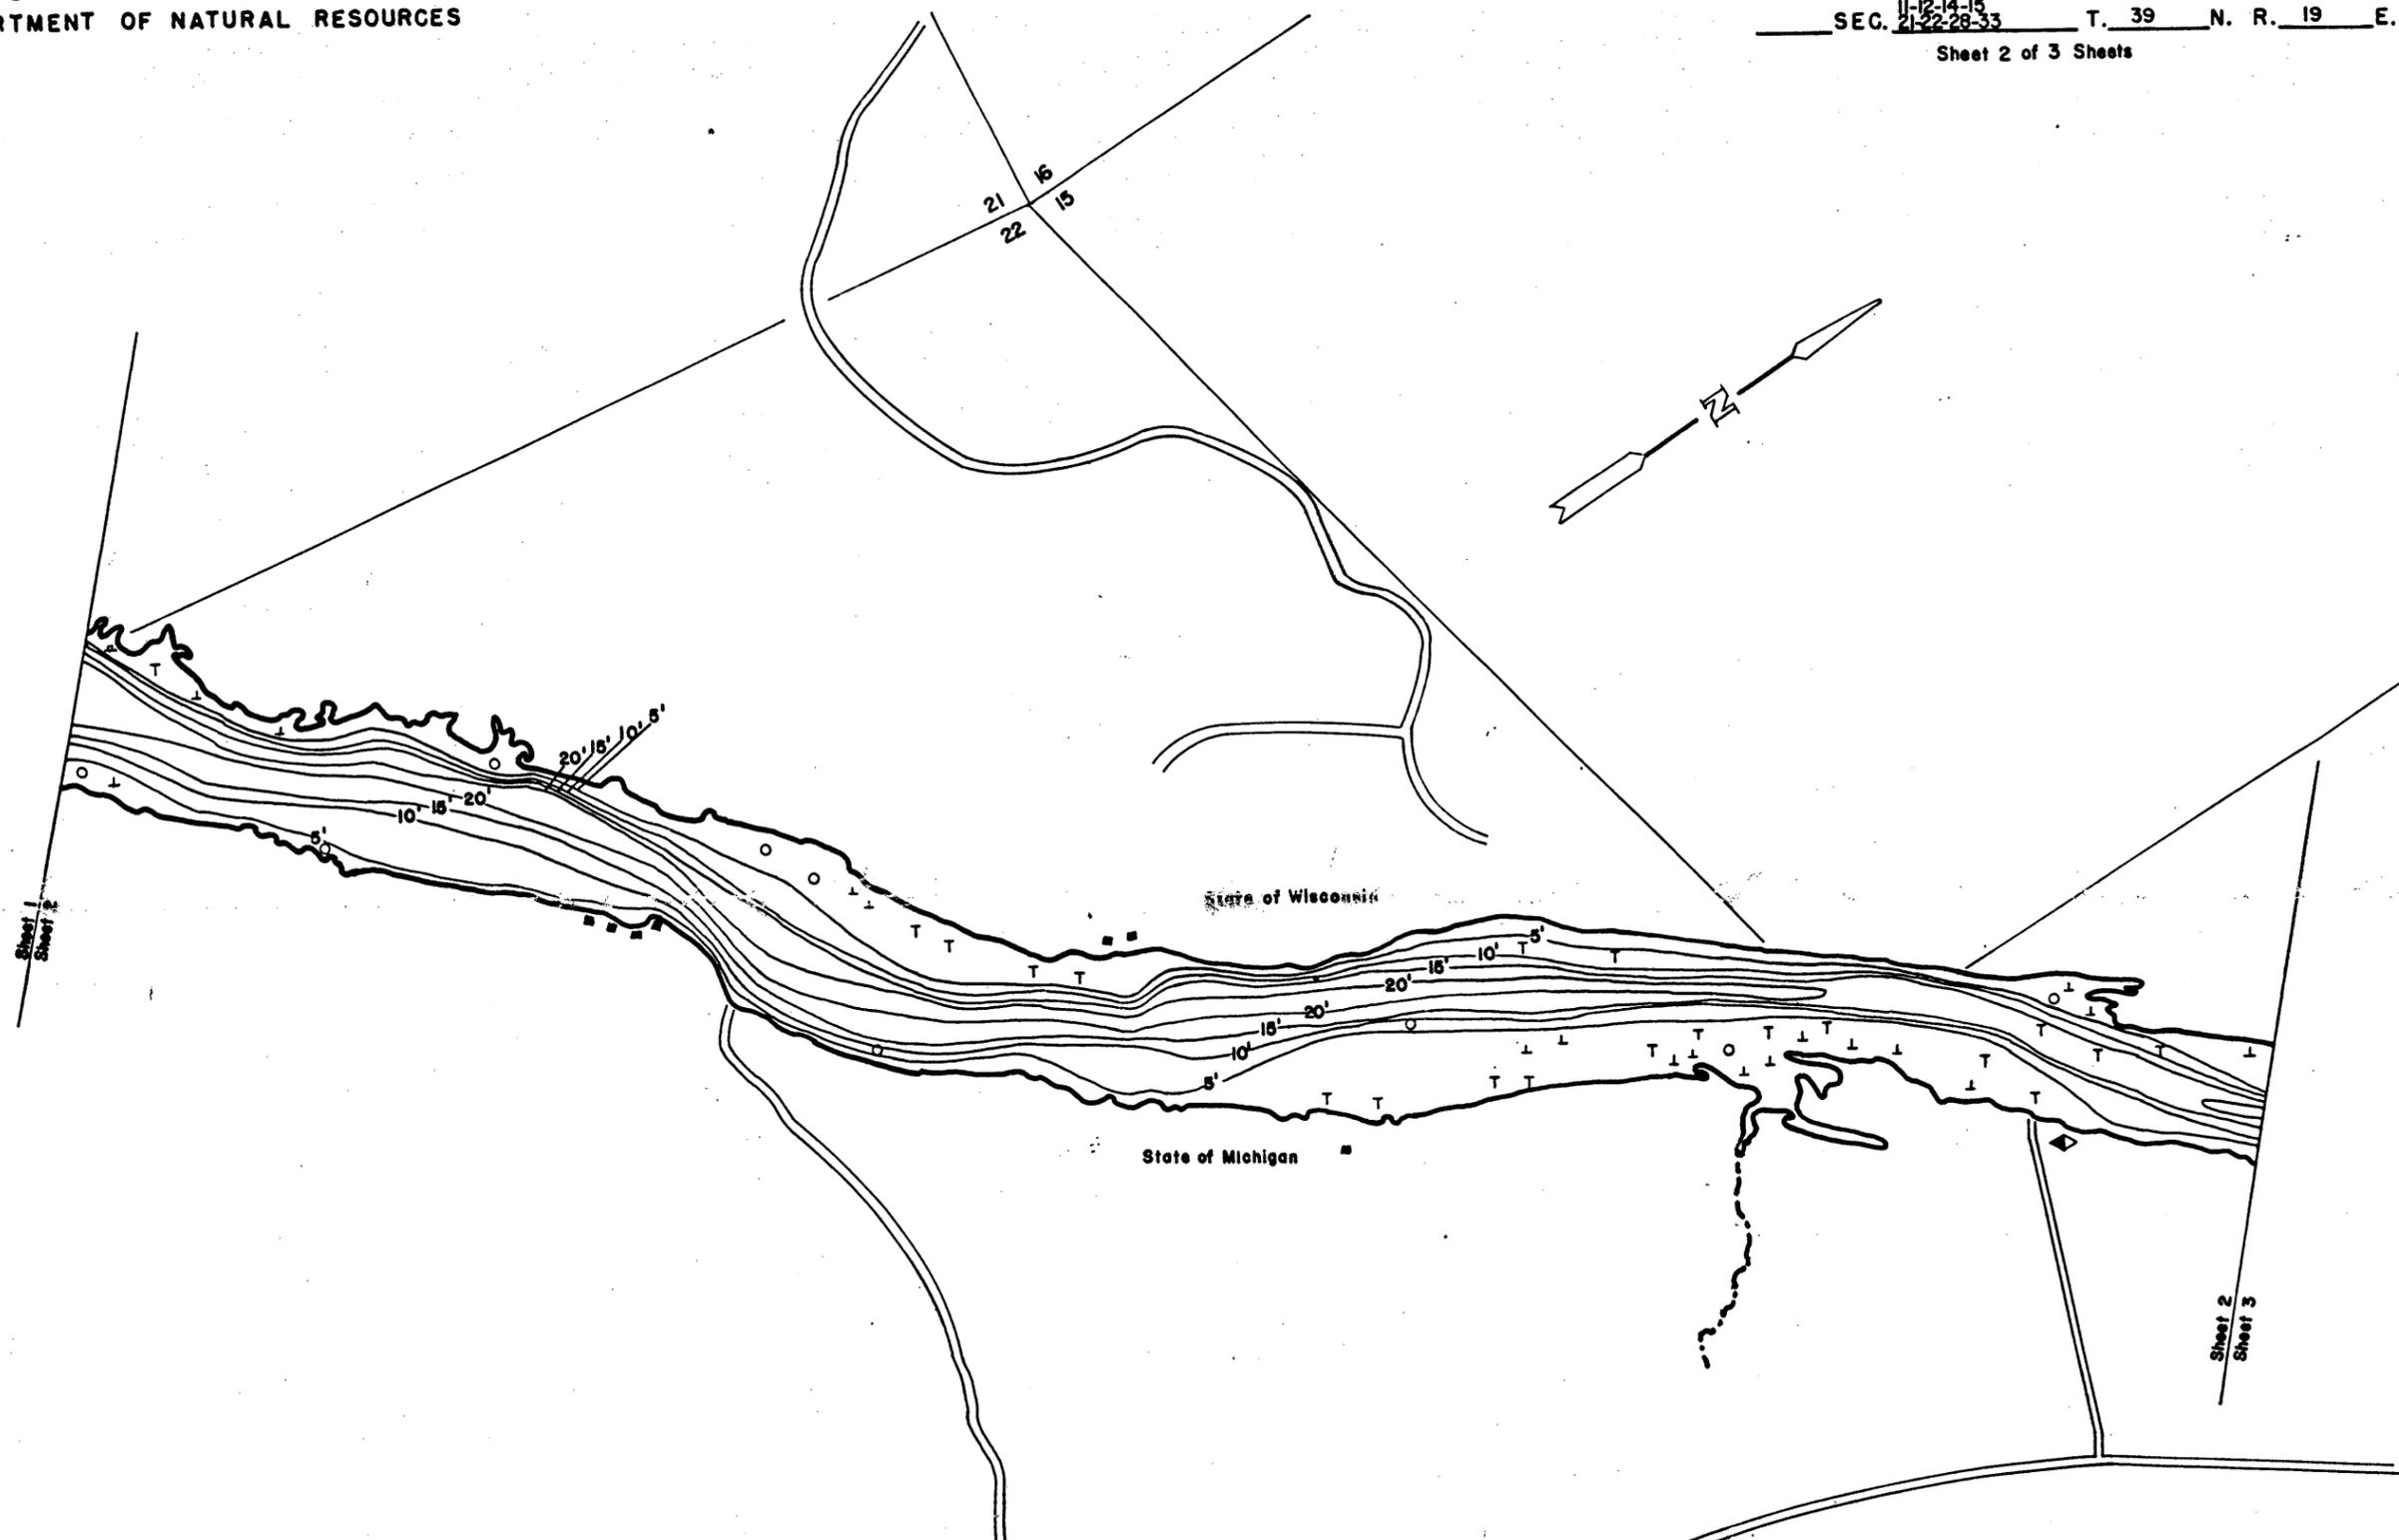
EQUIPMENT RECORDING SONAR MAPPED AUGUST 1977

WATER AREA 491.09 ACRES  
 UNDER 5 FT. 15 %  
 OVER 20 FT. 3 %  
 MAX. DEPTH 32 FEET.  
 TOTAL ALK. 65 P.P.M.  
 VOLUME 5,359.28 ACRE FT.  
 MAIN SHORELINE 12.94 MI.  
 ISLAND SHORELINE .99 MI.
