EQUIPMENT ECHO SOUNDING MAPPED AUG 1966
 MO. YR.

Source: Wisconsin Department of Natural Resources 608-266-2621
Army Lake – Walworth County, Wisconsin DNR Lake Map
Date – Aug 1966 - Historical Lake Map - Not for Navigation
A Public Document - Please Identify the Source when using it.

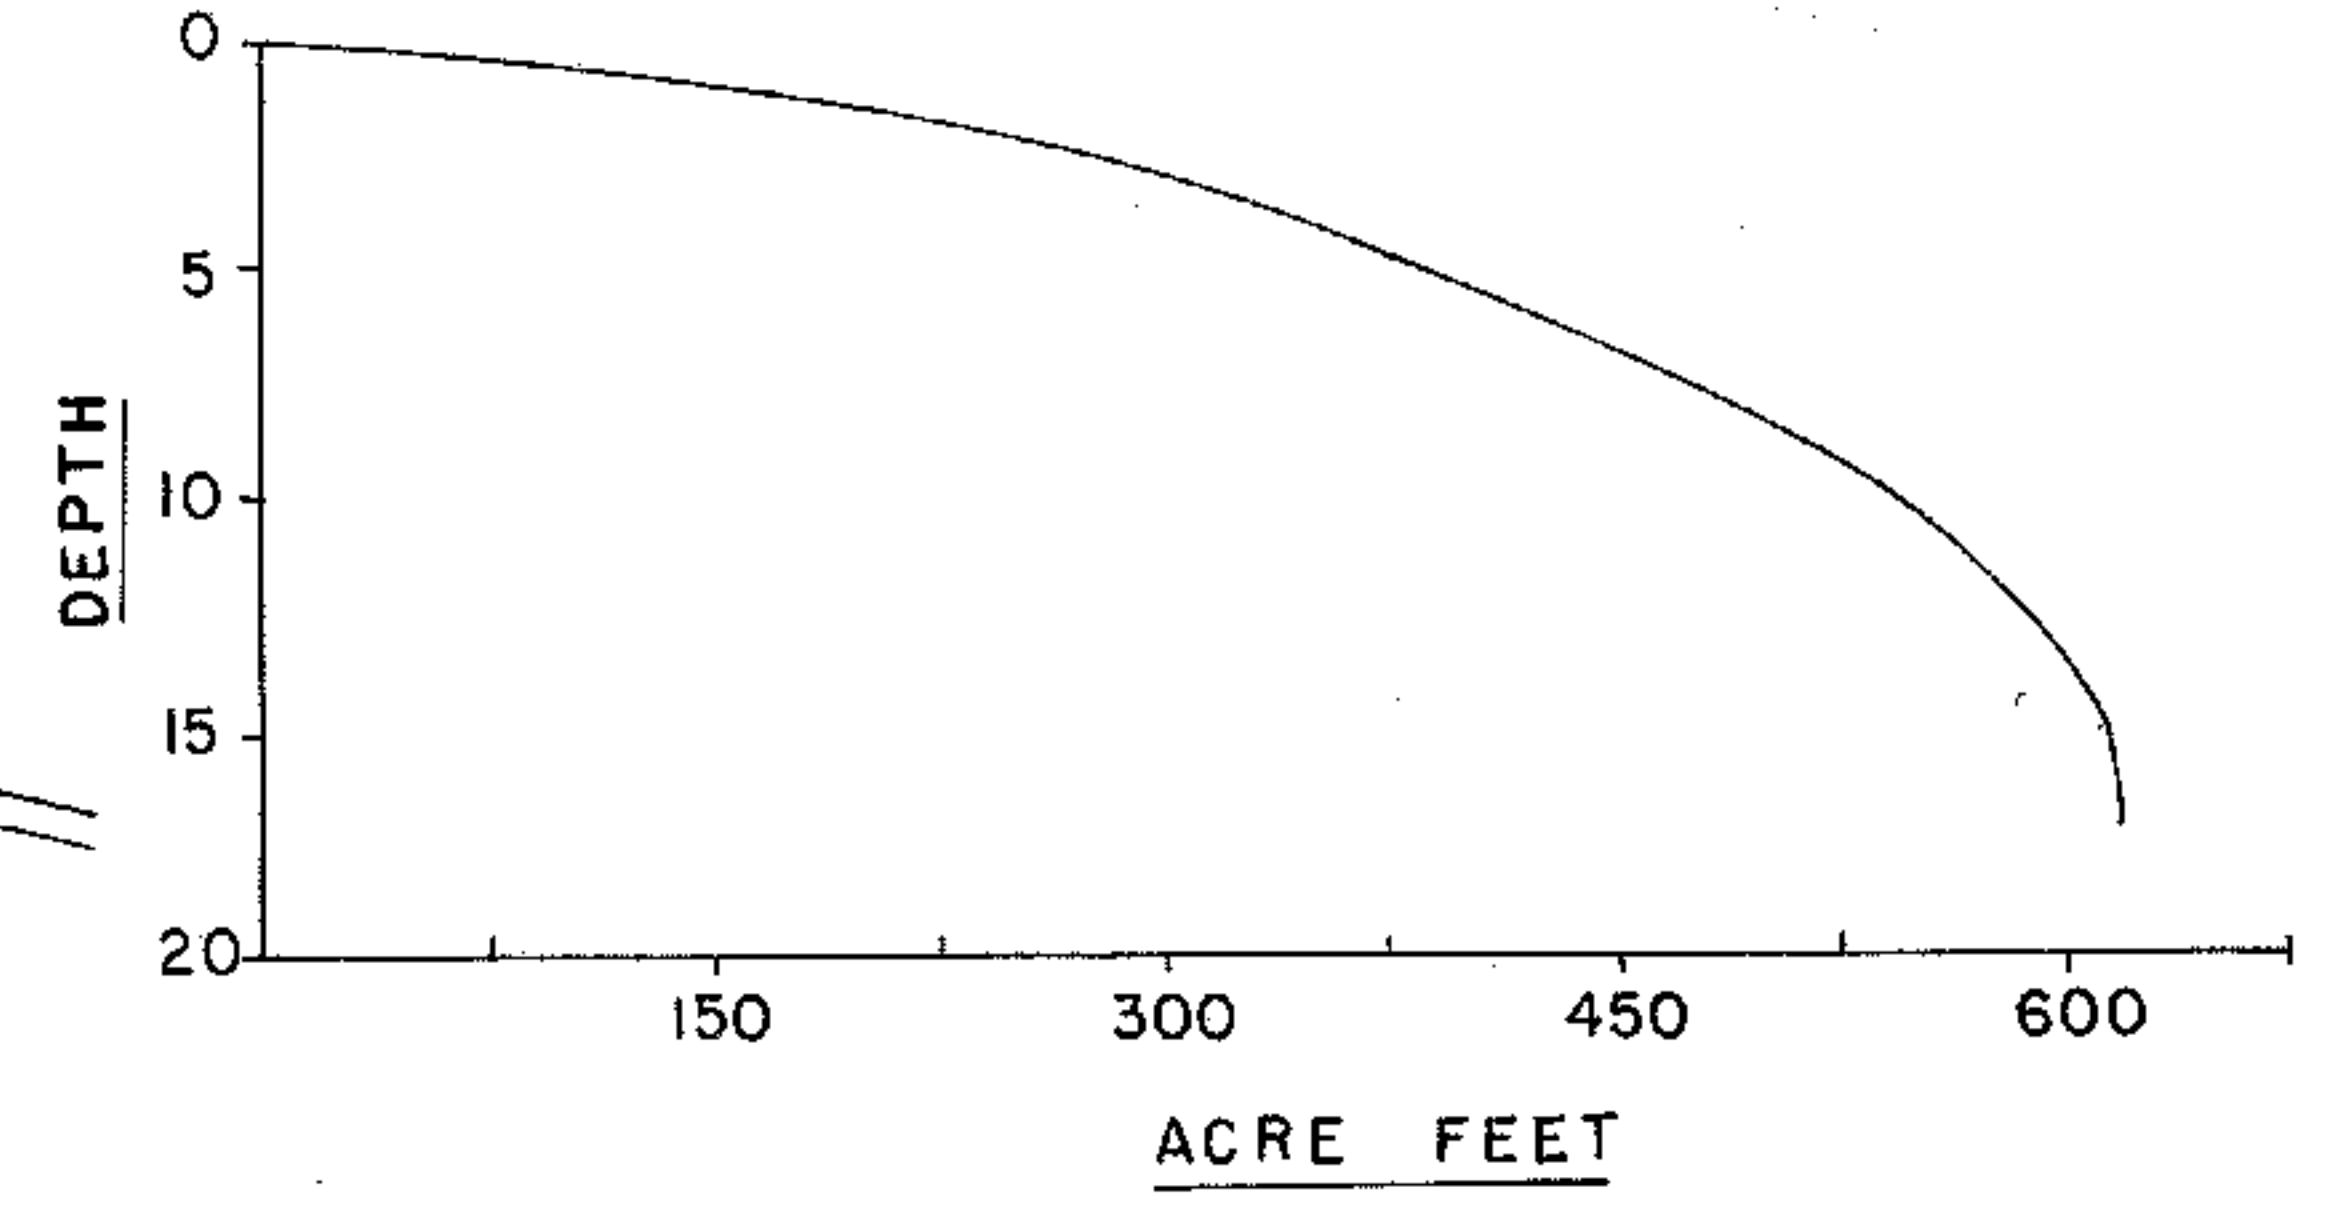
B.M. "X" Spike in base on S. side of oak tree
 100' from lake edge, 20' from access launch road
 Assumed elev. 100.0'
 Water elev. 93.2'

WATER ELEV. 93.2

AREA 78 ACRES
 UNDER 3FT. 18 %
 OVER 20FT. 0 %
 VOLUME 625.3 ACRE FT.
 TOTAL ALK. 174 P.P.M.
 SHORELINE 1.5 MILES
 MAX. DEPTH 17 FEET
