EQUIPMENT ECHO SOUNDER MAPPED JULY 1954
UPDATED AUGUST 1966
MO. YR.

Source: Wisconsin Department of Natural Resources 608-266-2621
Silver Lake – Walworth County, Wisconsin DNR Lake Map
Date – Aug 1966 - Historical Lake Map - Not for Navigation
A Public Document - Please Identify the Source when using it.

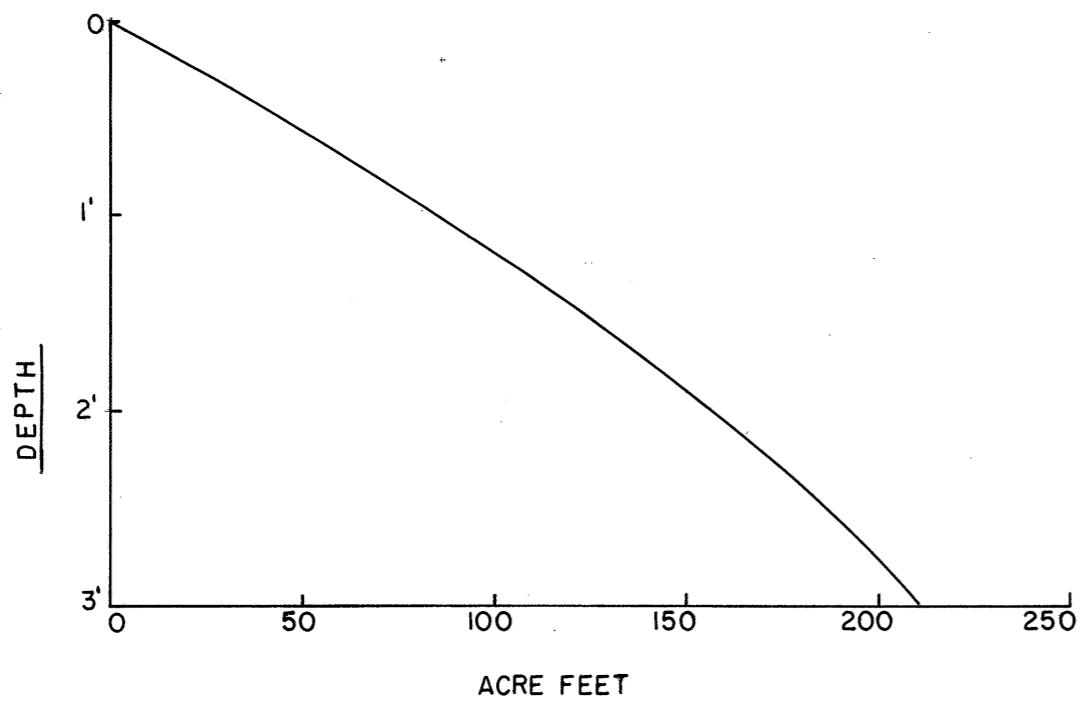
B.M. 'X' 2 nails in small boxelder tree 30' from lake.
Assumed elevation 100.00'
Water elevation 93.10'

WATER ELEV. 93.10'

AREA 84.51 ACRES
UNDER 3FT. 100 %
OVER 20FT. 0 %
VOLUME 211.21 ACRE FT.
TOTAL ALK. 152 P.P.M.
SHORELINE 1.59 MILES
MAX. DEPTH 3 FEET
