EQUIPMENT THRU ICE MAPPED FEBRUARY 1954
UPDATED JULY 1967
MO. YR.

Source: Wisconsin Department of Natural Resources 608-266-2621
Voltz Lake – Kenosha County, Wisconsin DNR Lake Map
Date – Jul 1967 - Historical Lake Map - Not for Navigation
A Public Document - Please Identify the Source when using it.

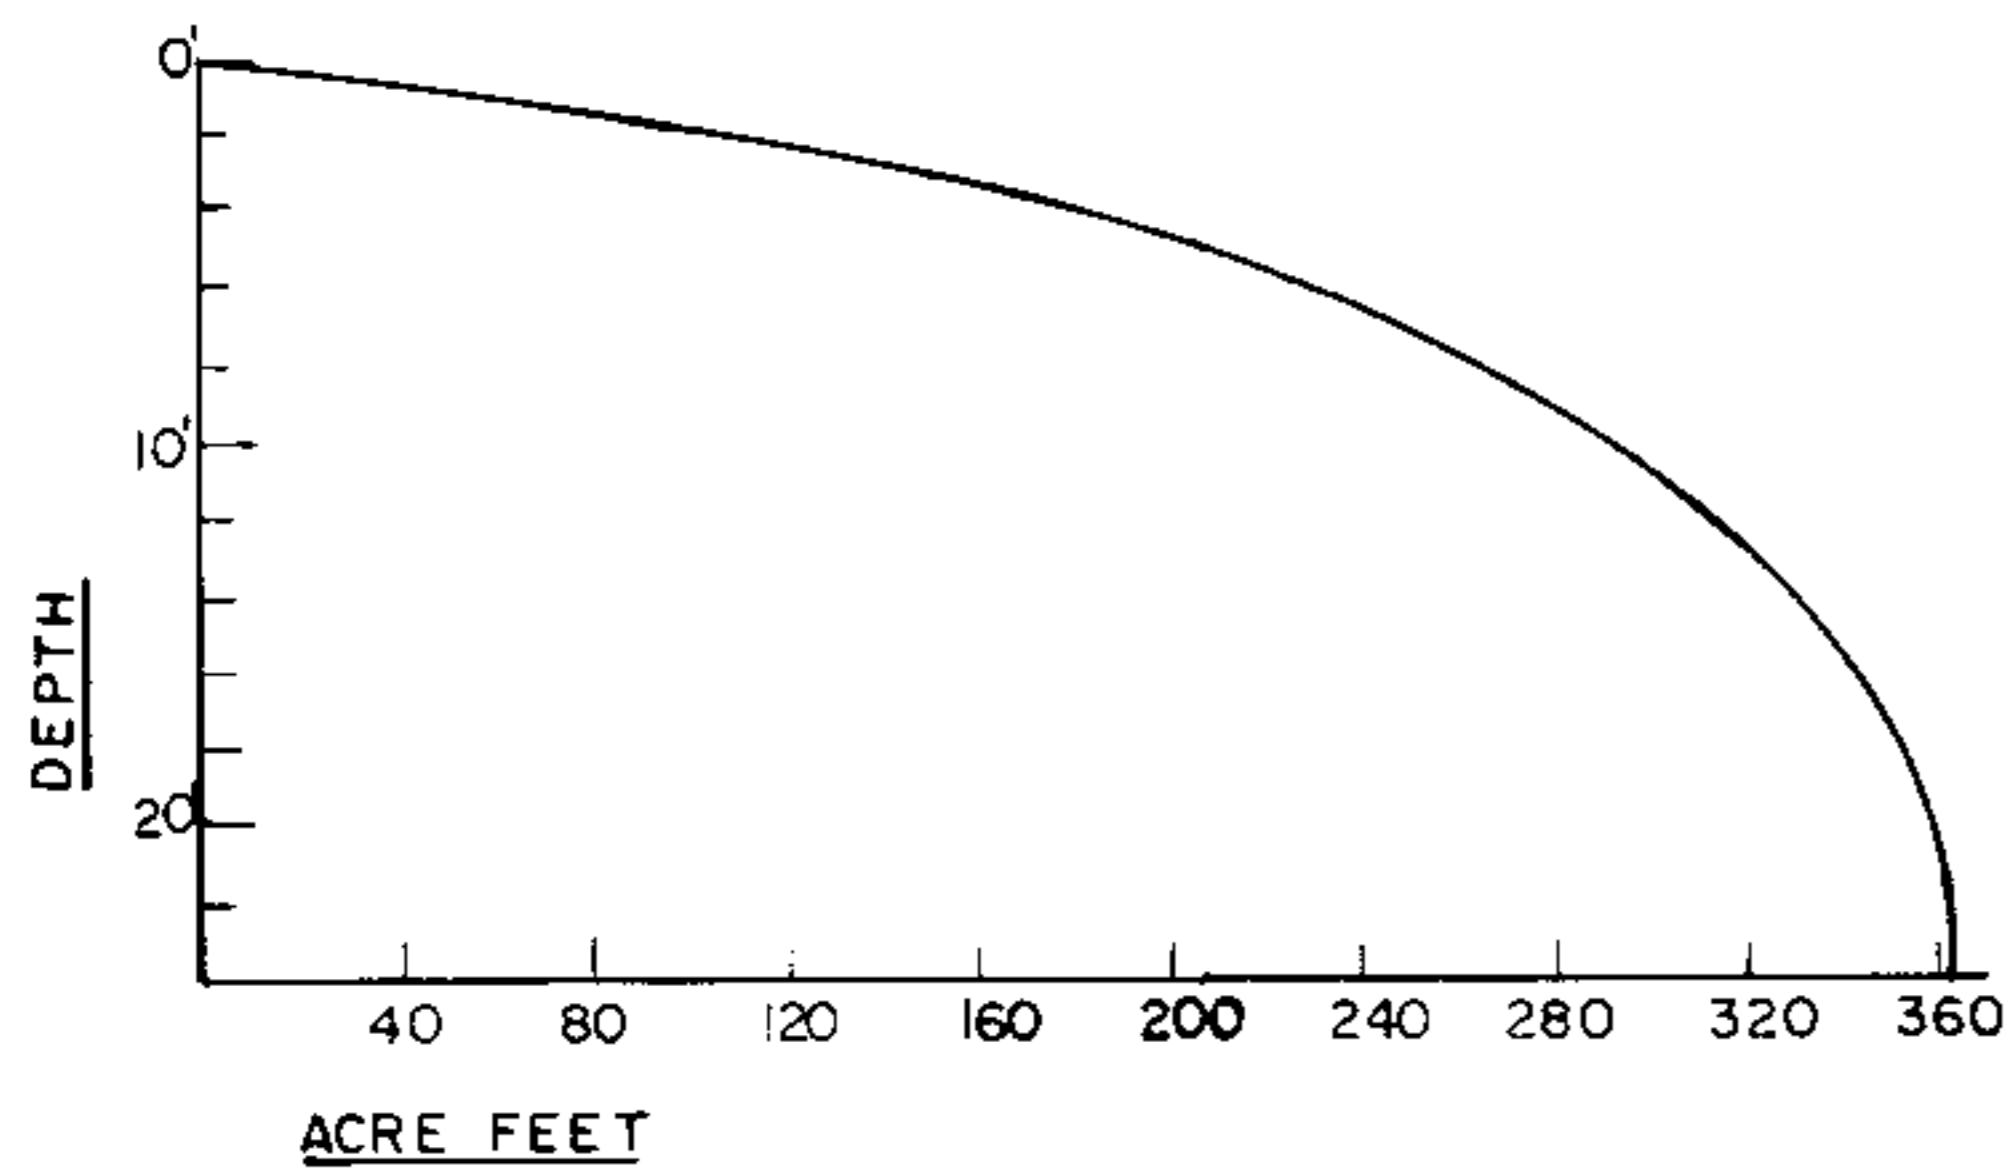
B.M. "X" 2.02' above water to top of upper headwall of dam.
Assumed elev. 100.00'
Water elev. 97.98'

AREA 5457 WITH IS.
51.75 ACRES
UNDER 3 FT. 24.8 %
OVER 20 FT. 5.4 %
VOLUME 361.90 ACRE FT.
TOTAL ALK. 142 P.P.M.
SHORELINE 230 MILES
MAX. DEPTH 24 FEET
