AREA 8.51 ACRES
 UNDER 3 FT. 98 %
 OVER 20 FT. 0 %
 VOLUME 13.12 ACRE FT.
 TOTAL ALK. 305 P.P.M.
 SHORELINE 0.61 MILES
 MAX. DEPTH 4 FEET

Source: Wisconsin Department of Natural Resources 608-266-2621
Lyons Millpond – Walworth County, Wisconsin DNR Lake Map
Date – Jun 1966 - Historical Lake Map - Not for Navigation
A Public Document - Please Identify the Source when using it.

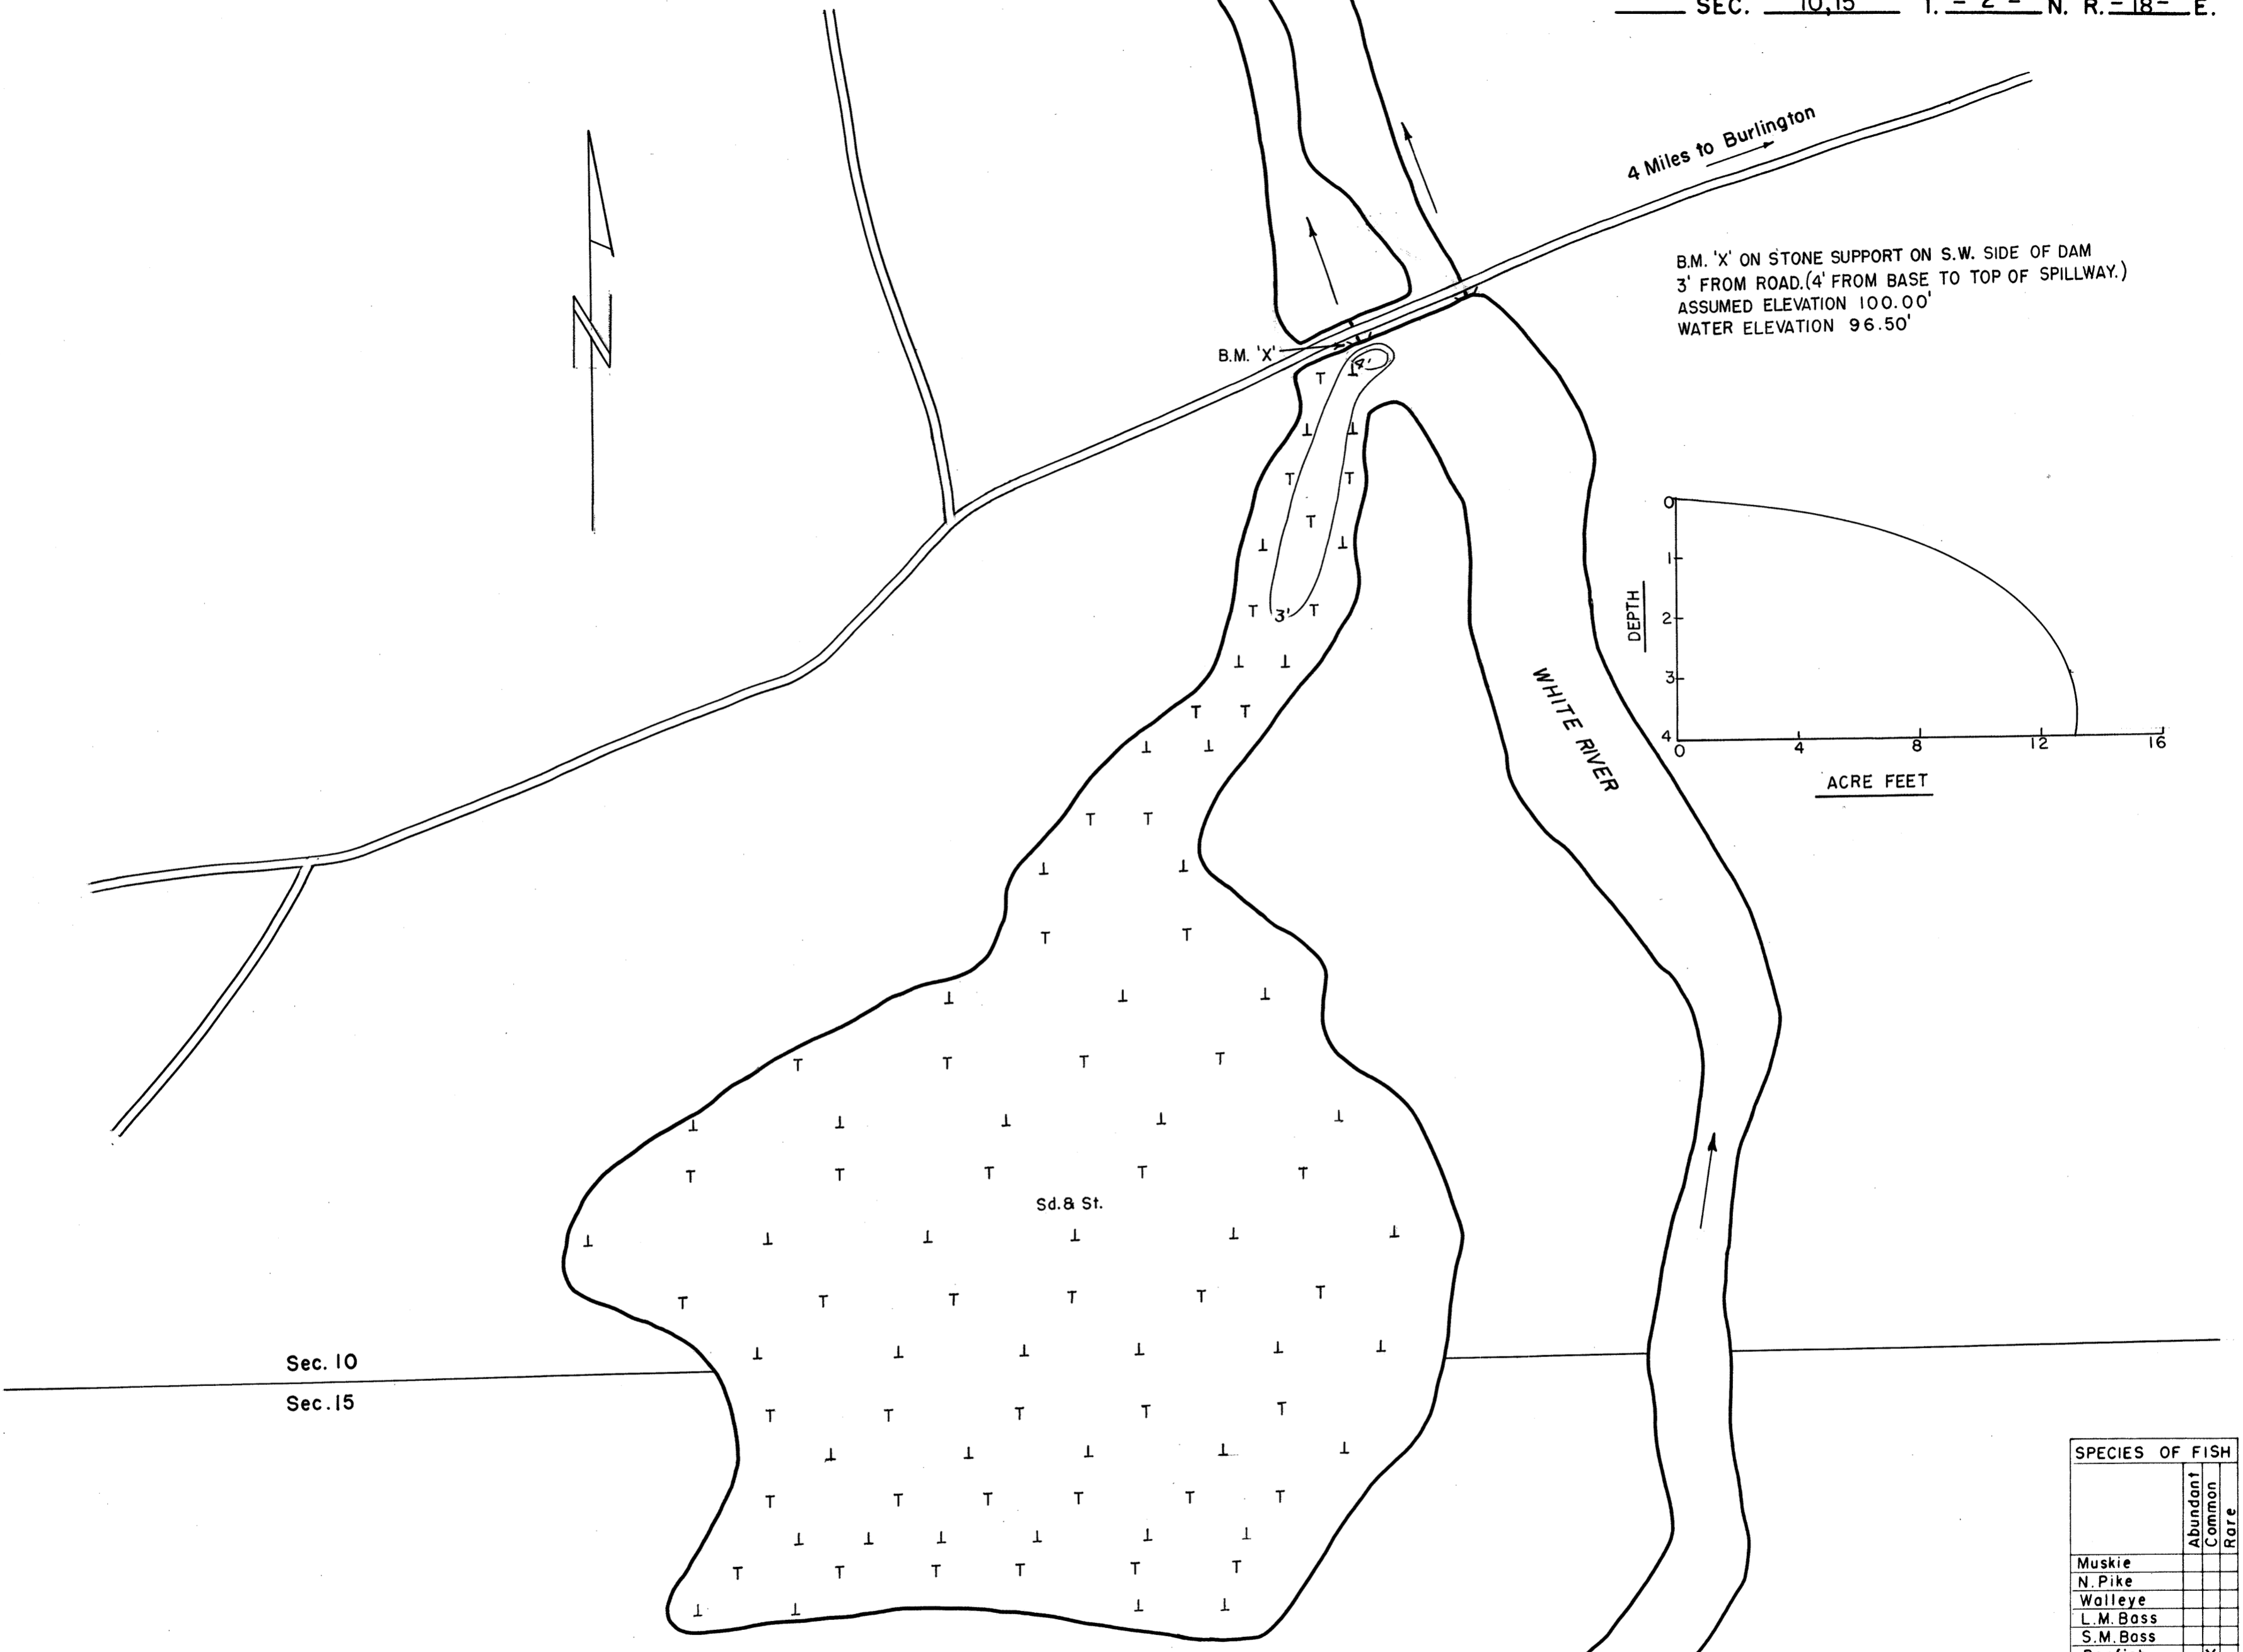
B.M. 'X' ON STONE SUPPORT ON S.W. SIDE OF DAM
 3' FROM ROAD (4' FROM BASE TO TOP OF SPILLWAY.)
 ASSUMED ELEVATION 100.00'
 WATER ELEVATION 96.50'

WATER ELEV. 96.50'
