(Sheet 1 of 2)

Source: Wisconsin Department of Natural Resources 608-266-2621
Tichigan Lake, Buena Lake and Waterford Dam – Racine County, Wisconsin DNR Lake Map
Date – Jul 1967 - Historical Lake Map - Not for Navigation
A Public Document - Please Identify the Source when using it.

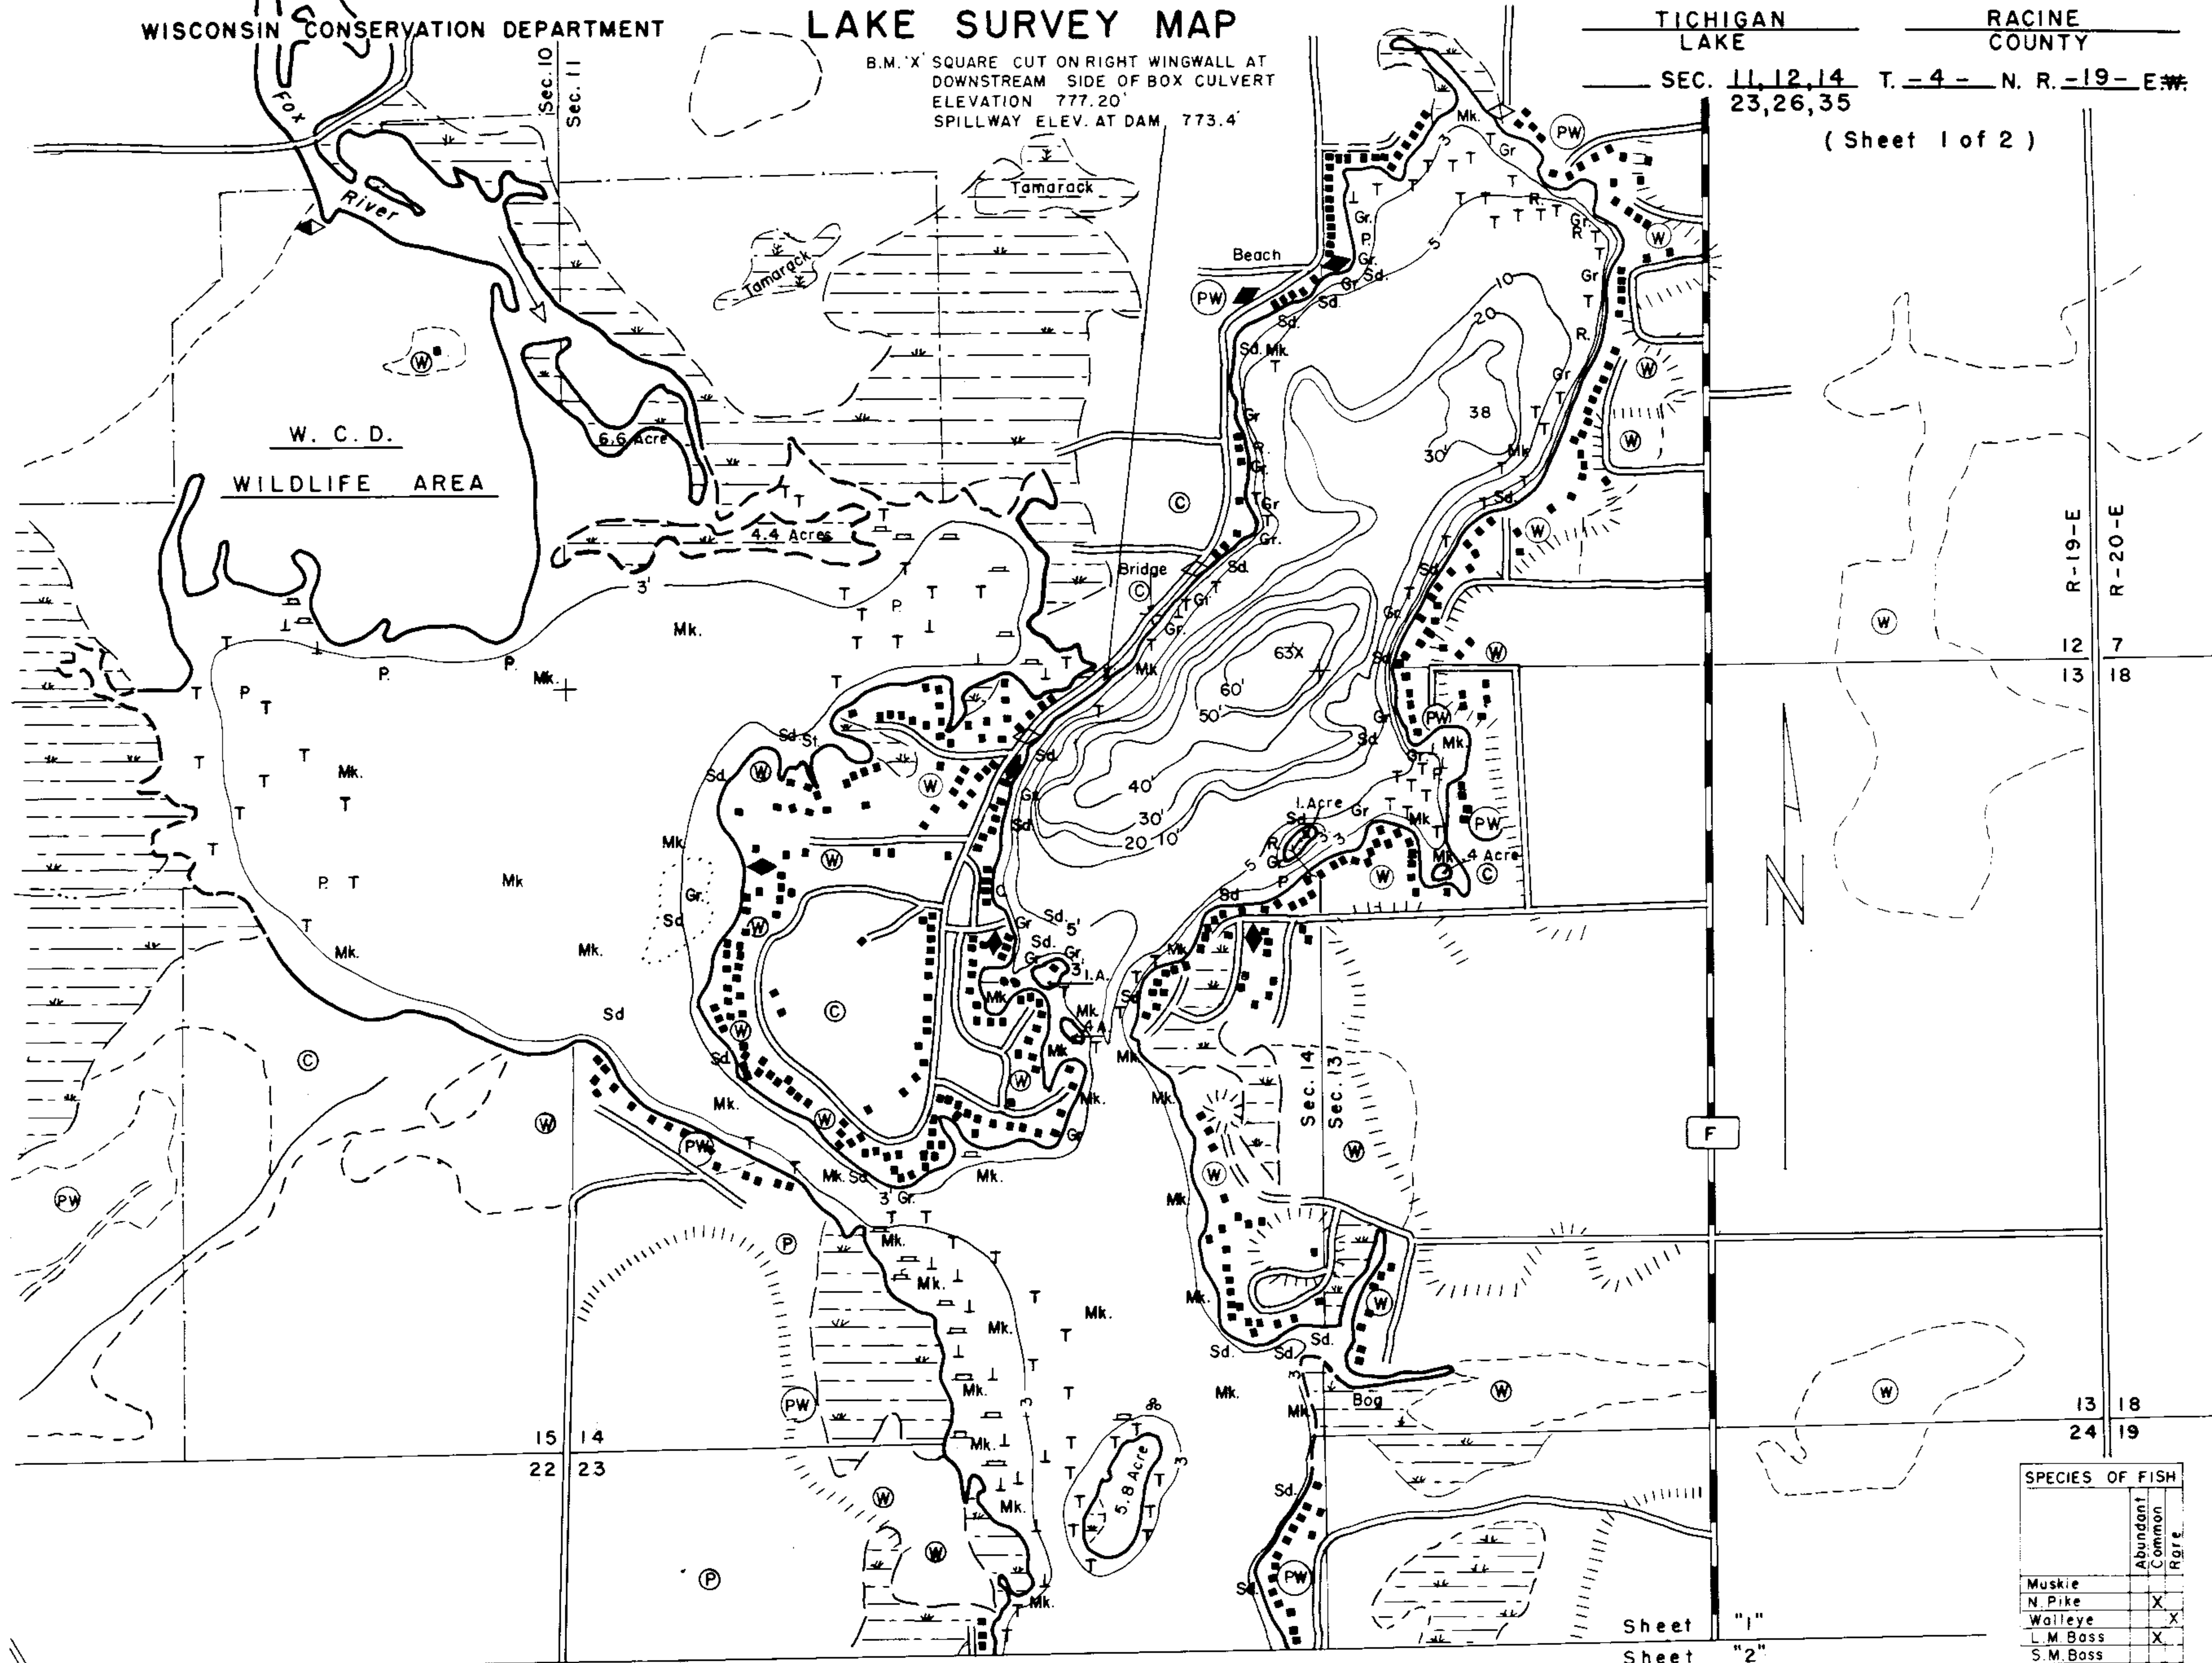
B.M. 'X' SQUARE CUT ON RIGHT WINGWALL AT DOWNSTREAM SIDE OF BOX CULVERT ELEVATION 777.20' SPILLWAY ELEV. AT DAM 773.4'

EQUIPMENT: SONAR
UPDATED JULY 1967
MAPPED SEPTEMBER 1954
MO. YR.

1,160.3 WITH ISLANDS
AREA 1,132.8 ACRES
UNDER 3 FT. 32 %
OVER 20 FT. 8 %
VOLUME 7,112.6 ACRE FT.
TOTAL ALK. 152 P.P.M.
SHORELINE 2.4 WITHOUT ISL.
MAX. DEPTH 63 FEET

B.M. 'X' Top of pillar below Ball at south east end of Park.
Assumed Elev. 103.68'
Water Elev. 99.40'

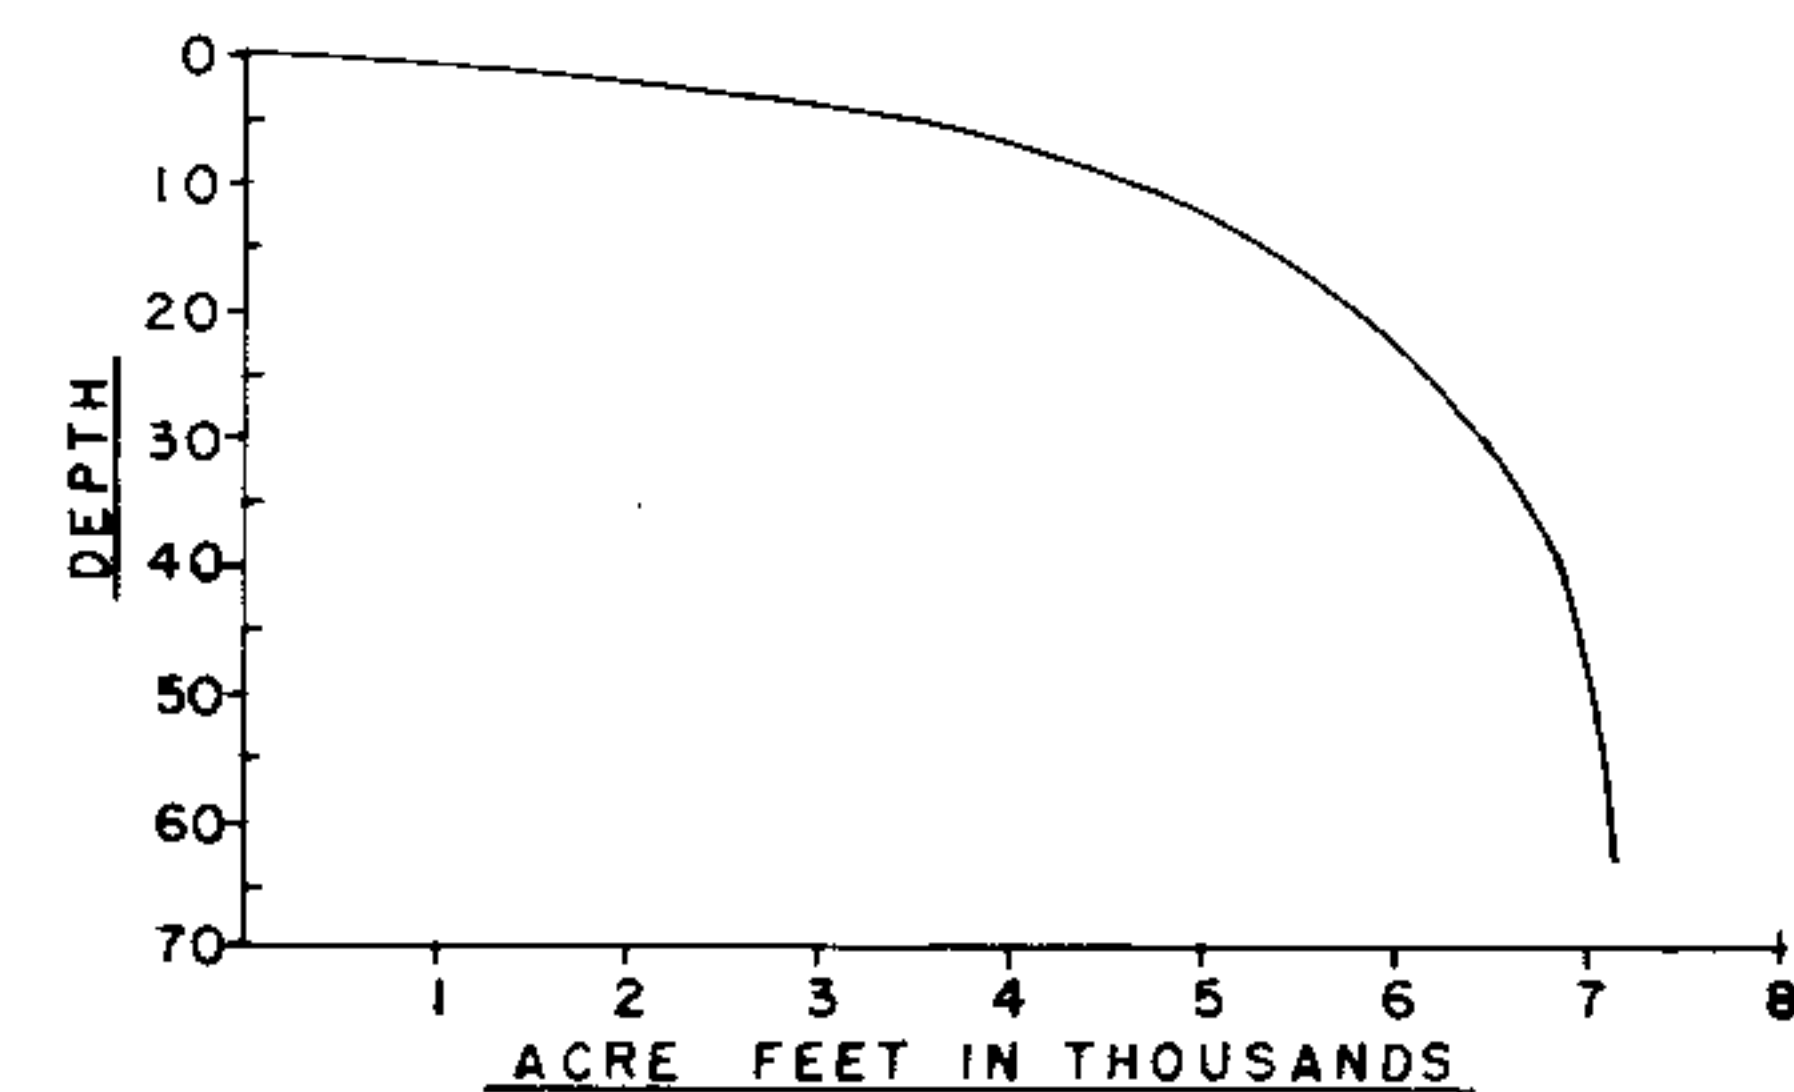
Dam 8' Head with concrete spillway
P.S.C. B.M. 'X' is A Bronze Tablet
Reads 296 C. On upstream end of left wall of flum 6" upstream from left headgate.
Assumed Elev. 101.78
Water Elev. 99.40

EQUIPMENT SONAR
UPDATED JULY 1967
MAPPED SEPTEMBER 1954
MO. YR.
WATER ELEV. 99.40

1,160.3 WITH ISLANDS
AREA 1,132.8 ACRES
UNDER 3FT. 32 %
OVER 20FT. 8 %
VOLUME 7,112.6 ACRE FT.
TOTAL ALK. 152 PPM
SHORELINE 28 MILES
MAX. DEPTH 63 FEET
