EQUIPMENT SONAR, POLE MAPPED JULY 1967
MO. YR.

Source: Wisconsin Department of Natural Resources 608-266-2621
Lulu Lake – Walworth County, Wisconsin DNR Lake Map
Date – Jul 1967 - Historical Lake Map - Not for Navigation
A Public Document - Please Identify the Source when using it.

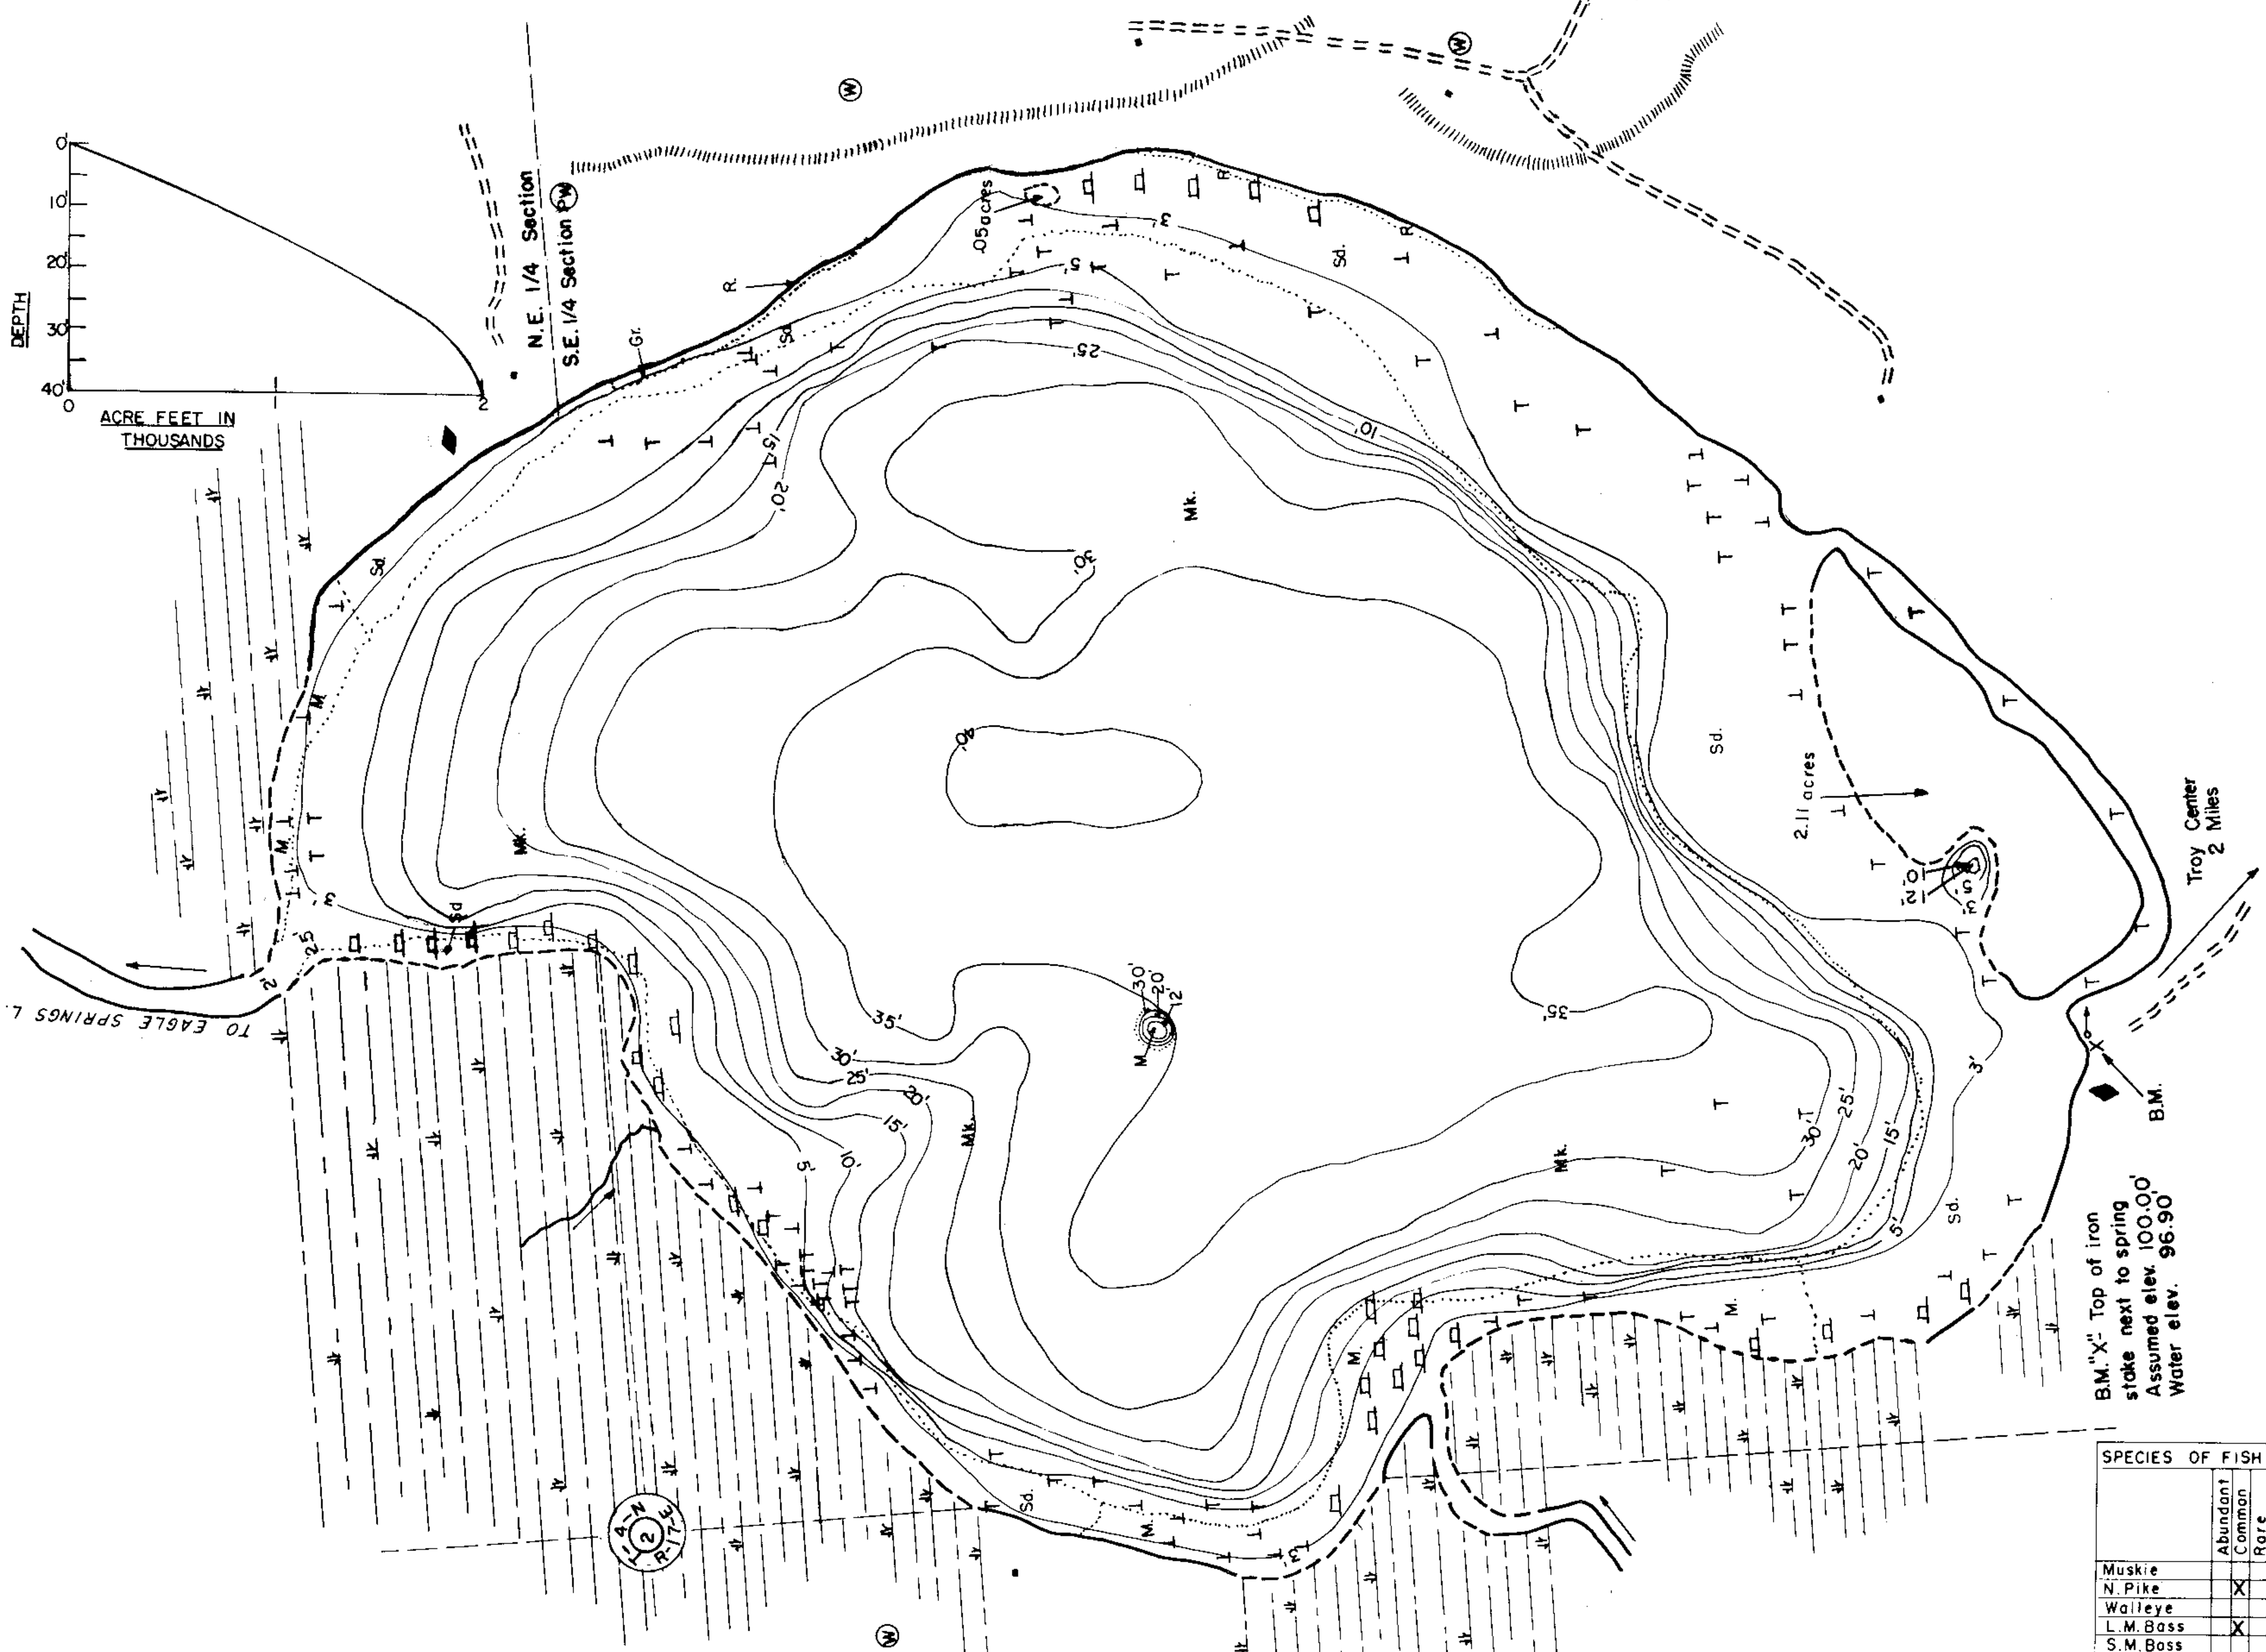
WATER ELEV. 96.90'

AREA 86.42 WITH IS.
84.26 ACRES
UNDER 3 FT. 10.1 %
OVER 20 FT. 63.1 %
VOLUME 2008.94 ACRE FT.
TOTAL ALK. 227 P.P.M.
SHORELINE 2.4 MILES
MAX. DEPTH 40 FEET

B.M. "X" Top of iron stake next to spring Assumed elev. 100.00' Water elev. 96.90'
