EQUIPMENT RECORDING SONAR MAPPED SEPT. 1963
 MO. YR.

Source: Wisconsin Department of Natural Resources 608-266-2621
Comus Lake – Walworth County, Wisconsin DNR Lake Map
Date – Sep 1963 - Historical Lake Map - Not for Navigation
A Public Document - Please Identify the Source when using it.

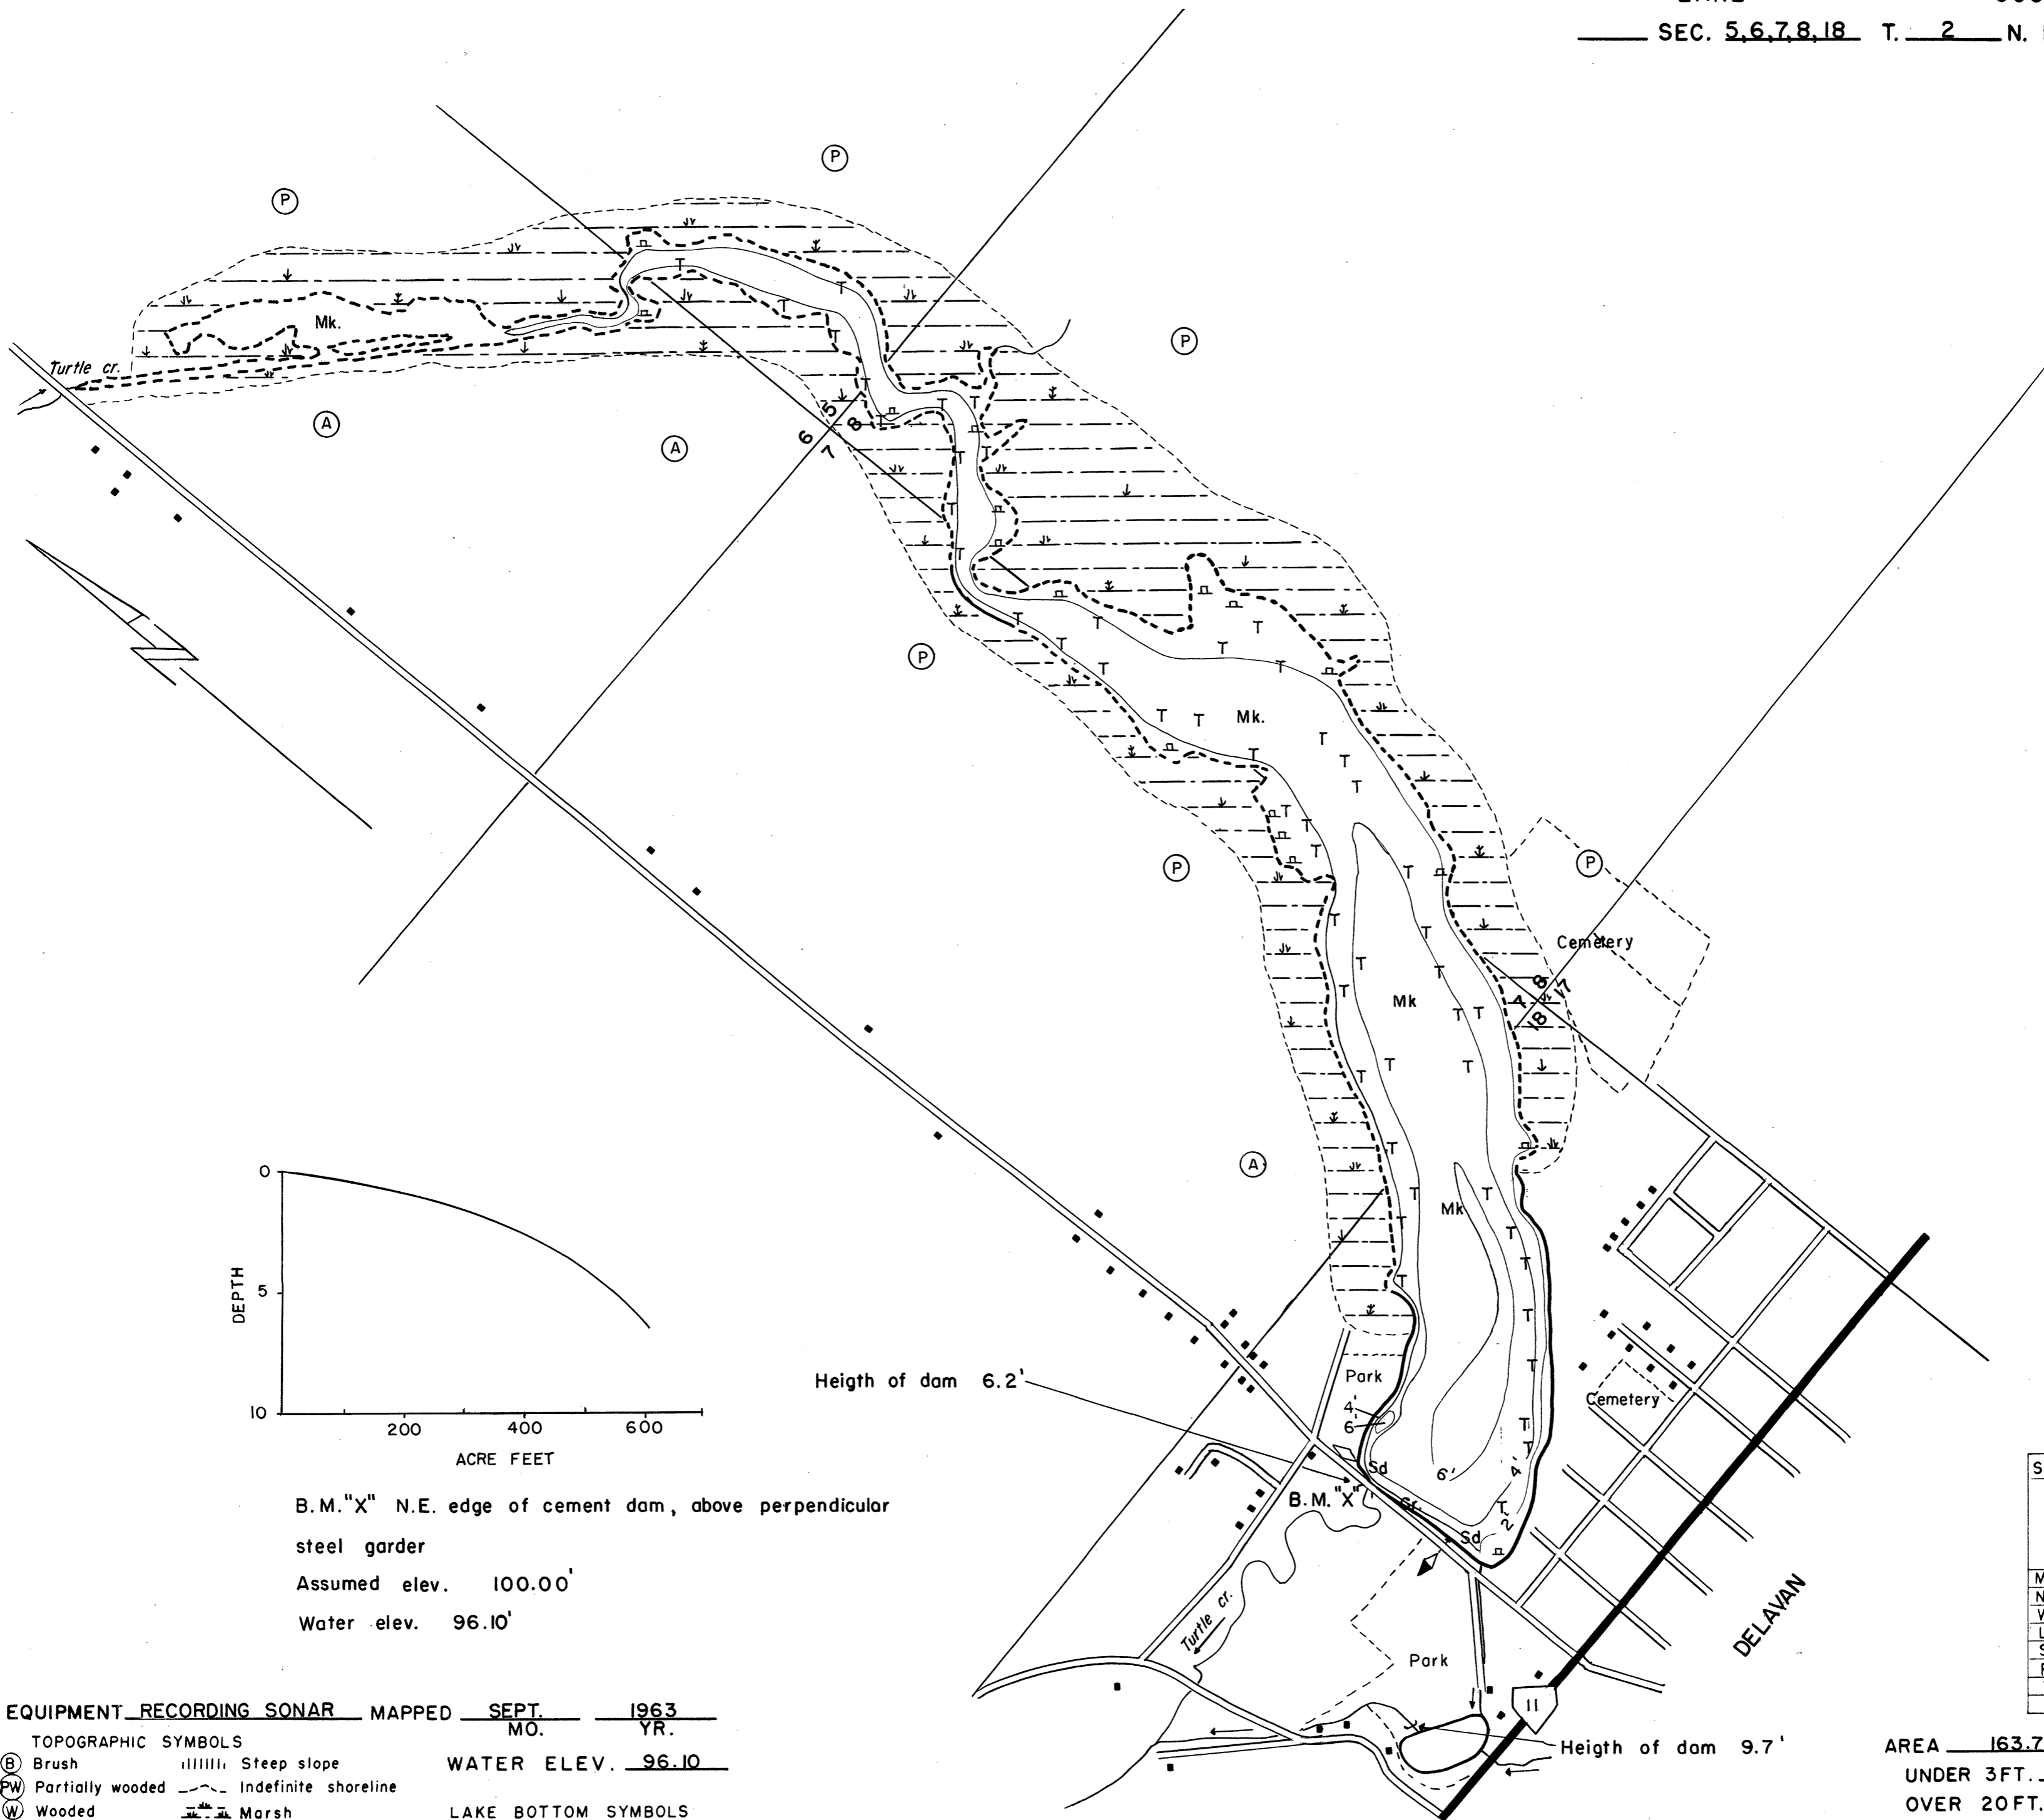
B.M. "X" N.E. edge of cement dam, above perpendicular steel gader
 Assumed elev. 100.00'
 Water elev. 96.10'

- TOPOGRAPHIC SYMBOLS
- (B) Brush
 - (PW) Partially wooded
 - (W) Wooded
 - (C) Cleared
 - (P) Pastured
 - (A) Agricultural
 - B.M. Bench Mark
 - Dwelling
 - Resort
 - ||||| Steep slope
 - - - Indefinite shoreline
 - Marsh
 - Spring
 - Intermittent stream
 - Permanent inlet
 - Permanent outlet
 - Dam
- LAKE BOTTOM SYMBOLS
- P. Peat
 - Mk. Muck
 - C. Clay
 - M. Marl
 - Sd. Sand
 - St. Silt
 - Gr. Gravel
 - R. Rubble
 - Br. Bedrock
 - Stumps & Snags
 - T Submergent vegetation
 - Emergent vegetation
 - Floating vegetation

WATER ELEV. 96.10

AREA 163.7 ACRES
 UNDER 3FT. 34 %
 OVER 20FT. 0 %
 VOLUME 606 ACRE FT.
 TOTAL ALK. 205 P.P.M.
 SHORELINE 6.4 MILES
 MAX. DEPTH 6 FEET
