EQUIPMENT RECORDING SONAR MAPPED JULY 1966
MO. YR.

Source: Wisconsin Department of Natural Resources 608-266-2621
Cravath Lake – Walworth County, Wisconsin DNR Lake Map
Date – Jul 1966 - Historical Lake Map - Not for Navigation
A Public Document - Please Identify the Source when using it.

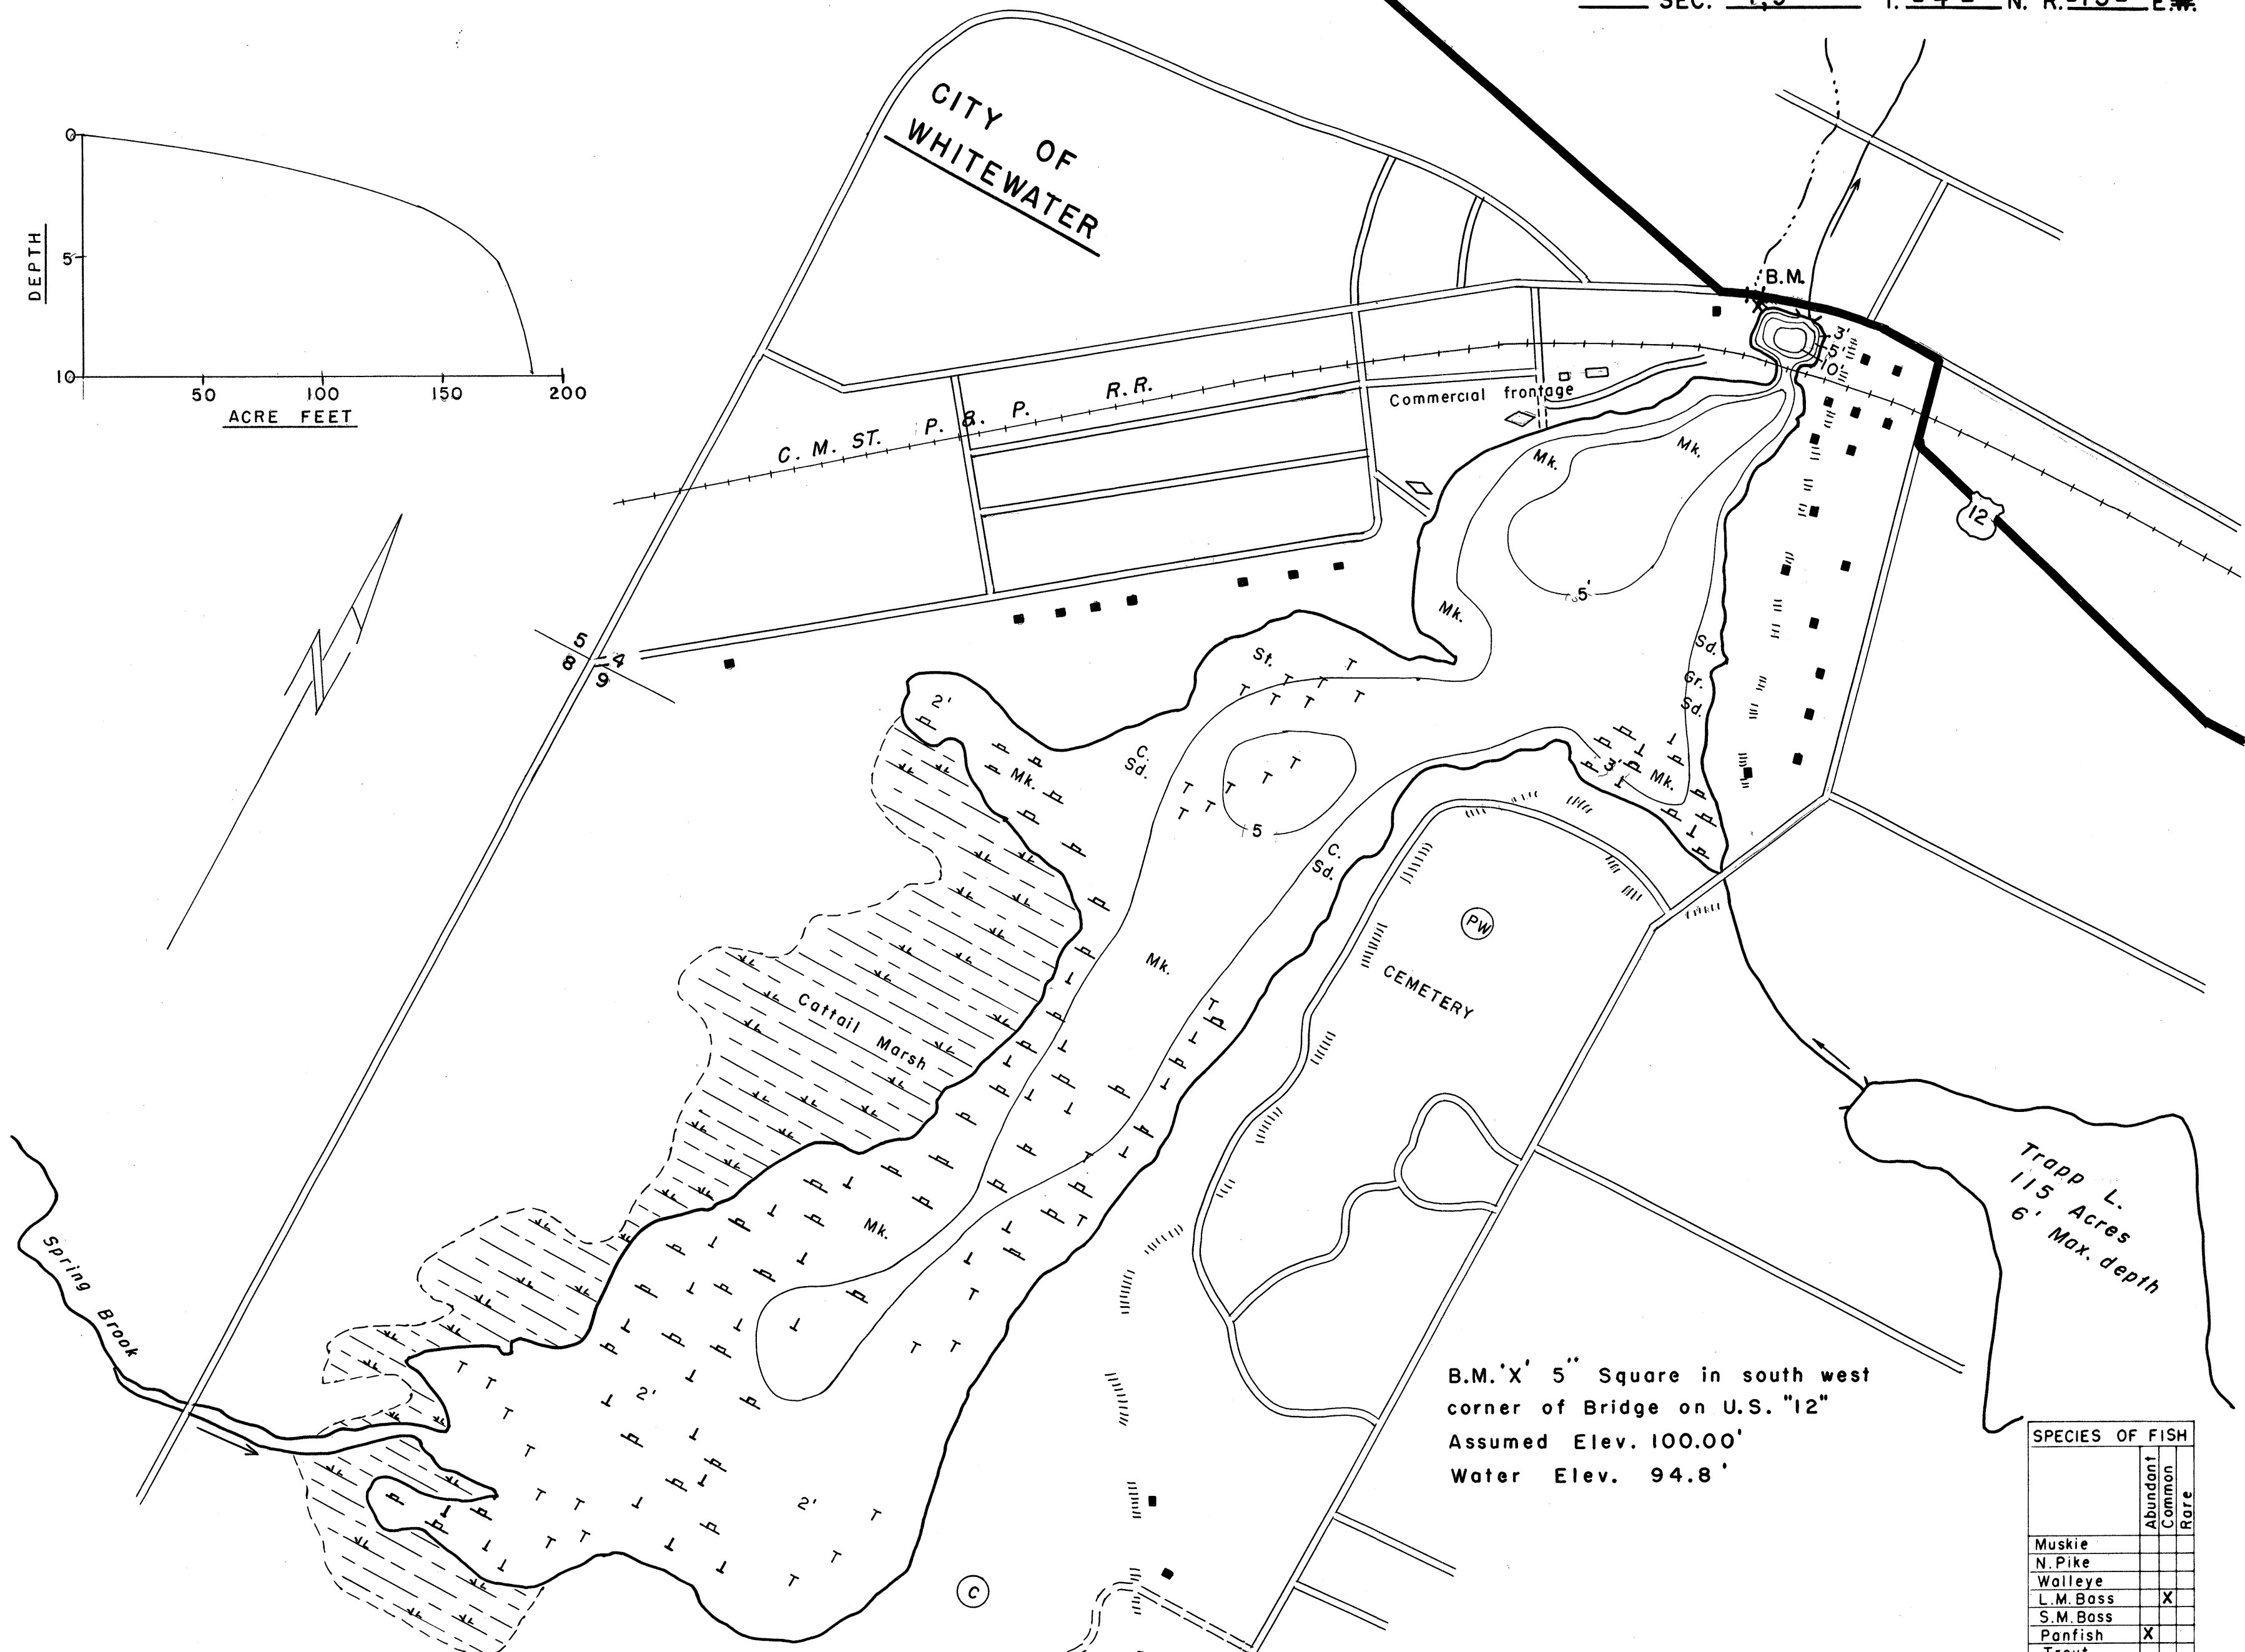
B.M. 'X' 5" Square in south west corner of Bridge on U.S. "12"
Assumed Elev. 100.00'
Water Elev. 94.8'

AREA 68.3 ACRES
UNDER 3FT. 63 %
OVER 20FT. 0 %
VOLUME 186.5 ACRE FT.
TOTAL ALK. 228 P.P.M.
SHORELINE 2.8 MILES
MAX. DEPTH 10 FEET
