EQUIPMENT SOUNDING POLE MAPPED JULY 1970

Source: Wisconsin Department of Natural Resources 608-266-2621
Hahns Lake – Jefferson County, Wisconsin DNR Lake Map
Date – Jul 1970 - Historical Lake Map - Not for Navigation
A Public Document - Please Identify the Source when using it.

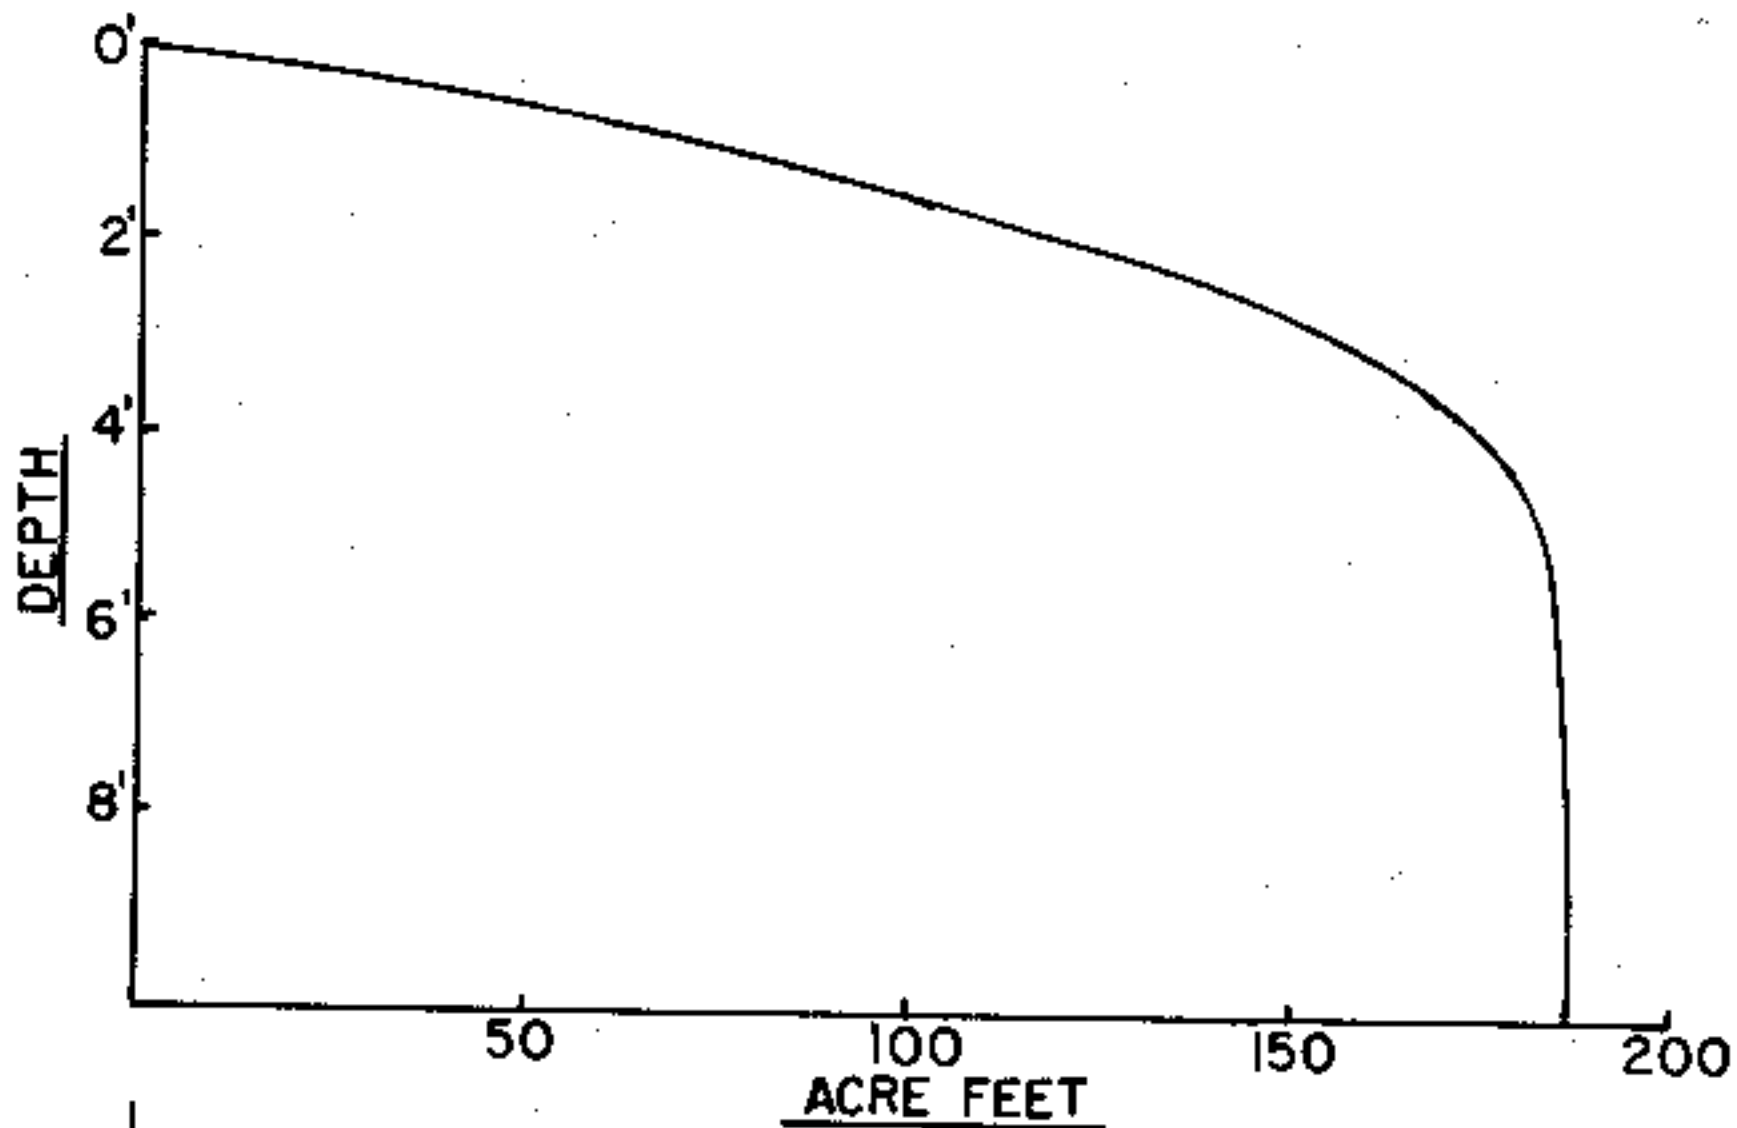
BM. 'X' 1529-A Railroad spike in large
double willow tree 35' north of lakeshore
& 10' west of private drive.
Assumed Elev. 100.00'
Water Elev. 95.15'

WATER AREA 81.5 ACRES
UNDER 3 FT. 65.5 %
OVER 20 FT. 0 %
MAX. DEPTH 10 FEET.
TOTAL ALK. 265 P.P.M.
VOLUME 185.1 ACRE FT.
SHORELINE 1.69 MILES
