EQUIPMENT RECORDING SONAR MAPPED JULY 1978
MONTH YEAR

Source: Wisconsin Department of Natural Resources 608-266-2621
Horseshoe Lake - Lincoln County, Wisconsin DNR Lake Map
Date – Jul. 1978 - Historical Lake Map - Not for Navigation
A Public Document - Please Identify the Source when using it.

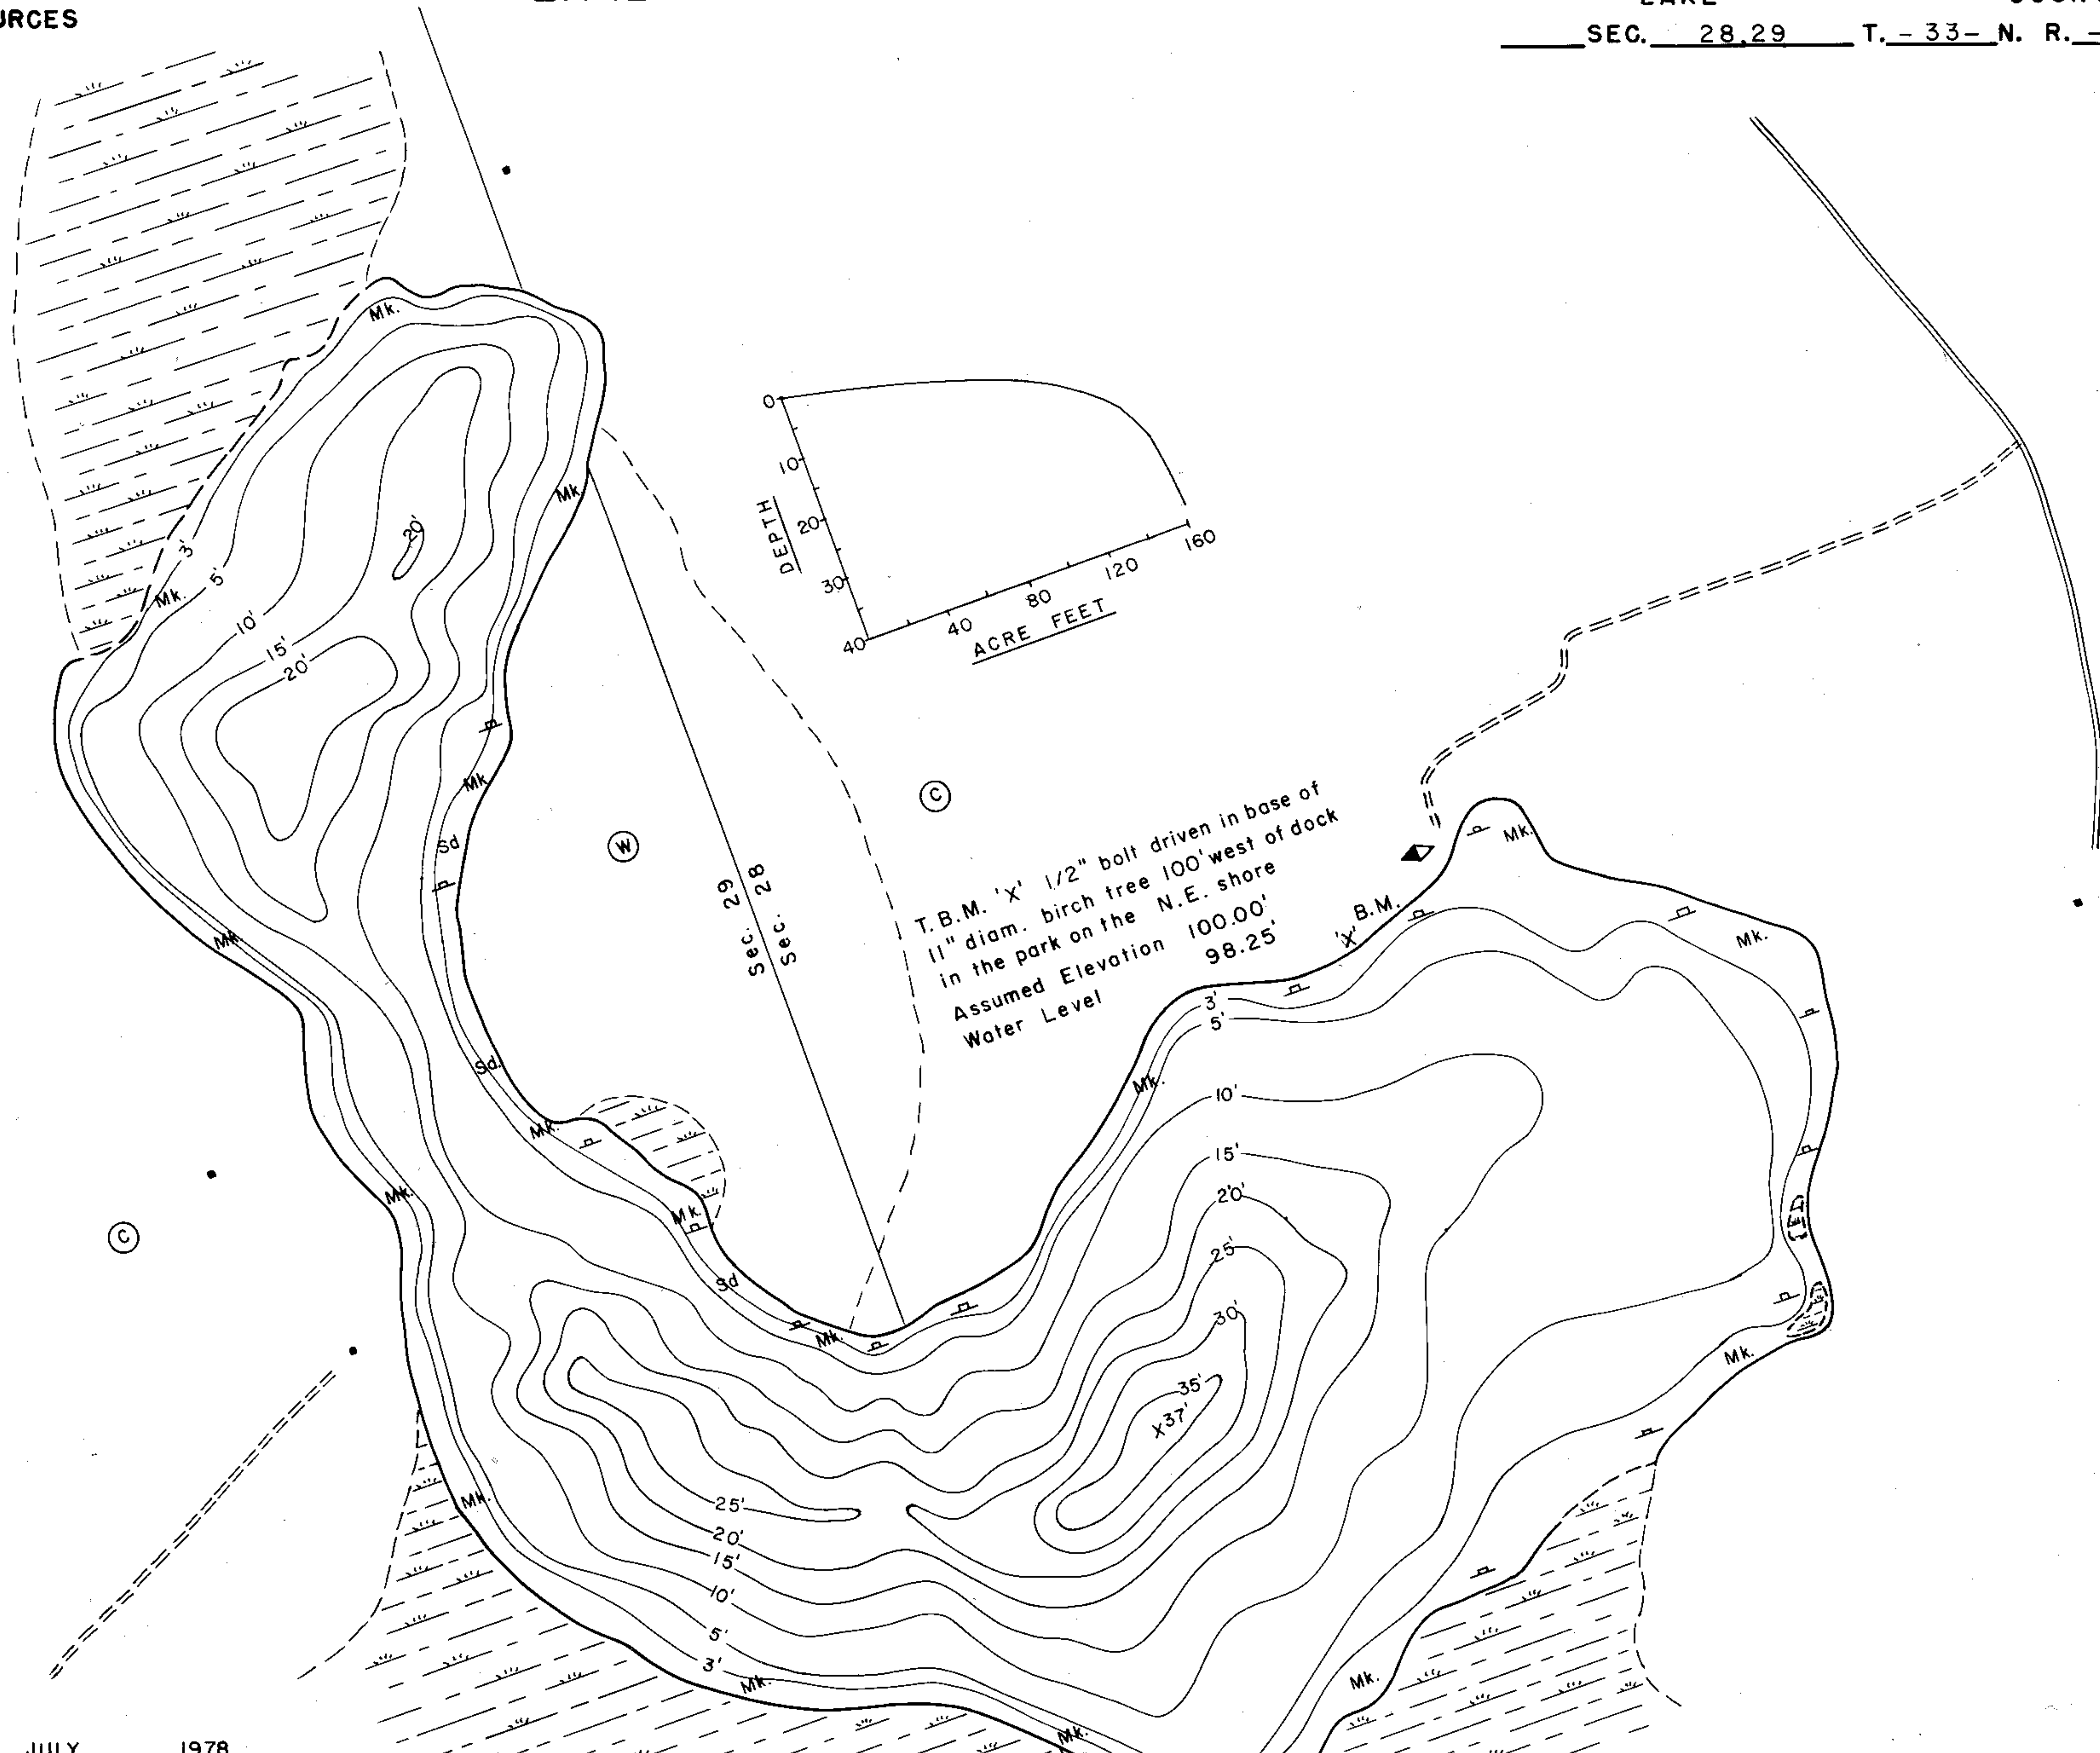
T.B.M. 'X' 1/2" bolt driven in base of
11" diam. birch tree 100' west of dock
in the park on the N.E. shore
Assumed Elevation 100.00'
Water Level 98.25'

WATER AREA 15.2 ACRES
 UNDER 3 FT. 14 %
 OVER 20 FT. 14 %
 MAX. DEPTH 37 FEET.
 TOTAL ALK. 6 P.P.M.
 VOLUME 161.3 ACRE FT.
 MAIN SHORELINE .95 MI.
 ISLAND SHORELINE .038 MI.
