EQUIPMENT RECORDING SONAR MAPPED AUGUST 1966

Source: Wisconsin Department of Natural Resources 608-266-2621
Muskellunge Lake – Oneida County, Wisconsin - DNR Lake Map
Date – Aug 1966 - Historical Lake Map - Not for Navigation
A Public Document - Please Identify the Source when using it.

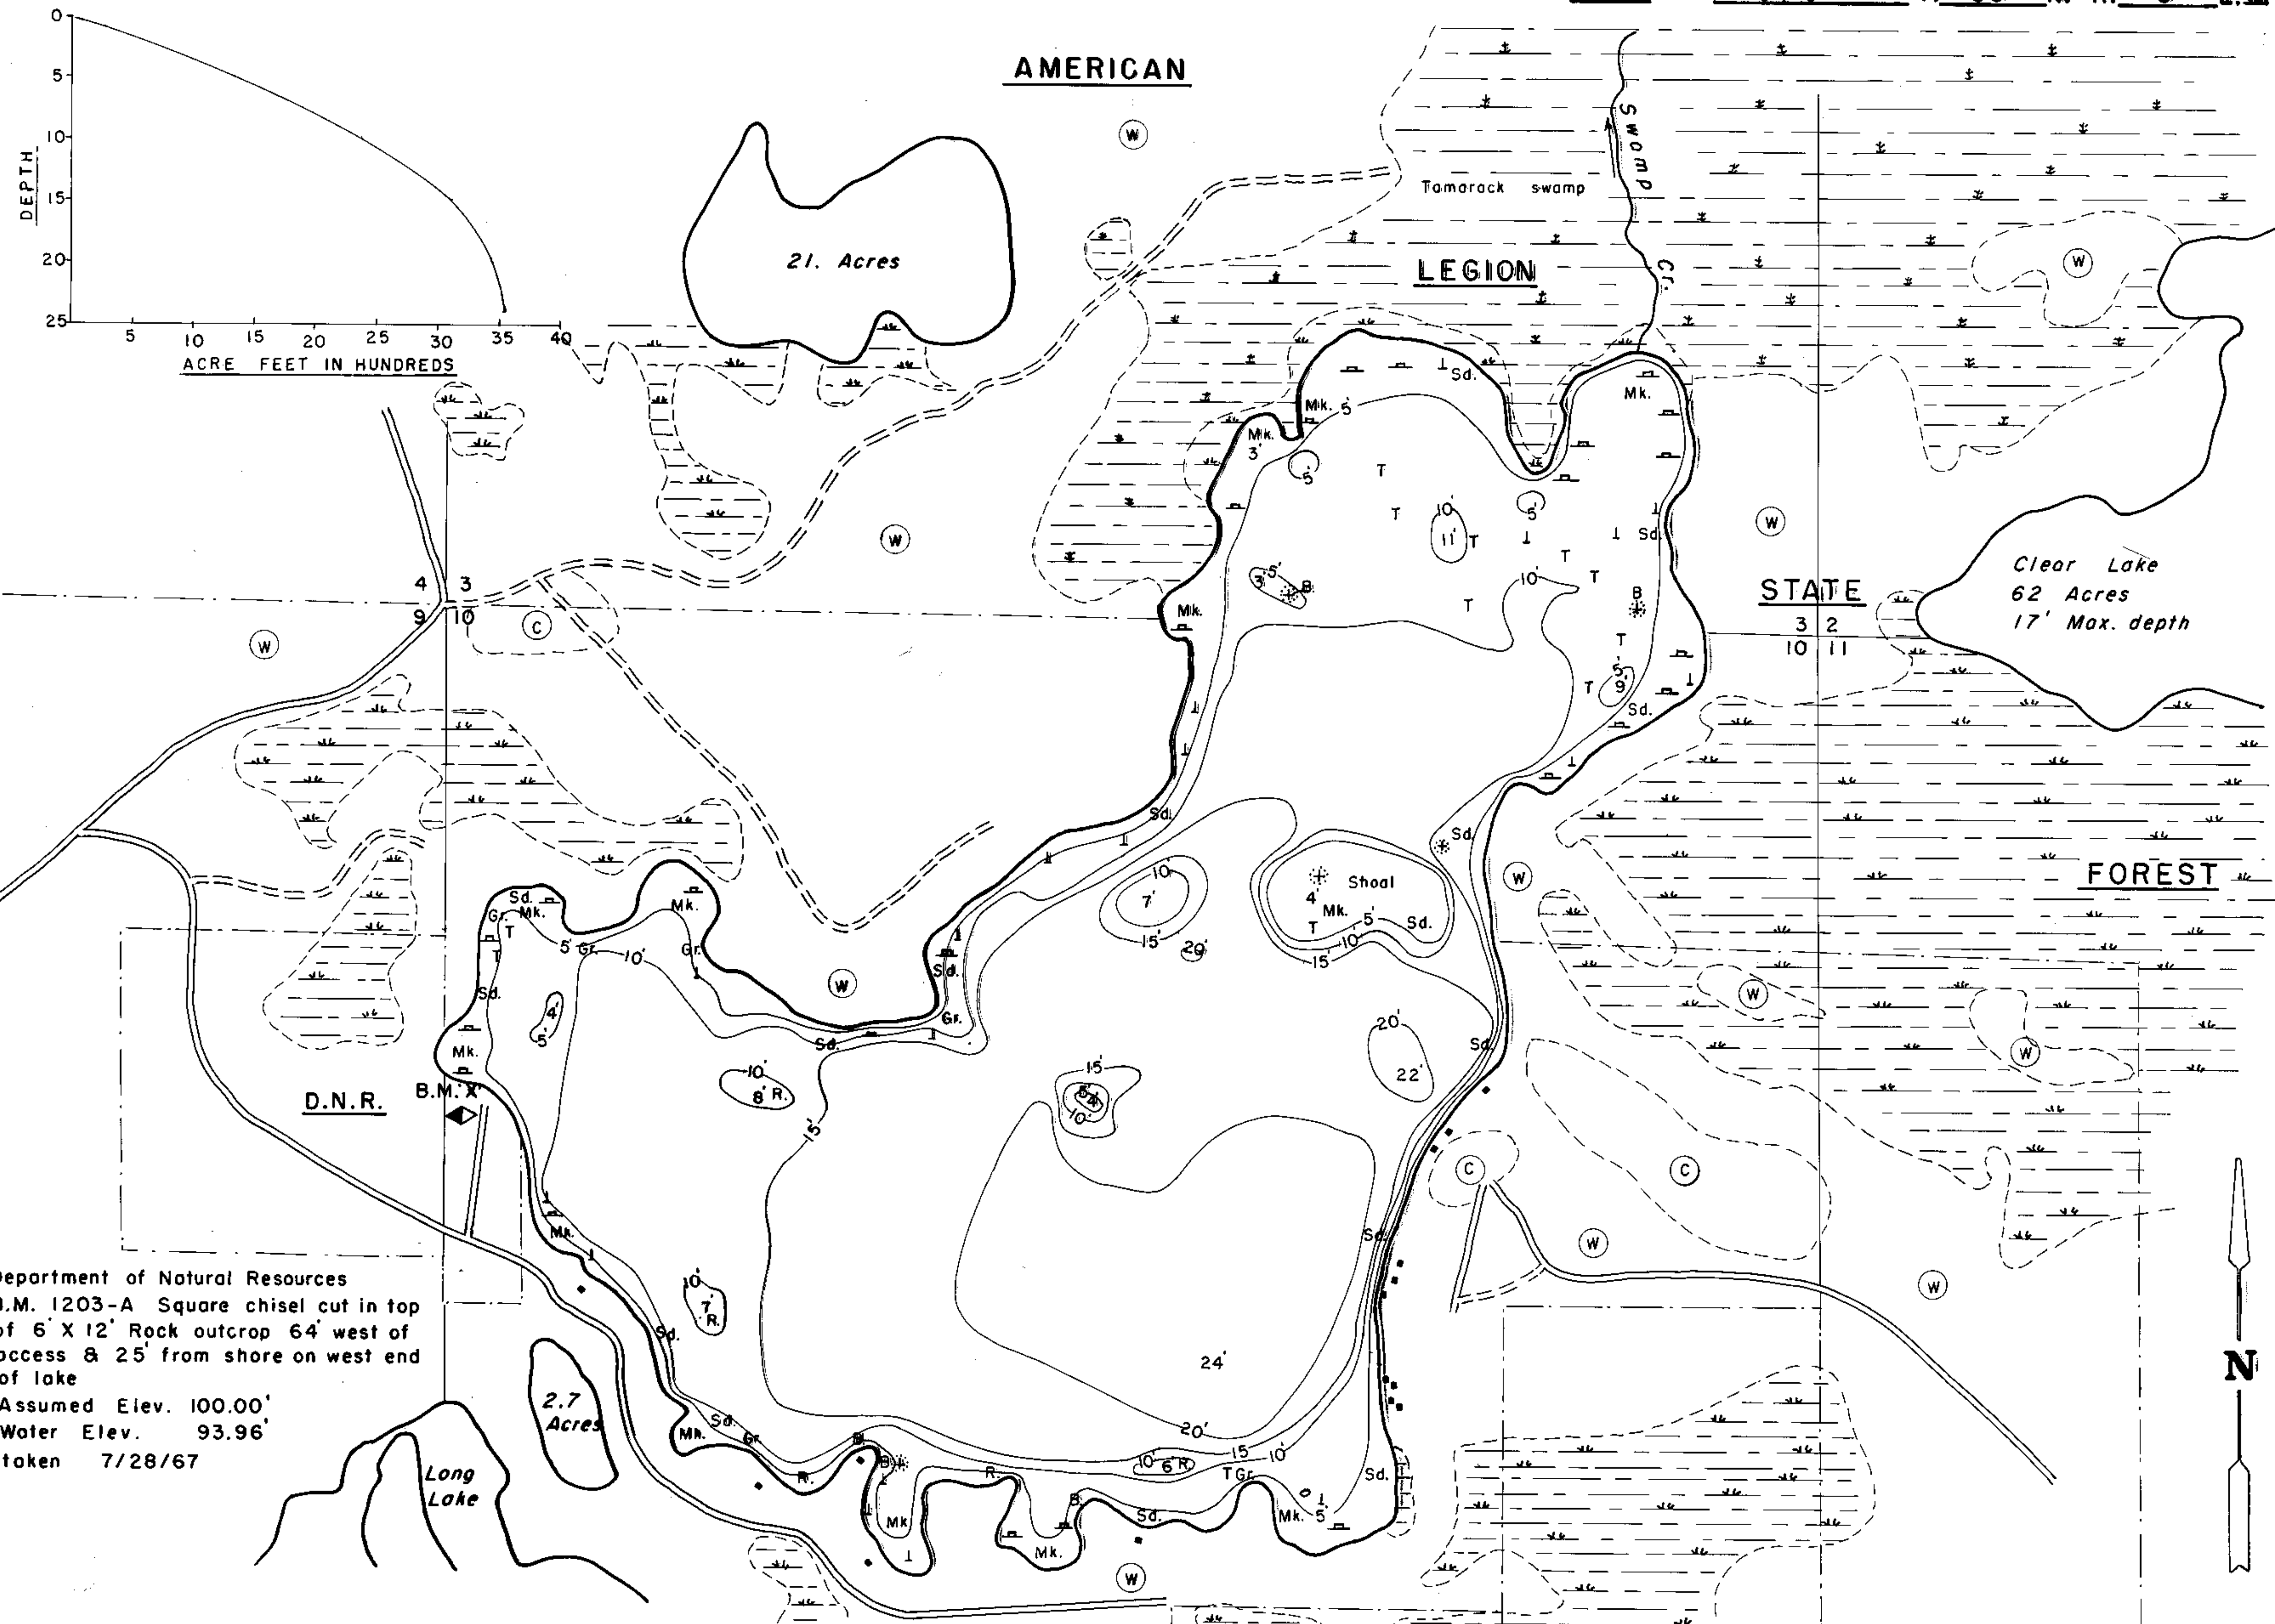
Department of Natural Resources
B.M. 1203-A Square chisel cut in top of 6' X 12' Rock outcrop 64' west of access & 25' from shore on west end of lake
Assumed Elev. 100.00'
Water Elev. 93.96'
taken 7/28/67

WATER AREA 284.2 ACRES
UNDER 3 FT. 8 %
OVER 20 FT. 13 %
MAX. DEPTH 24 FEET.
TOTAL ALK. 30 P.P.M.
VOLUME 3,557.3 ACRE FT.
SHORELINE 4.0 MILES
