EQUIPMENT RECORDING SONAR MAPPED JUNE 1966 MO. YR.

Source: Wisconsin Department of Natural Resources 608-266-2621
Muskellunge Lake - Vilas County, Wisconsin DNR Lake Map
Date – Jun 1966 - Historical Lake Map - Not for Navigation
A Public Document - Please Identify the Source when using it.

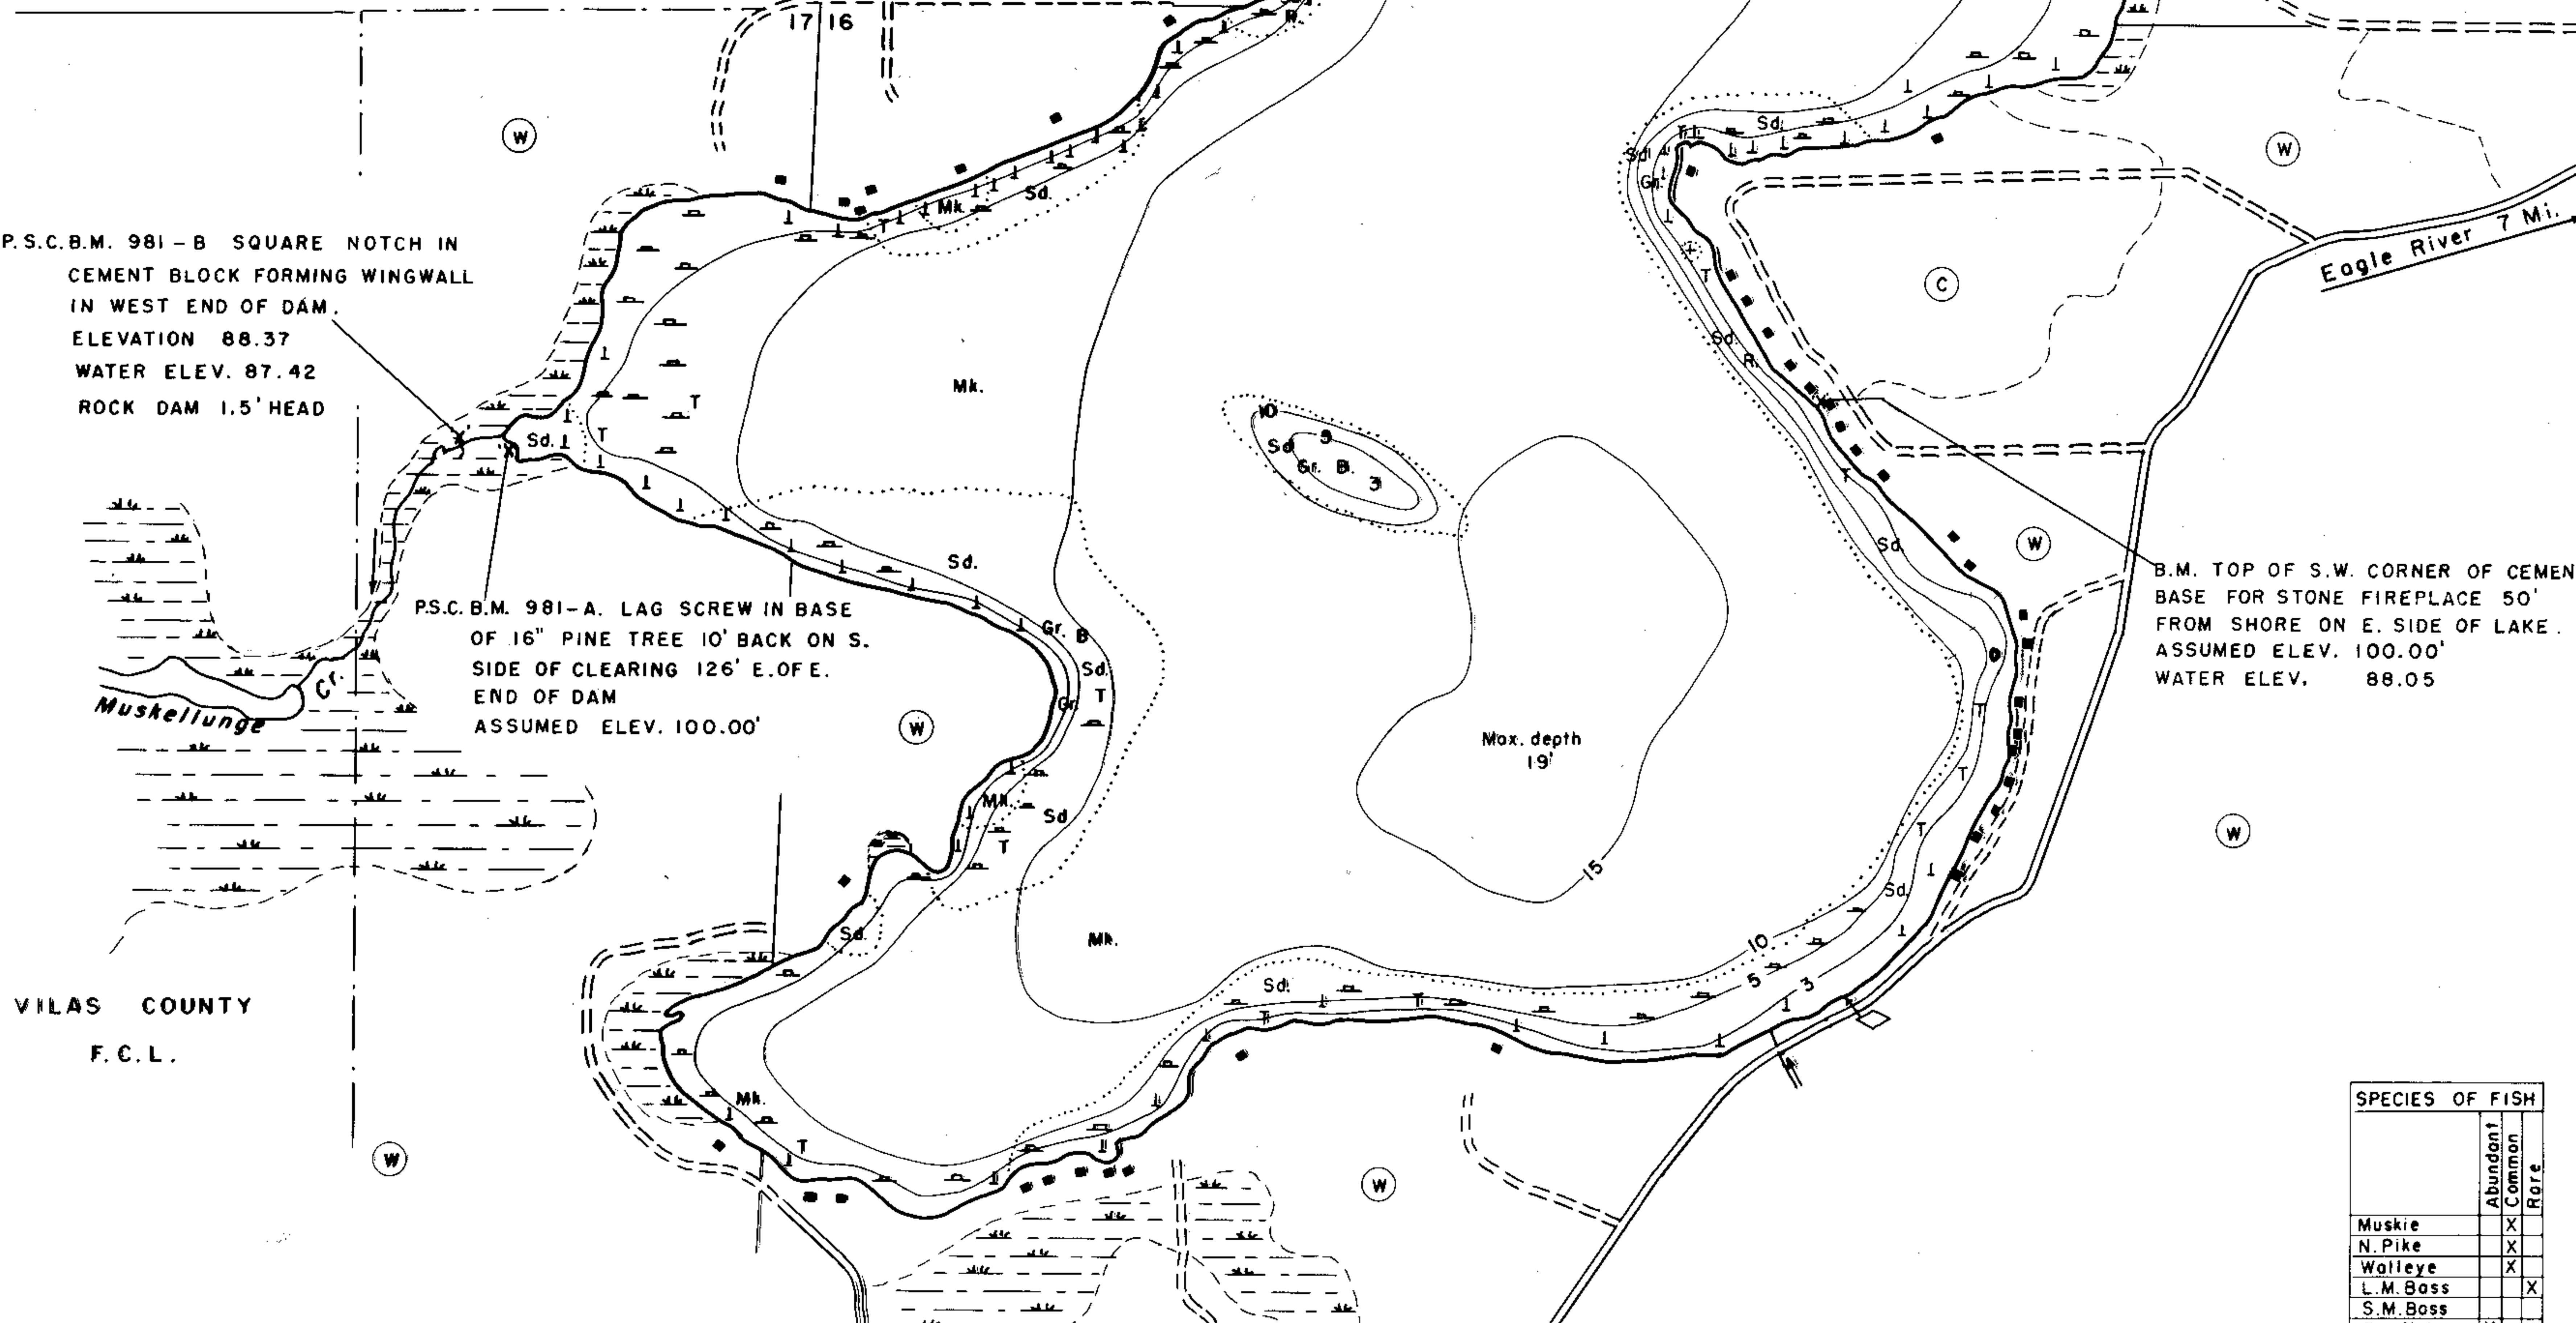
P.S.C.B.M. 981-A LAG SCREW IN BASE OF 16" PINE TREE 10' BACK ON S. SIDE OF CLEARING 126' E.O.F.E. END OF DAM ASSUMED ELEV. 100.00'

B.M. TOP OF S.W. CORNER OF CEMENT BASE FOR STONE FIREPLACE 50' FROM SHORE ON E. SIDE OF LAKE. ASSUMED ELEV. 100.00' WATER ELEV. 88.05

AREA 271.6 ACRES
UNDER 3FT. 11 %
OVER 20FT. 0 %
VOLUME 2,519.7 ACRE FT.
TOTAL ALK. 38 P.P.M.
SHORELINE 3.6 MILES
MAX. DEPTH 19 FEET
