# LAKE SURVEY MAP

NORTH TWIN  
LAKE

VILAS  
COUNTY

Sheet 2 of 2

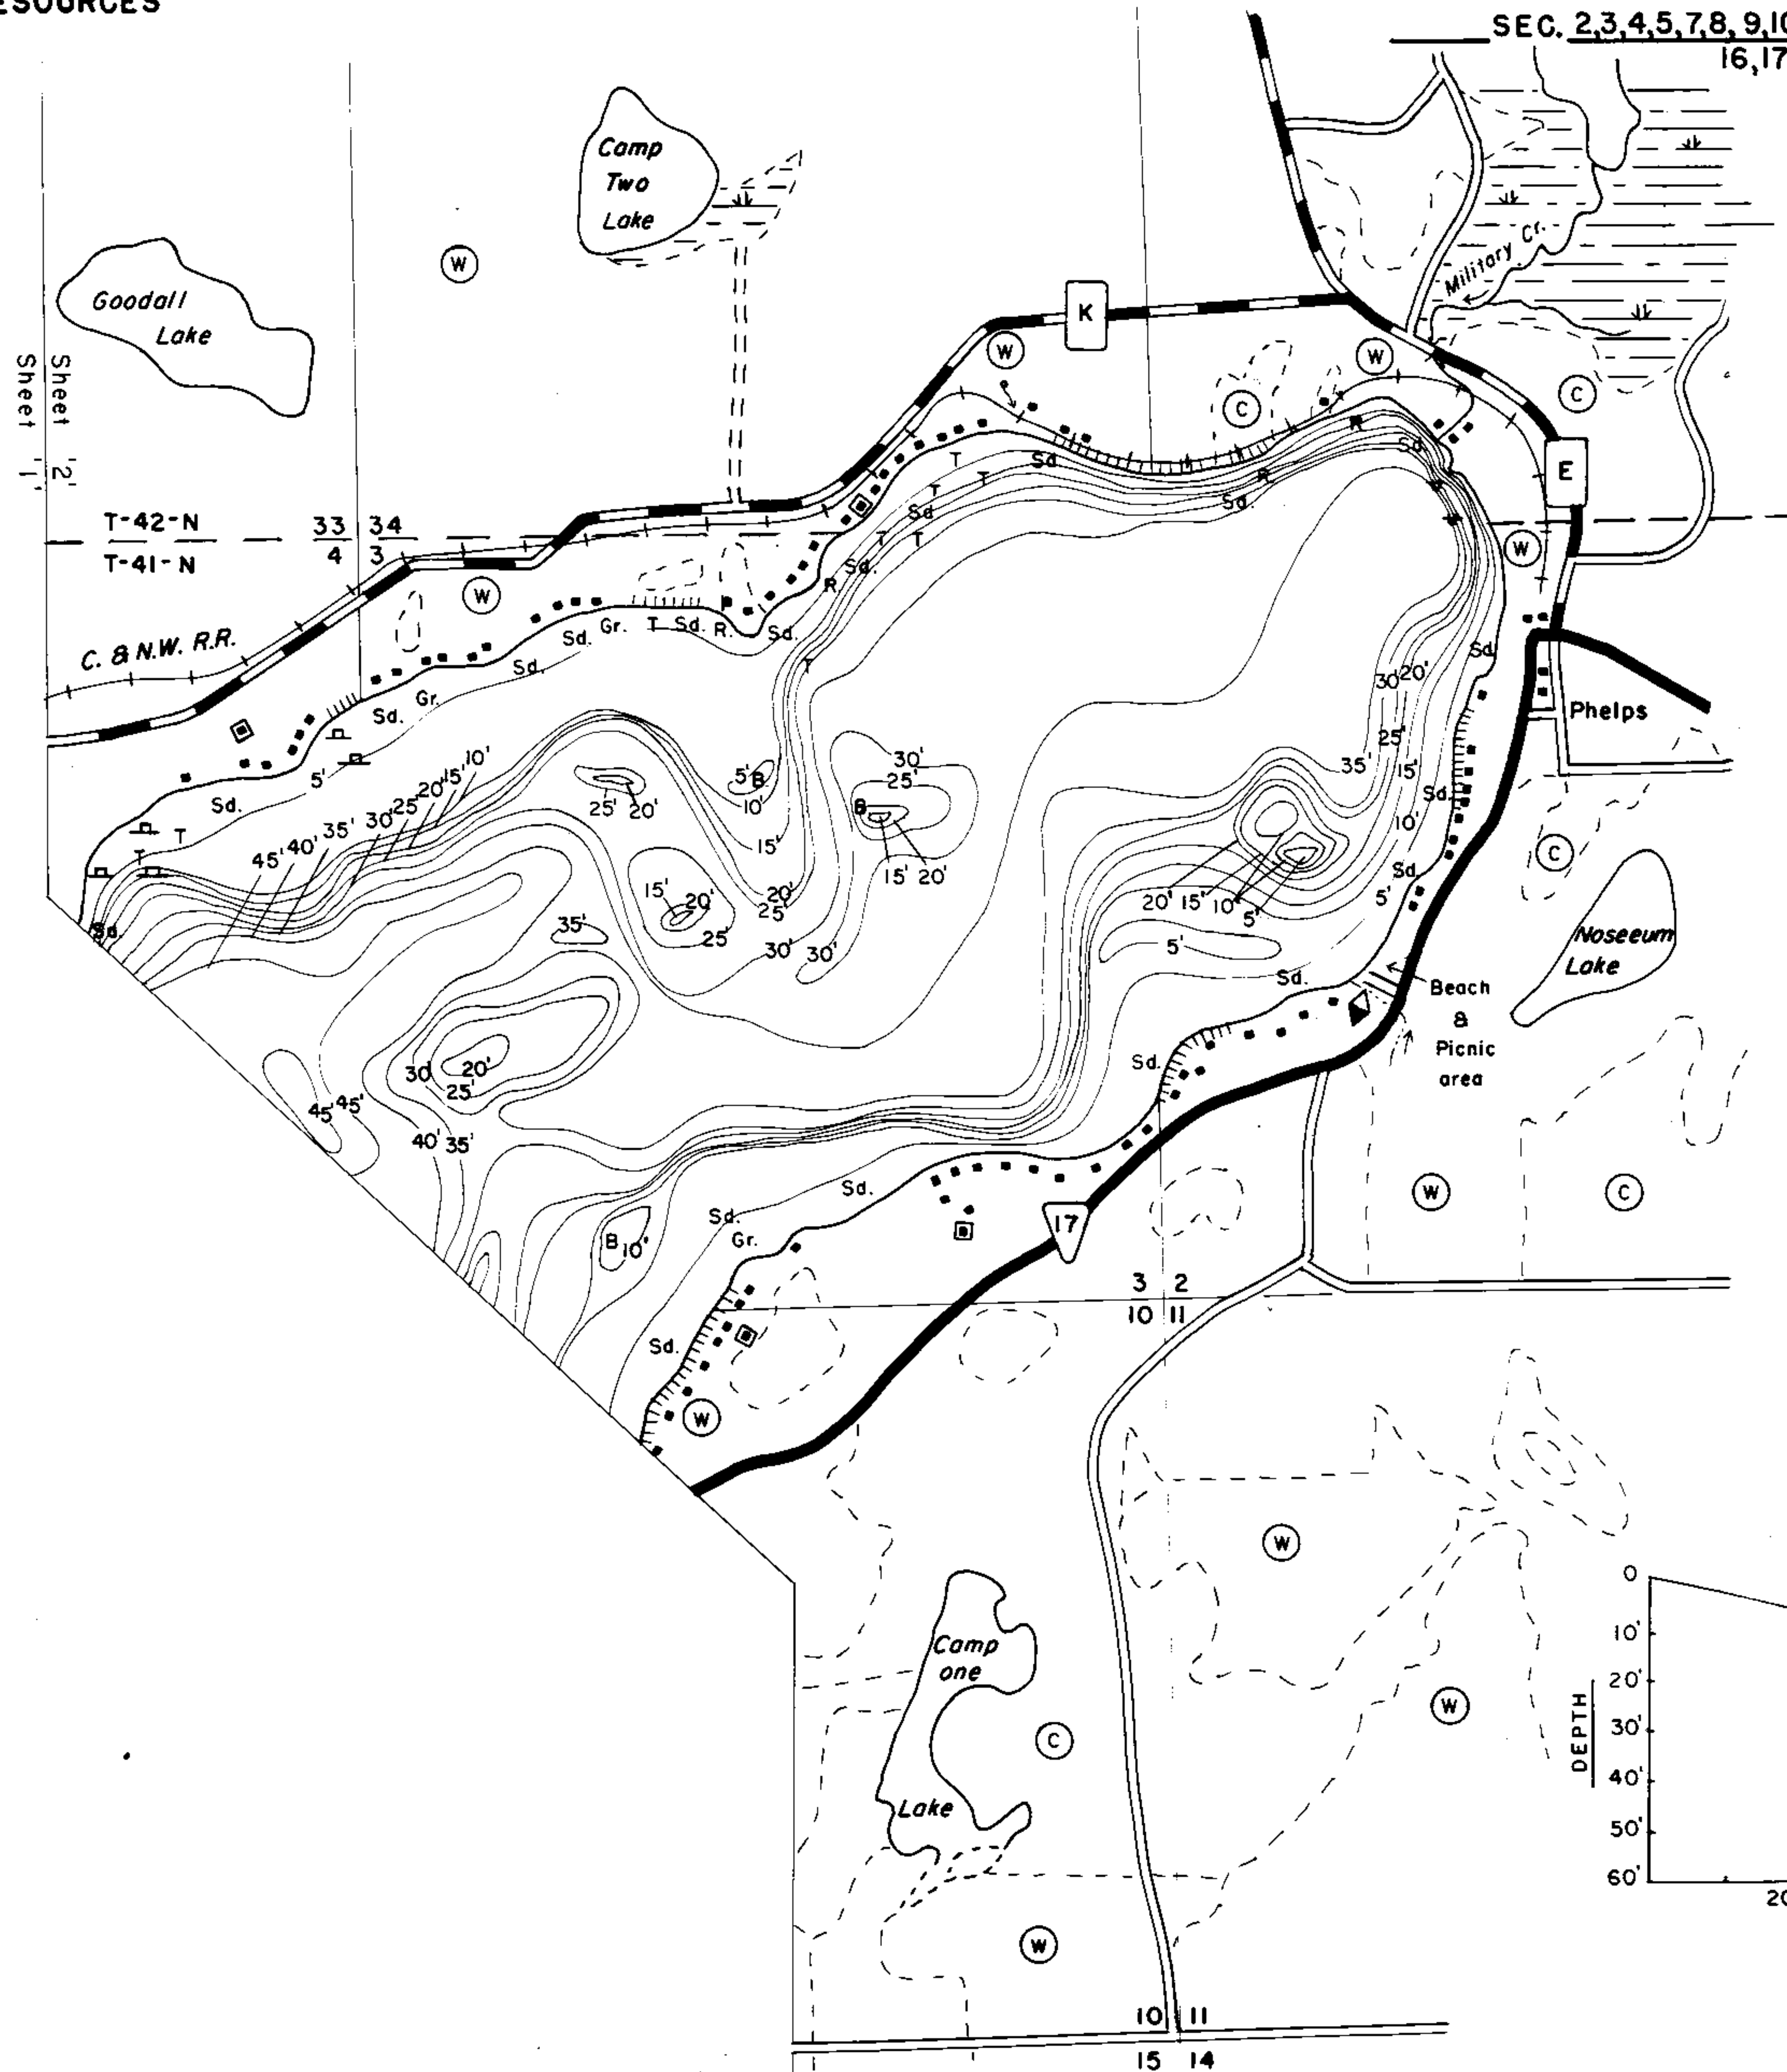
EQUIPMENT RECORDINGS SONAR MAPPED JUNE 1971

WATER AREA 2788 ACRES  
UNDER 3 FT. 7 %  
OVER 20 FT. 69 %  
MAX. DEPTH 60 FEET.  
TOTAL ALK. 50 P.P.M.  
VOLUME 76,936 ACRE FT.  
SHORELINE 10 MILES  
WITH ISLAND 10.37 MILES
