Source: Wisconsin Department of Natural Resources 608-266-2621
Upper Devils Lake – Barron County, Wisconsin DNR Lake Map
Date – Jul 1970 - Historical Lake Map - Not for Navigation
A Public Document - Please Identify the Source when using it.

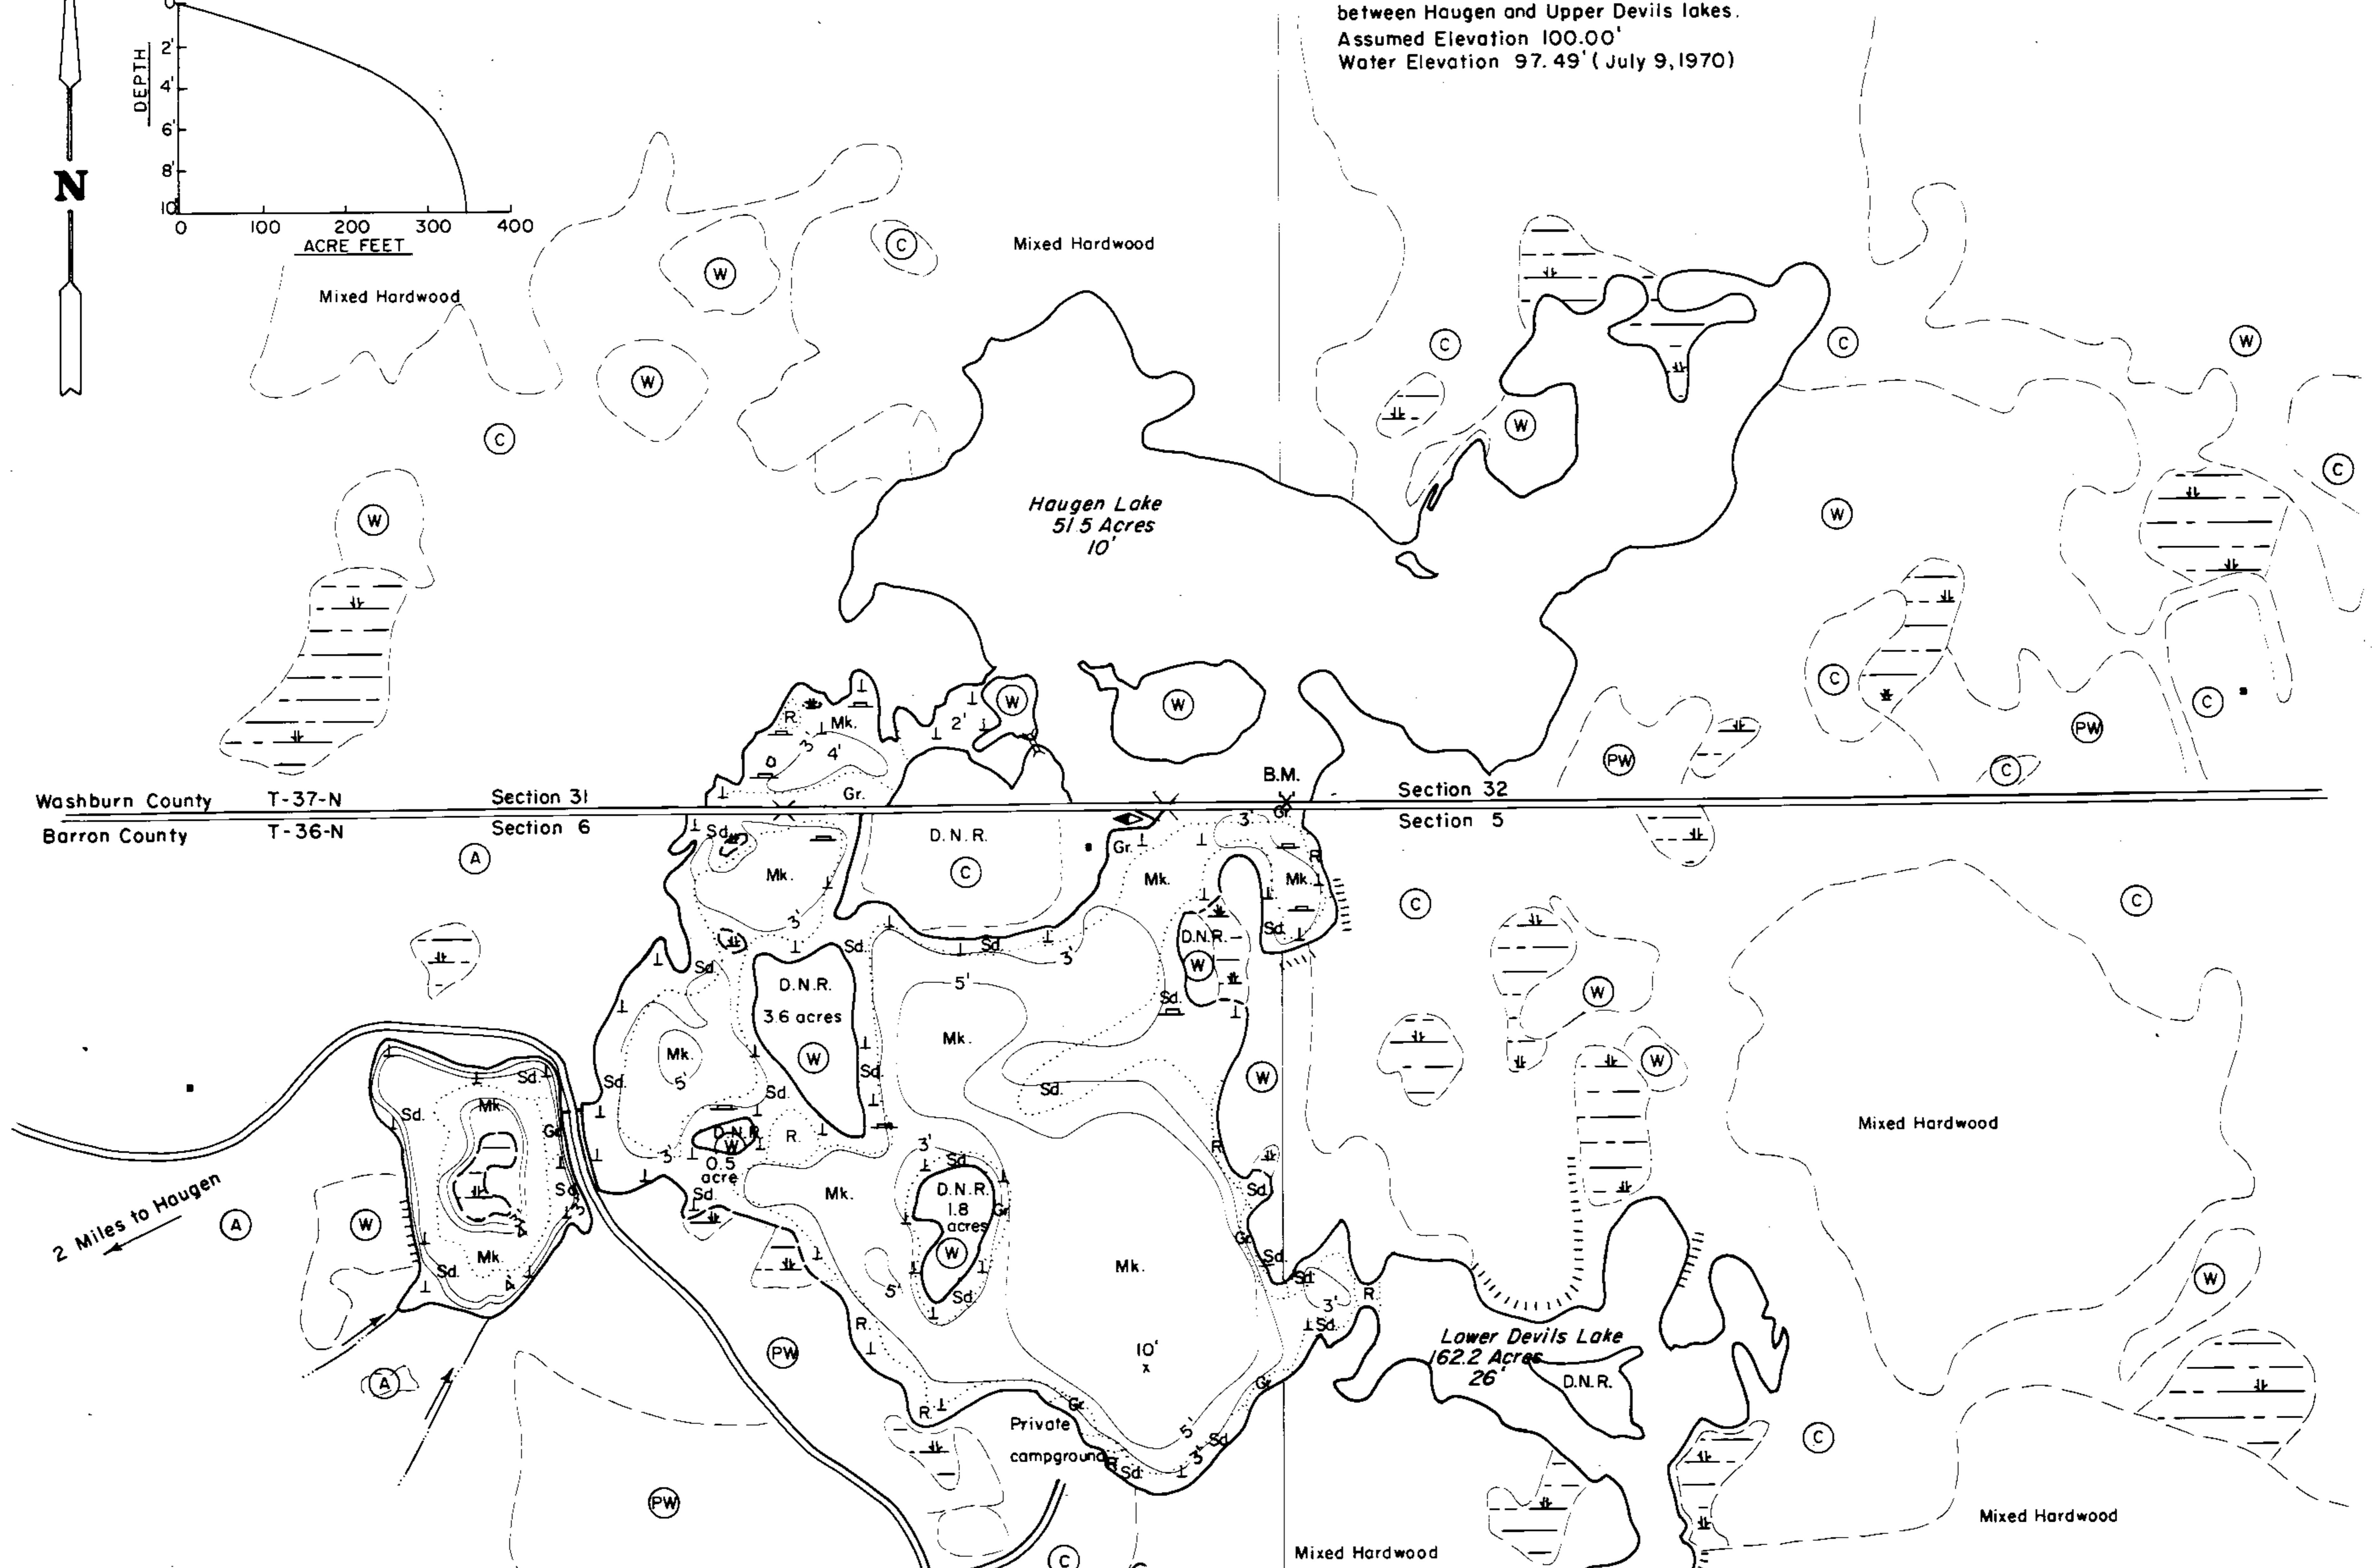
Department of Natural Resources Bench Mark.
2' square cut in a 2' pointed boulder 25' north
of centerline of road and 300' east of culvert
between Haugen and Upper Devils lakes.
Assumed Elevation 100.00'
Water Elevation 97.49' (July 9, 1970)

WATER AREA 86.5 ACRES
 UNDER 3 FT. 31 %
 OVER 20 FT. 0 %
 MAX. DEPTH 10 FEET.
 TOTAL ALK. 10 P.P.M.
 VOLUME 346.5 ACRE FT.
 SHORELINE 4.05 MILES
 3.40 MILES OF SHORELINE
 EXCLUDING ISLANDS
