EQUIPMENT SONAR & POLE MAPPED MAY 1970
MONTH YEAR

Source: Wisconsin Department of Natural Resources 608-266-2621
Mirror Lake – Dunn County, Wisconsin DNR Lake Map
Date – May 1970 - Historical Lake Map - Not for Navigation
A Public Document - Please Identify the Source when using it.

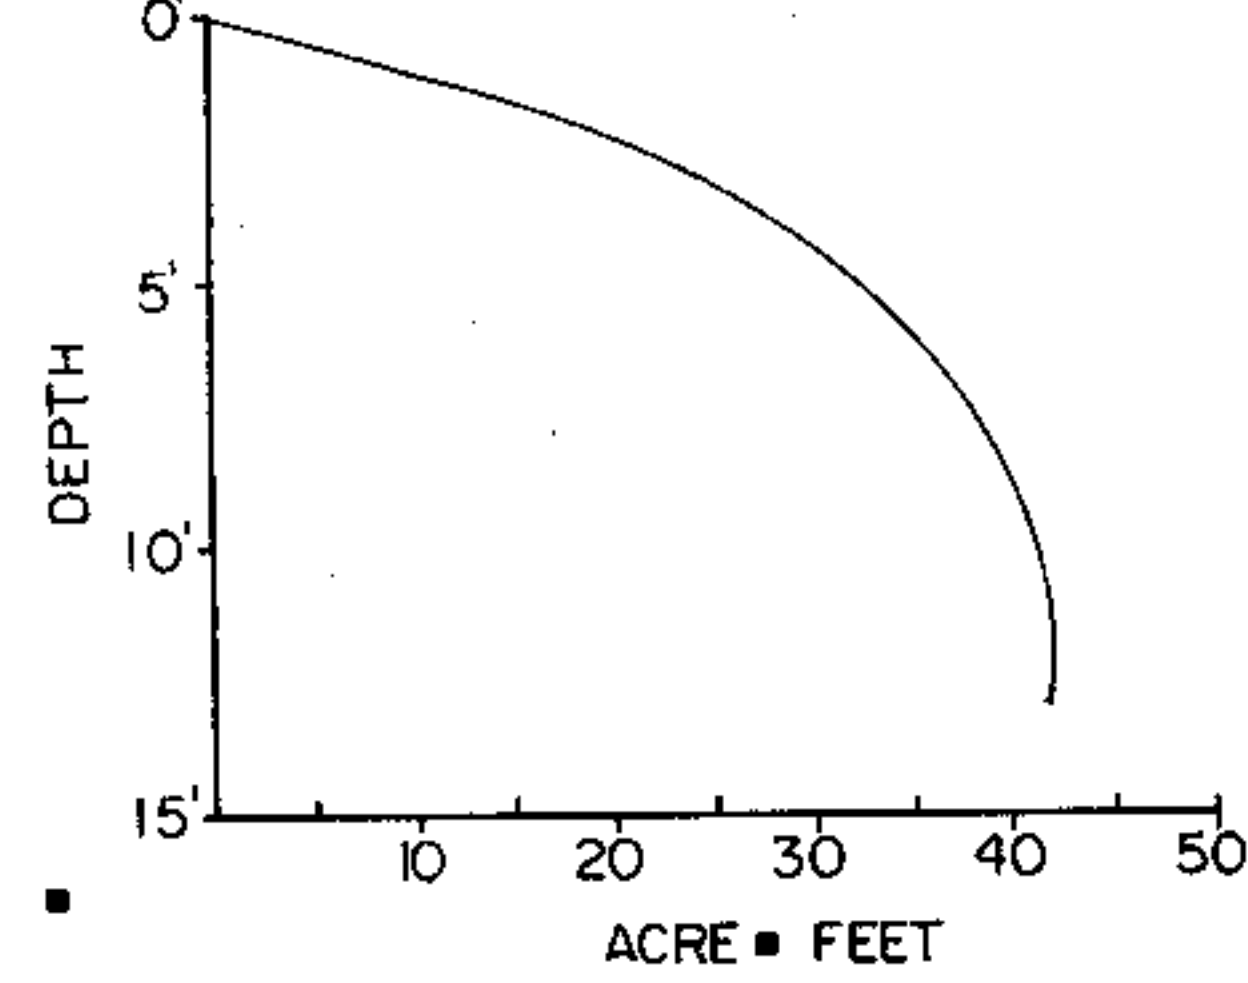
B.M. 'X' Top of E. end of N. concrete retaining wall of dam
Assumed elevation 100.00'
Water level 95.35'

WATER AREA 9.5 ACRES
UNDER 3 FT. 36 %
OVER 20 FT. 0 %
MAX. DEPTH 13 FEET.
TOTAL ALK. 65 P.P.M.
VOLUME 41.7 ACRE FT.
SHORELINE 1.47 MILES
