KIEZER LAKE WILDLIFE AREA

Source: Wisconsin Department of Natural Resources 608-266-2621  
Banach Lake – Burnett County, Wisconsin DNR Lake Map  
Date – Jun 1965 - Historical Lake Map - Not for Navigation  
A Public Document - Please Identify the Source when using it.

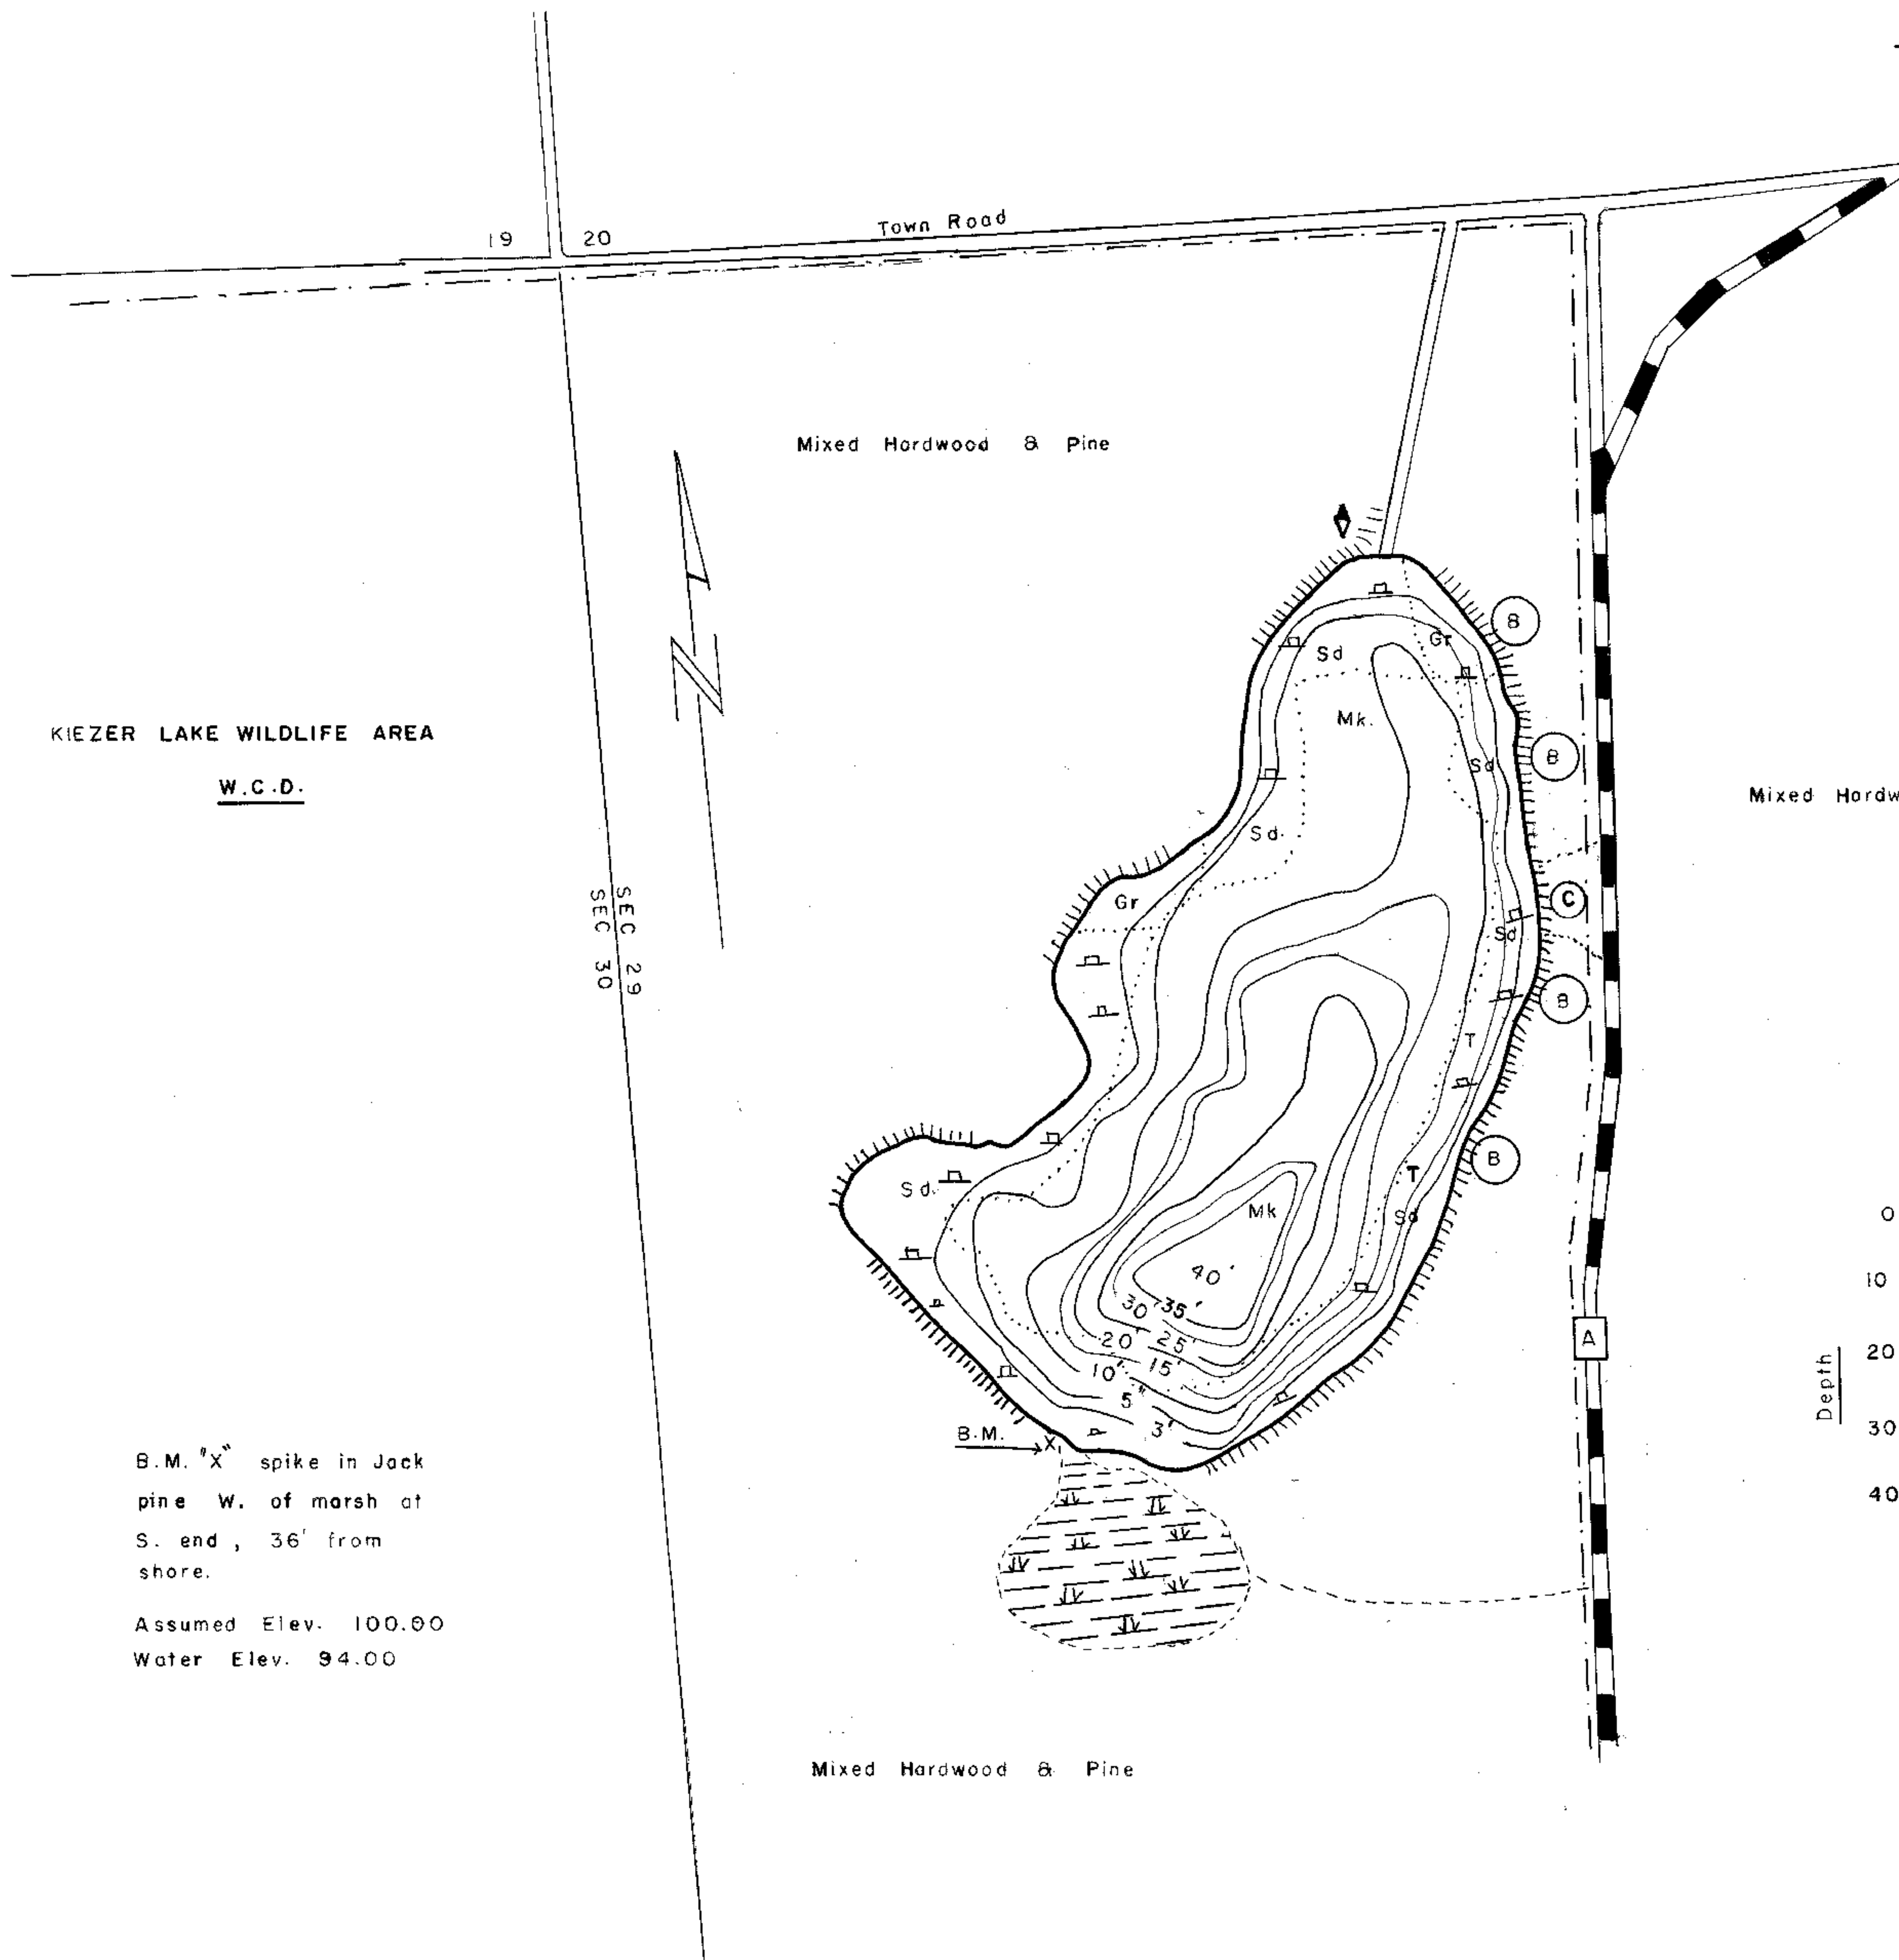
B.M. "X" spike in Jack pine W. of marsh at S. end, 36' from shore.

Assumed Elev. 100.00  
 Water Elev. 94.00

EQUIPMENT RECORDING SONAR MAPPED JUNE 1965  
 MO. YR.

AREA 15.6 ACRES  
 UNDER 3 FT. 19 %  
 OVER 20 FT. 22 %  
 VOLUME 195 ACRE FT.  
 TOTAL ALK. 8 P.P.M.  
 SHORELINE .7 MILES  
 MAX. DEPTH 40 FEET

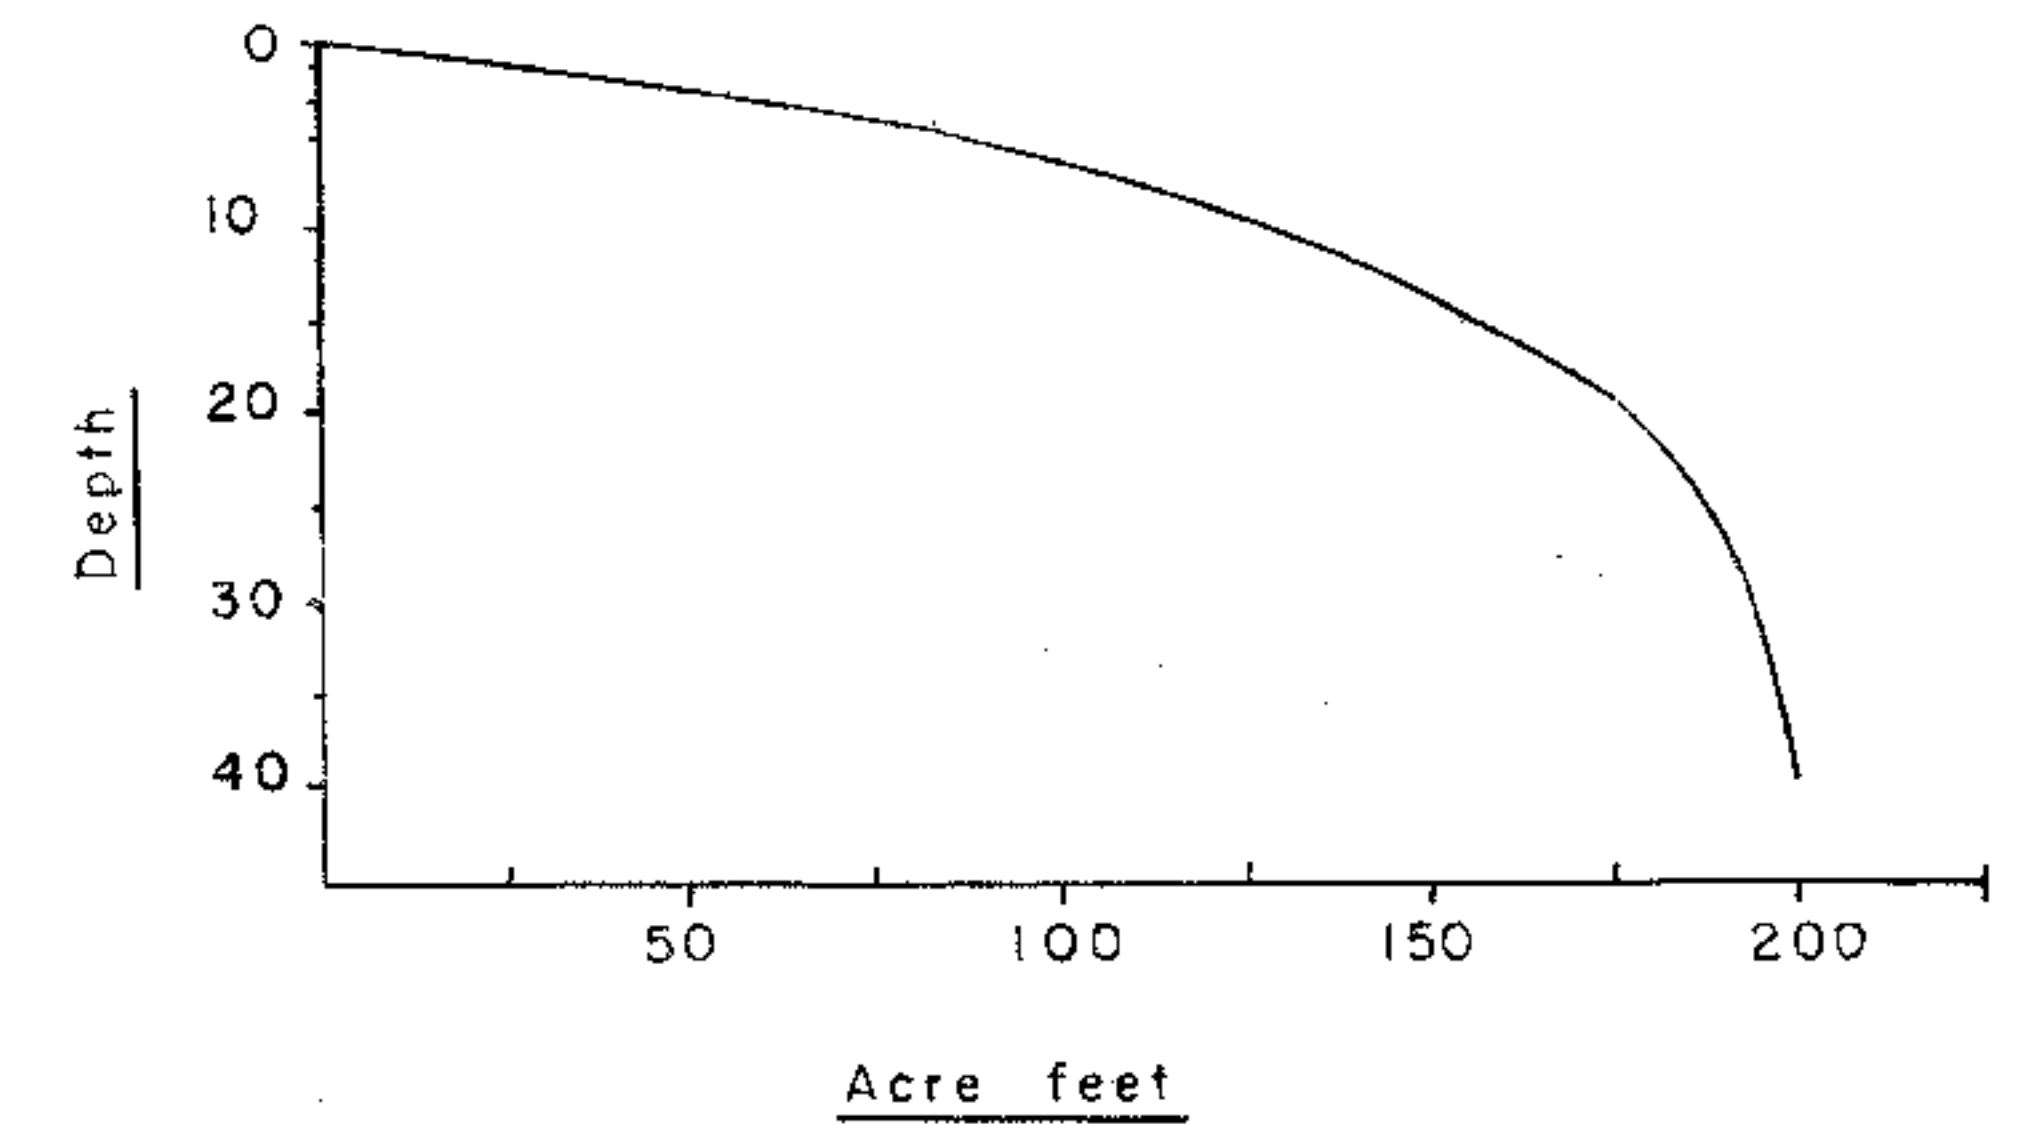
WATER ELEV. 94.00
