LAKE SURVEY MAP

Source: Wisconsin Department of Natural Resources 608-266-2621
Cloverleaf Lake - Washburn County, Wisconsin DNR Lake Map
Date – Sep 1976 - Historical Lake Map - Not for Navigation
A Public Document - Please Identify the Source when using it.

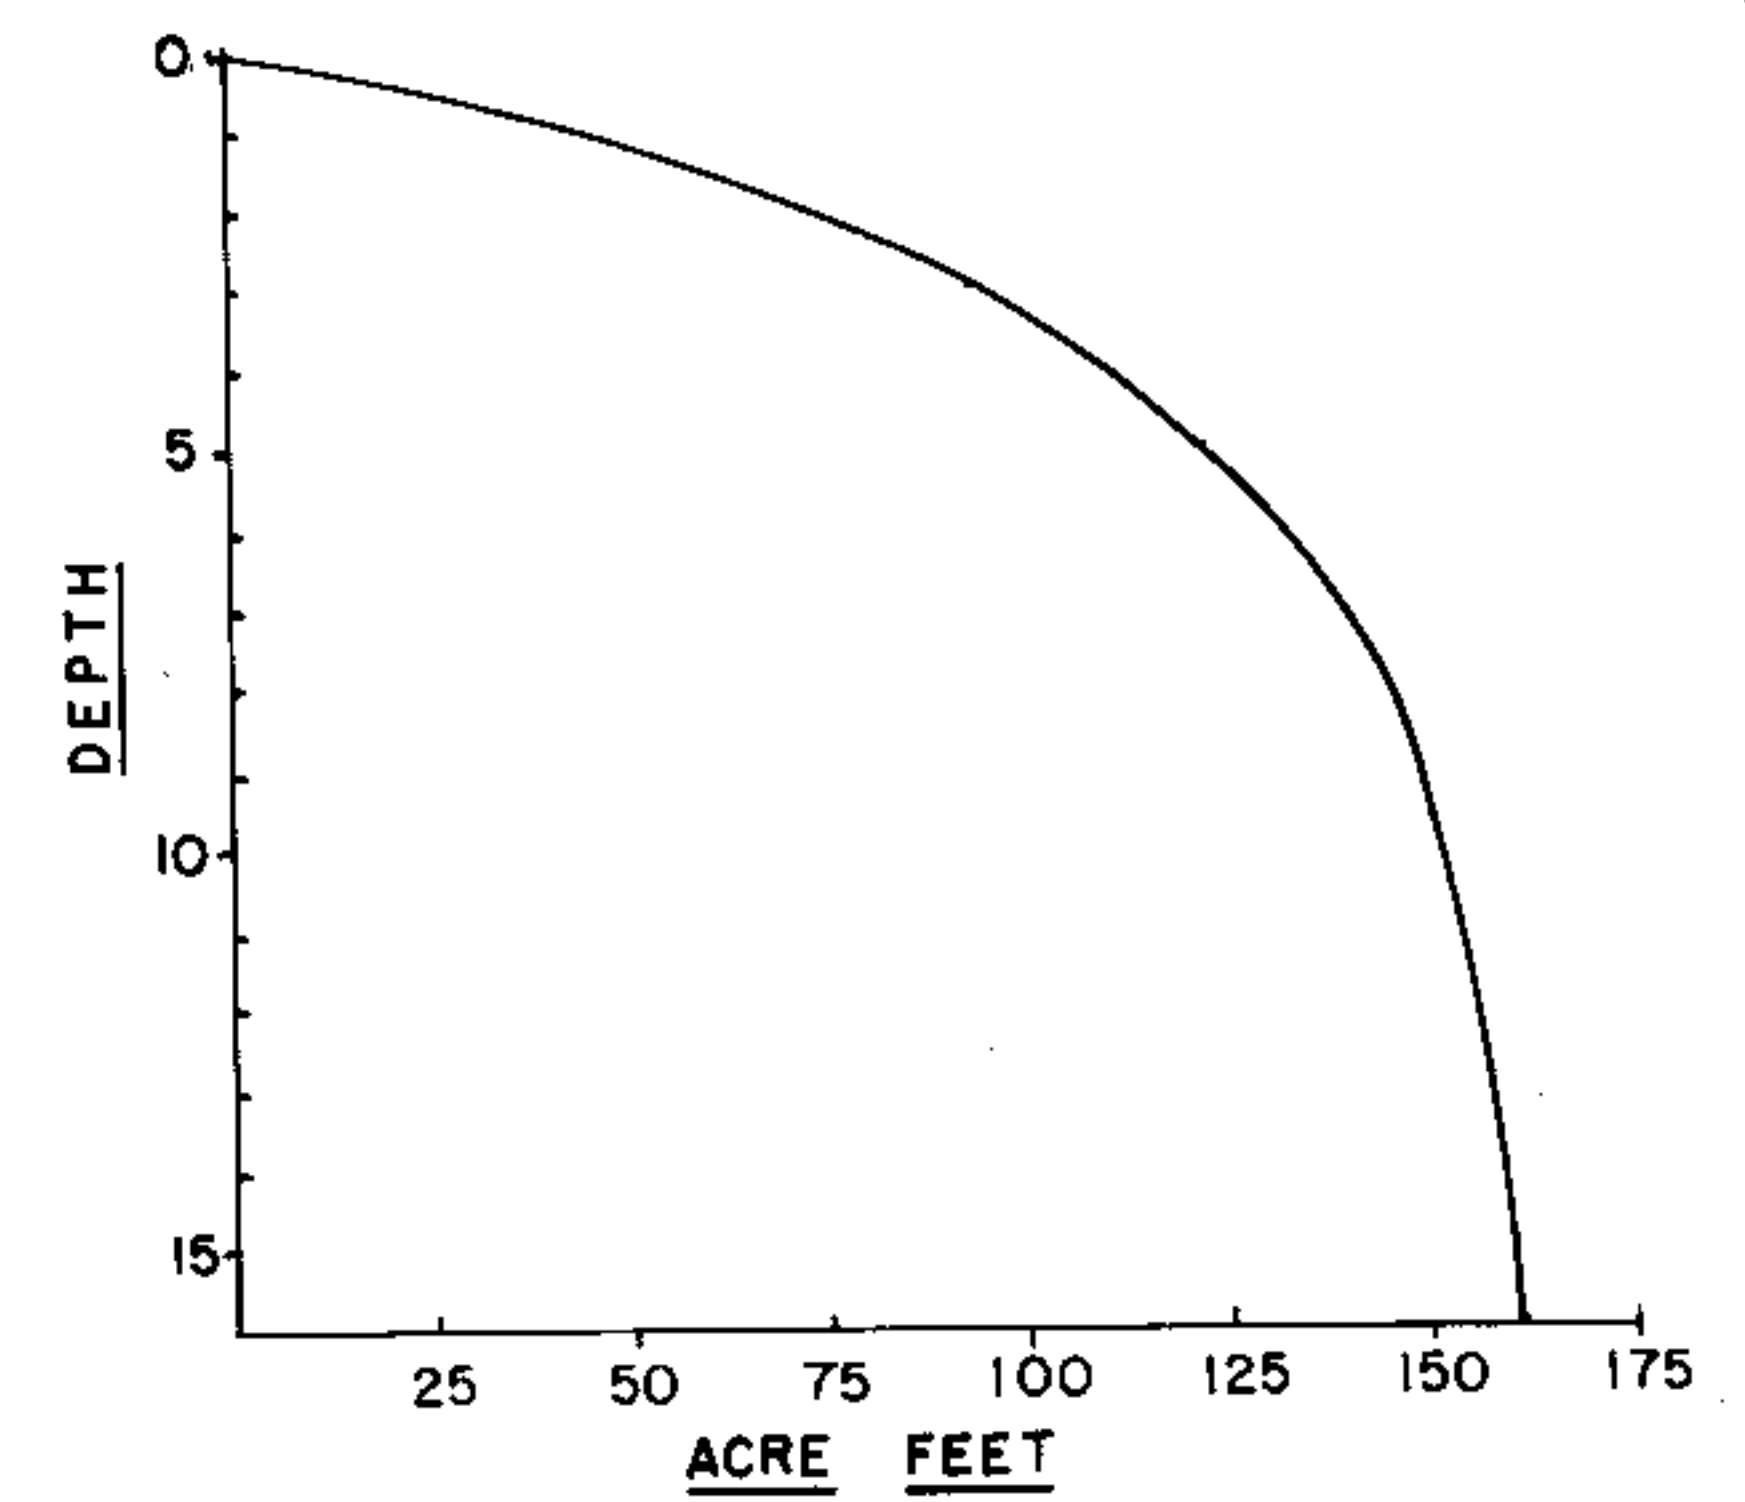
B.M. "X" is a railroad spike in the base of a group of oak trees located 4' E. of walk-in access, 24' S. of @ of town road and 102' N. of water's edge on the north side of lake.
Assumed elevation = 100.00'
Water level = 93.83'

EQUIPMENT RECORDING SONAR MAPPED SEPT. 1976

WATER AREA 36.3 ACRES
 UNDER 3 FT. 35 %
 OVER 20 FT. 0 %
 MAX. DEPTH 16 FEET.
 TOTAL ALK. 6 P.P.M.
 VOLUME 159.6 ACRE FT.
 MAIN SHORELINE 1.3 MI.
 ISLAND SHORELINE 0 MI.
