EQUIPMENT RECORDING SONAR MAPPED MAY 1969

Source: Wisconsin Department of Natural Resources 608-266-2621  
Black Brook Flowage – Polk County, Wisconsin DNR Lake Map  
Date – May 1969 - Historical Lake Map - Not for Navigation  
A Public Document - Please Identify the Source when using it.

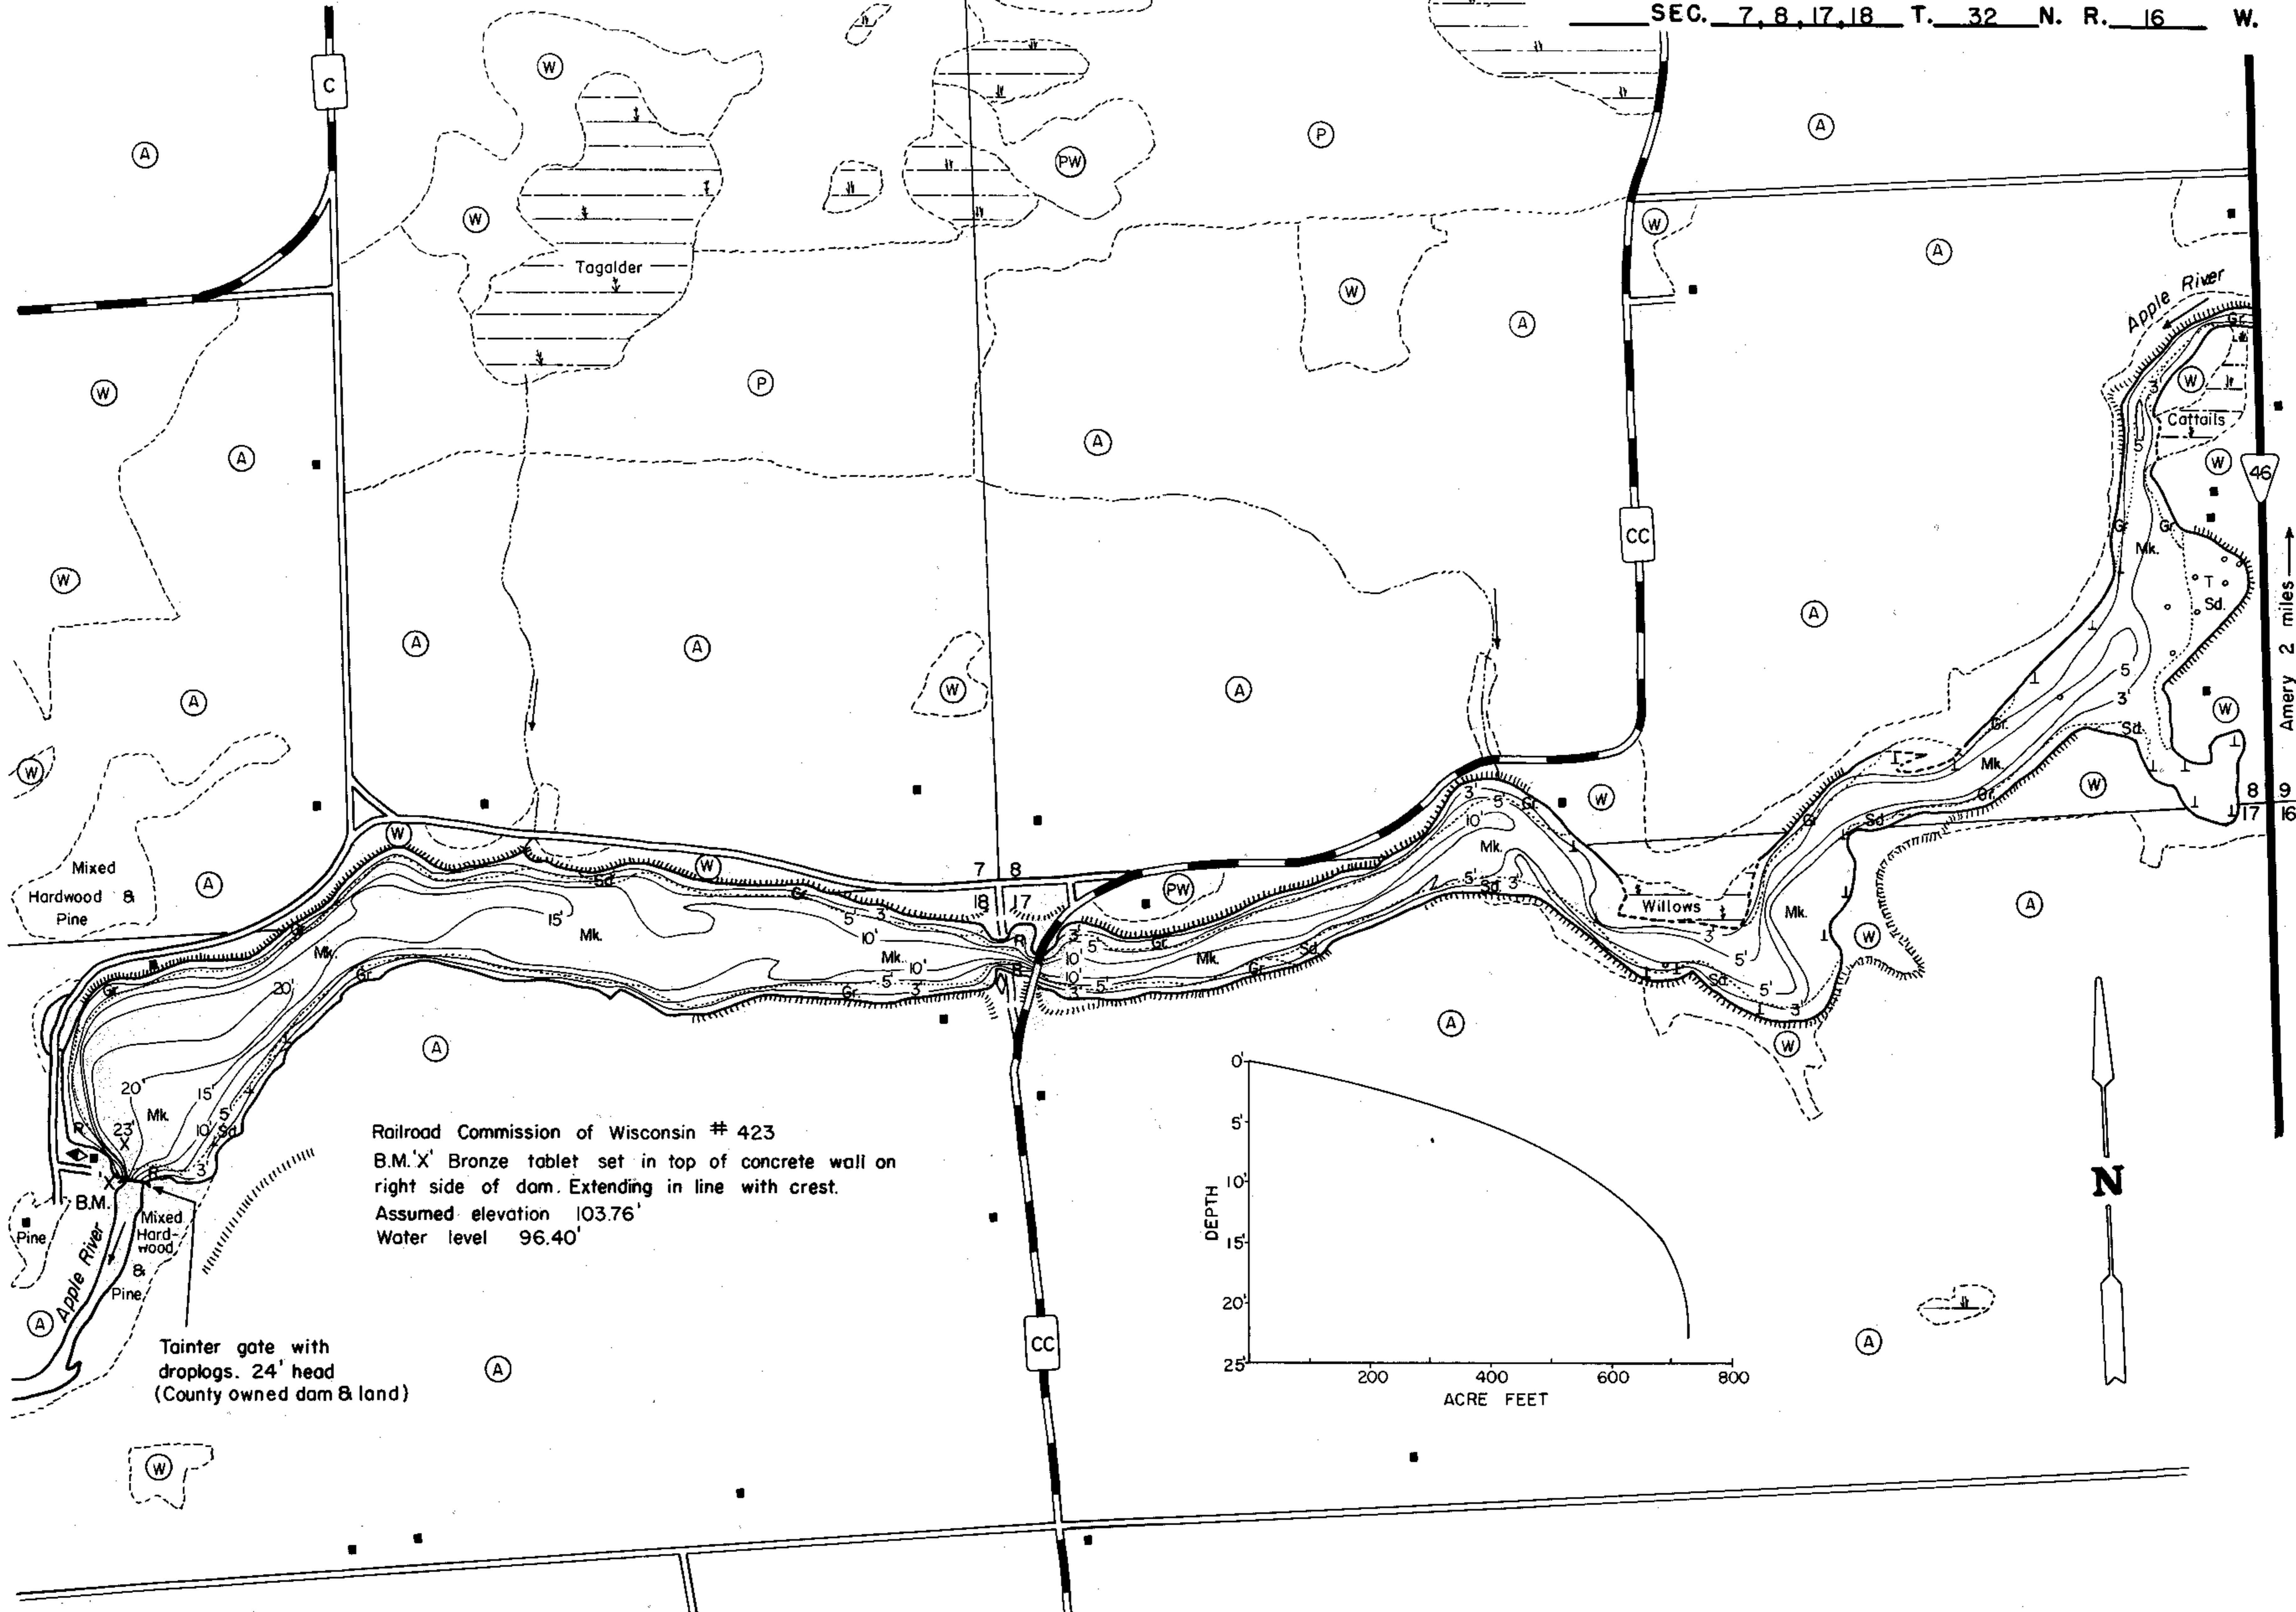
Railroad Commission of Wisconsin # 423  
B.M. 'X' Bronze tablet set in top of concrete wall on right side of dam. Extending in line with crest.  
Assumed elevation 103.76'  
Water level 96.40'

Tainter gate with droplogs. 24' head  
(County owned dam & land)

WATER AREA 98.1 ACRES  
 UNDER 3 FT. 28 %  
 OVER 20 FT. 3 %  
 MAX. DEPTH 23 FEET.  
 TOTAL ALK. 100 P.P.M.  
 VOLUME 726.6 ACRE FT.  
 SHORELINE 5.01 MILES
