AREA 189.3 ACRES
 UNDER 3FT. 14.6 %
 OVER 20FT. 1.6 %
 VOLUME 1580.6 ACRE FT.
 TOTAL ALK. 66 P.P.M.
 SHORELINE 2.4 MILES
 MAX. DEPTH 23 FEET

Source: Wisconsin Department of Natural Resources 608-266-2621
Little Butternut Lake – Polk County, Wisconsin DNR Lake Map
Date – Jul 1967 - Historical Lake Map - Not for Navigation
A Public Document - Please Identify the Source when using it.

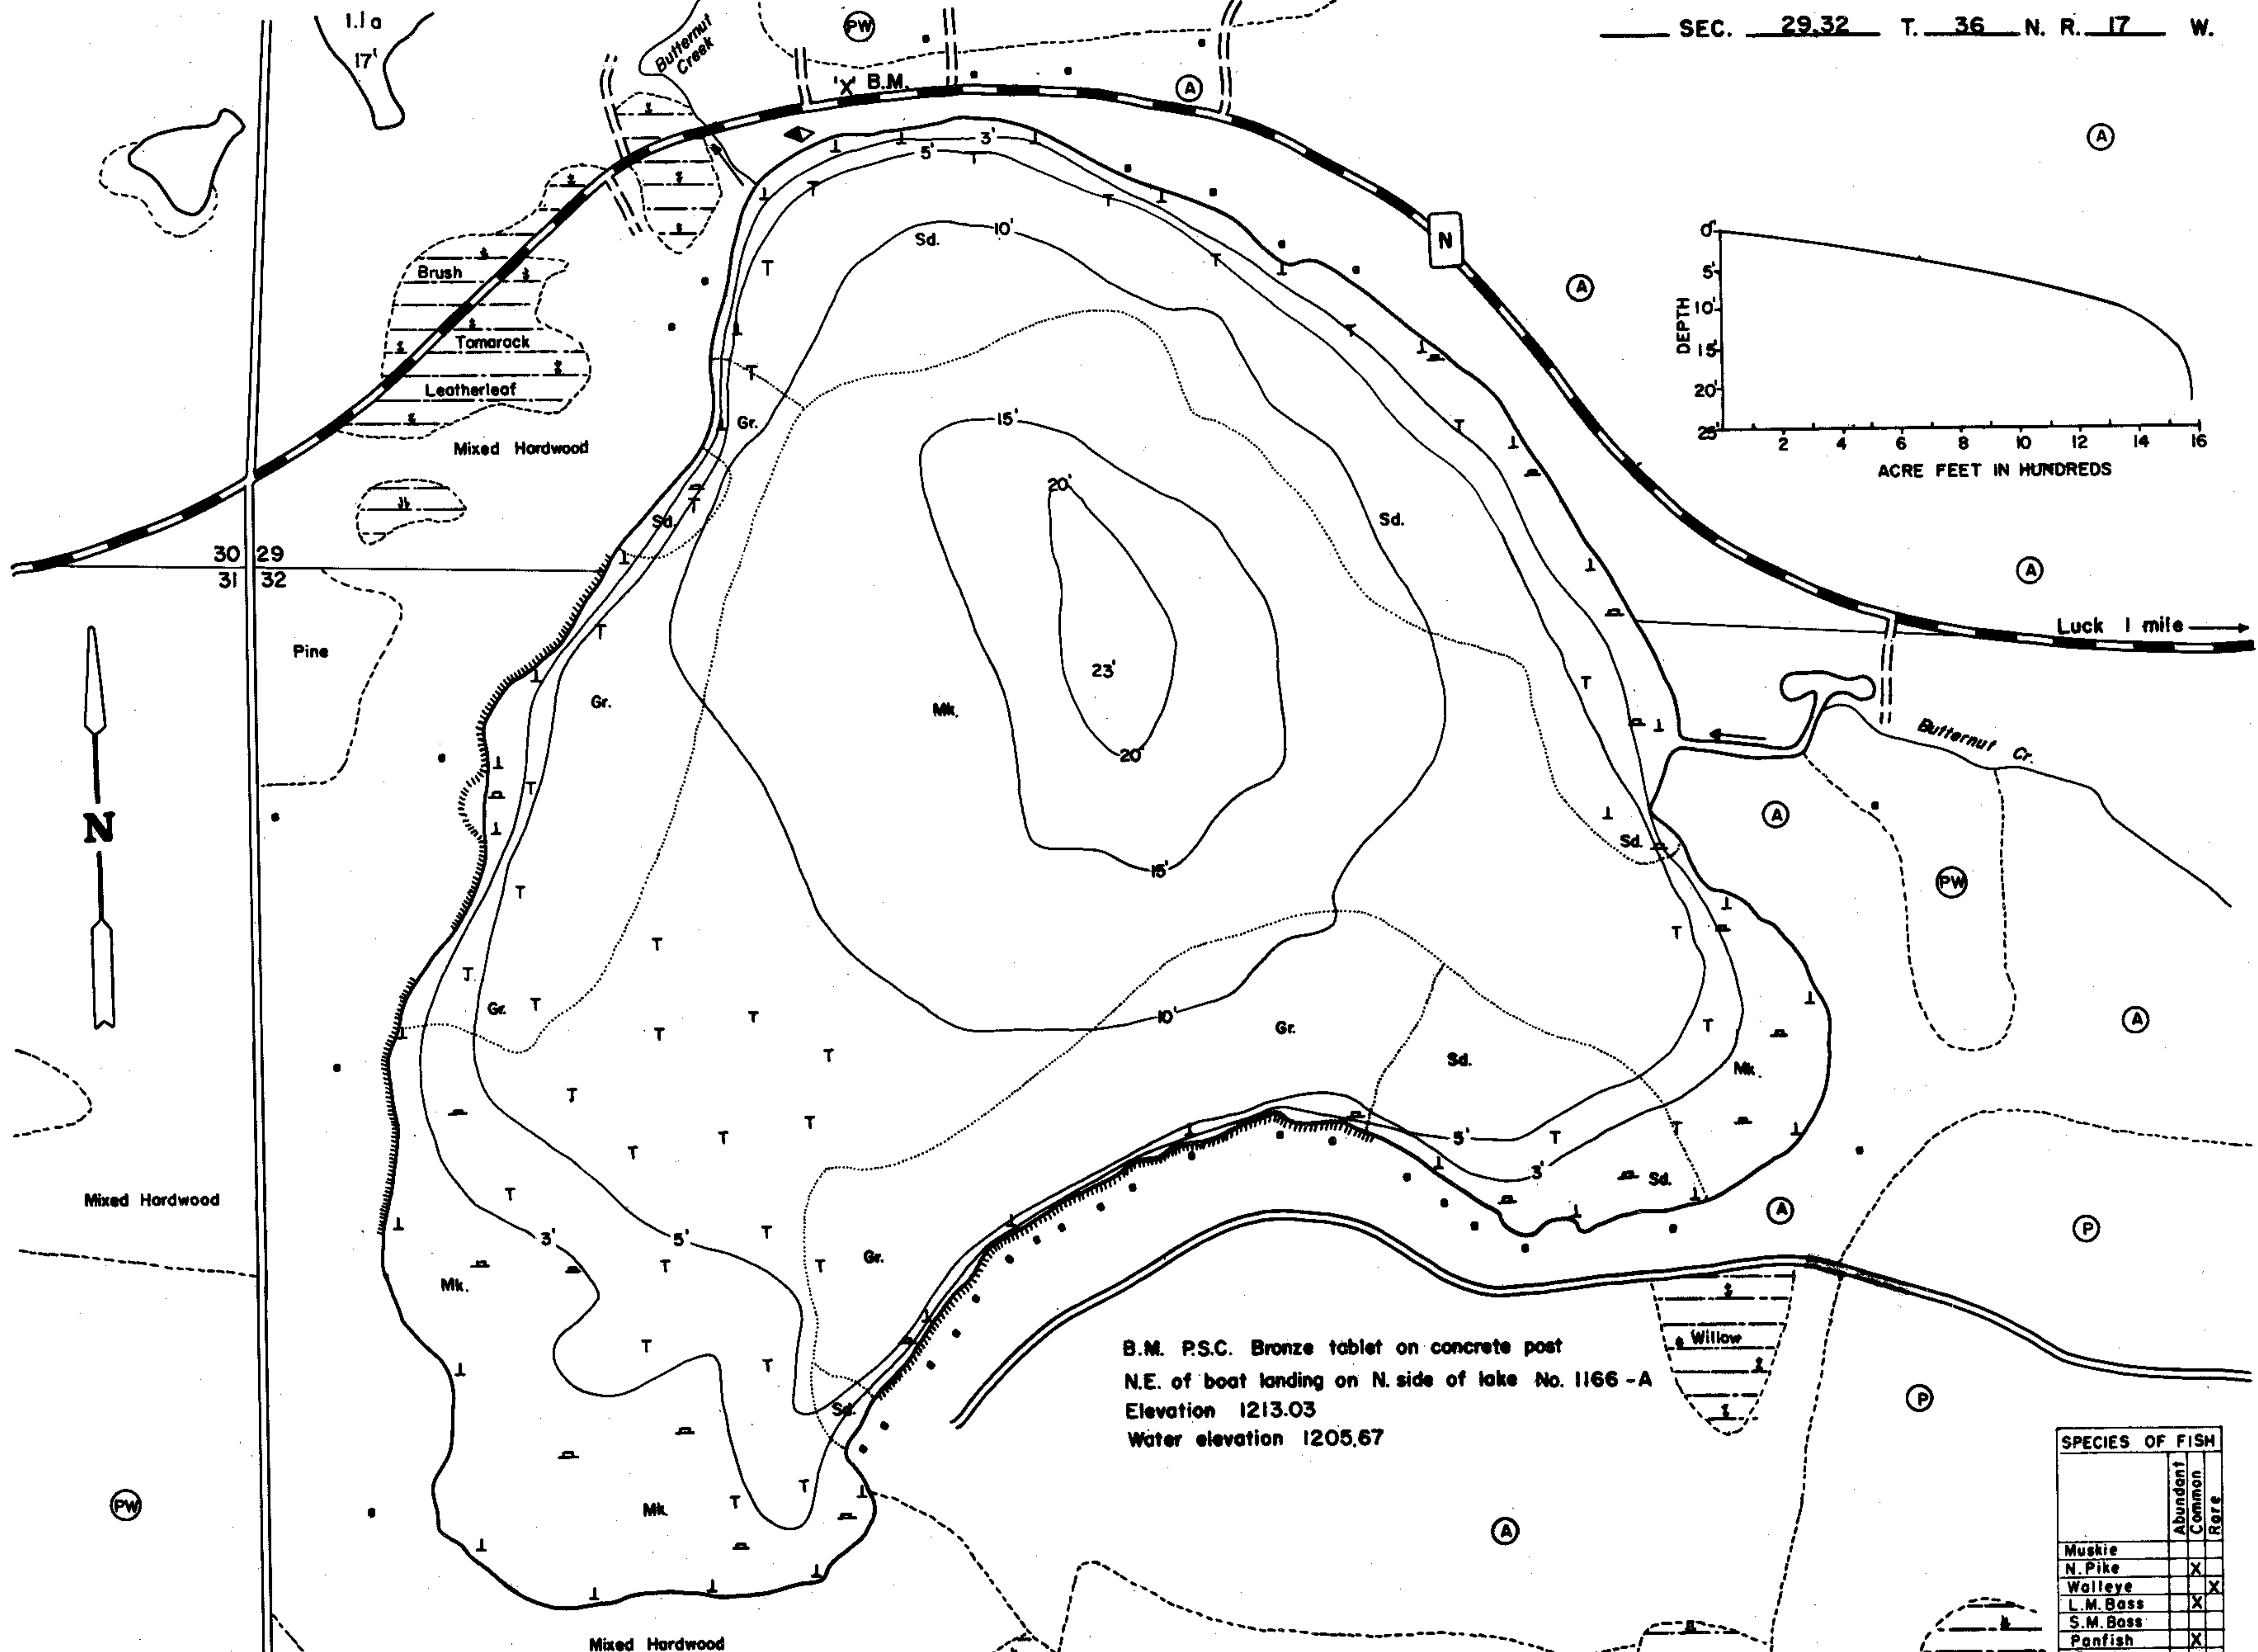
B.M. P.S.C. Bronze tablet on concrete post
N.E. of boat landing on N. side of lake No. 1166 - A
Elevation 1213.03
Water elevation 1205.67

EQUIPMENT RECORDING SONAR MAPPED JULY 1967
MO. YR.
