EQUIPMENT RECORDING SONAR MAPPED APRIL 1968
MO. YR.

Source: Wisconsin Department of Natural Resources 608-266-2621
Big Brook Lake – Bayfield County, Wisconsin DNR Lake Map
Date – Apr 1968 - Historical Lake Map - Not for Navigation
A Public Document - Please Identify the Source when using it.

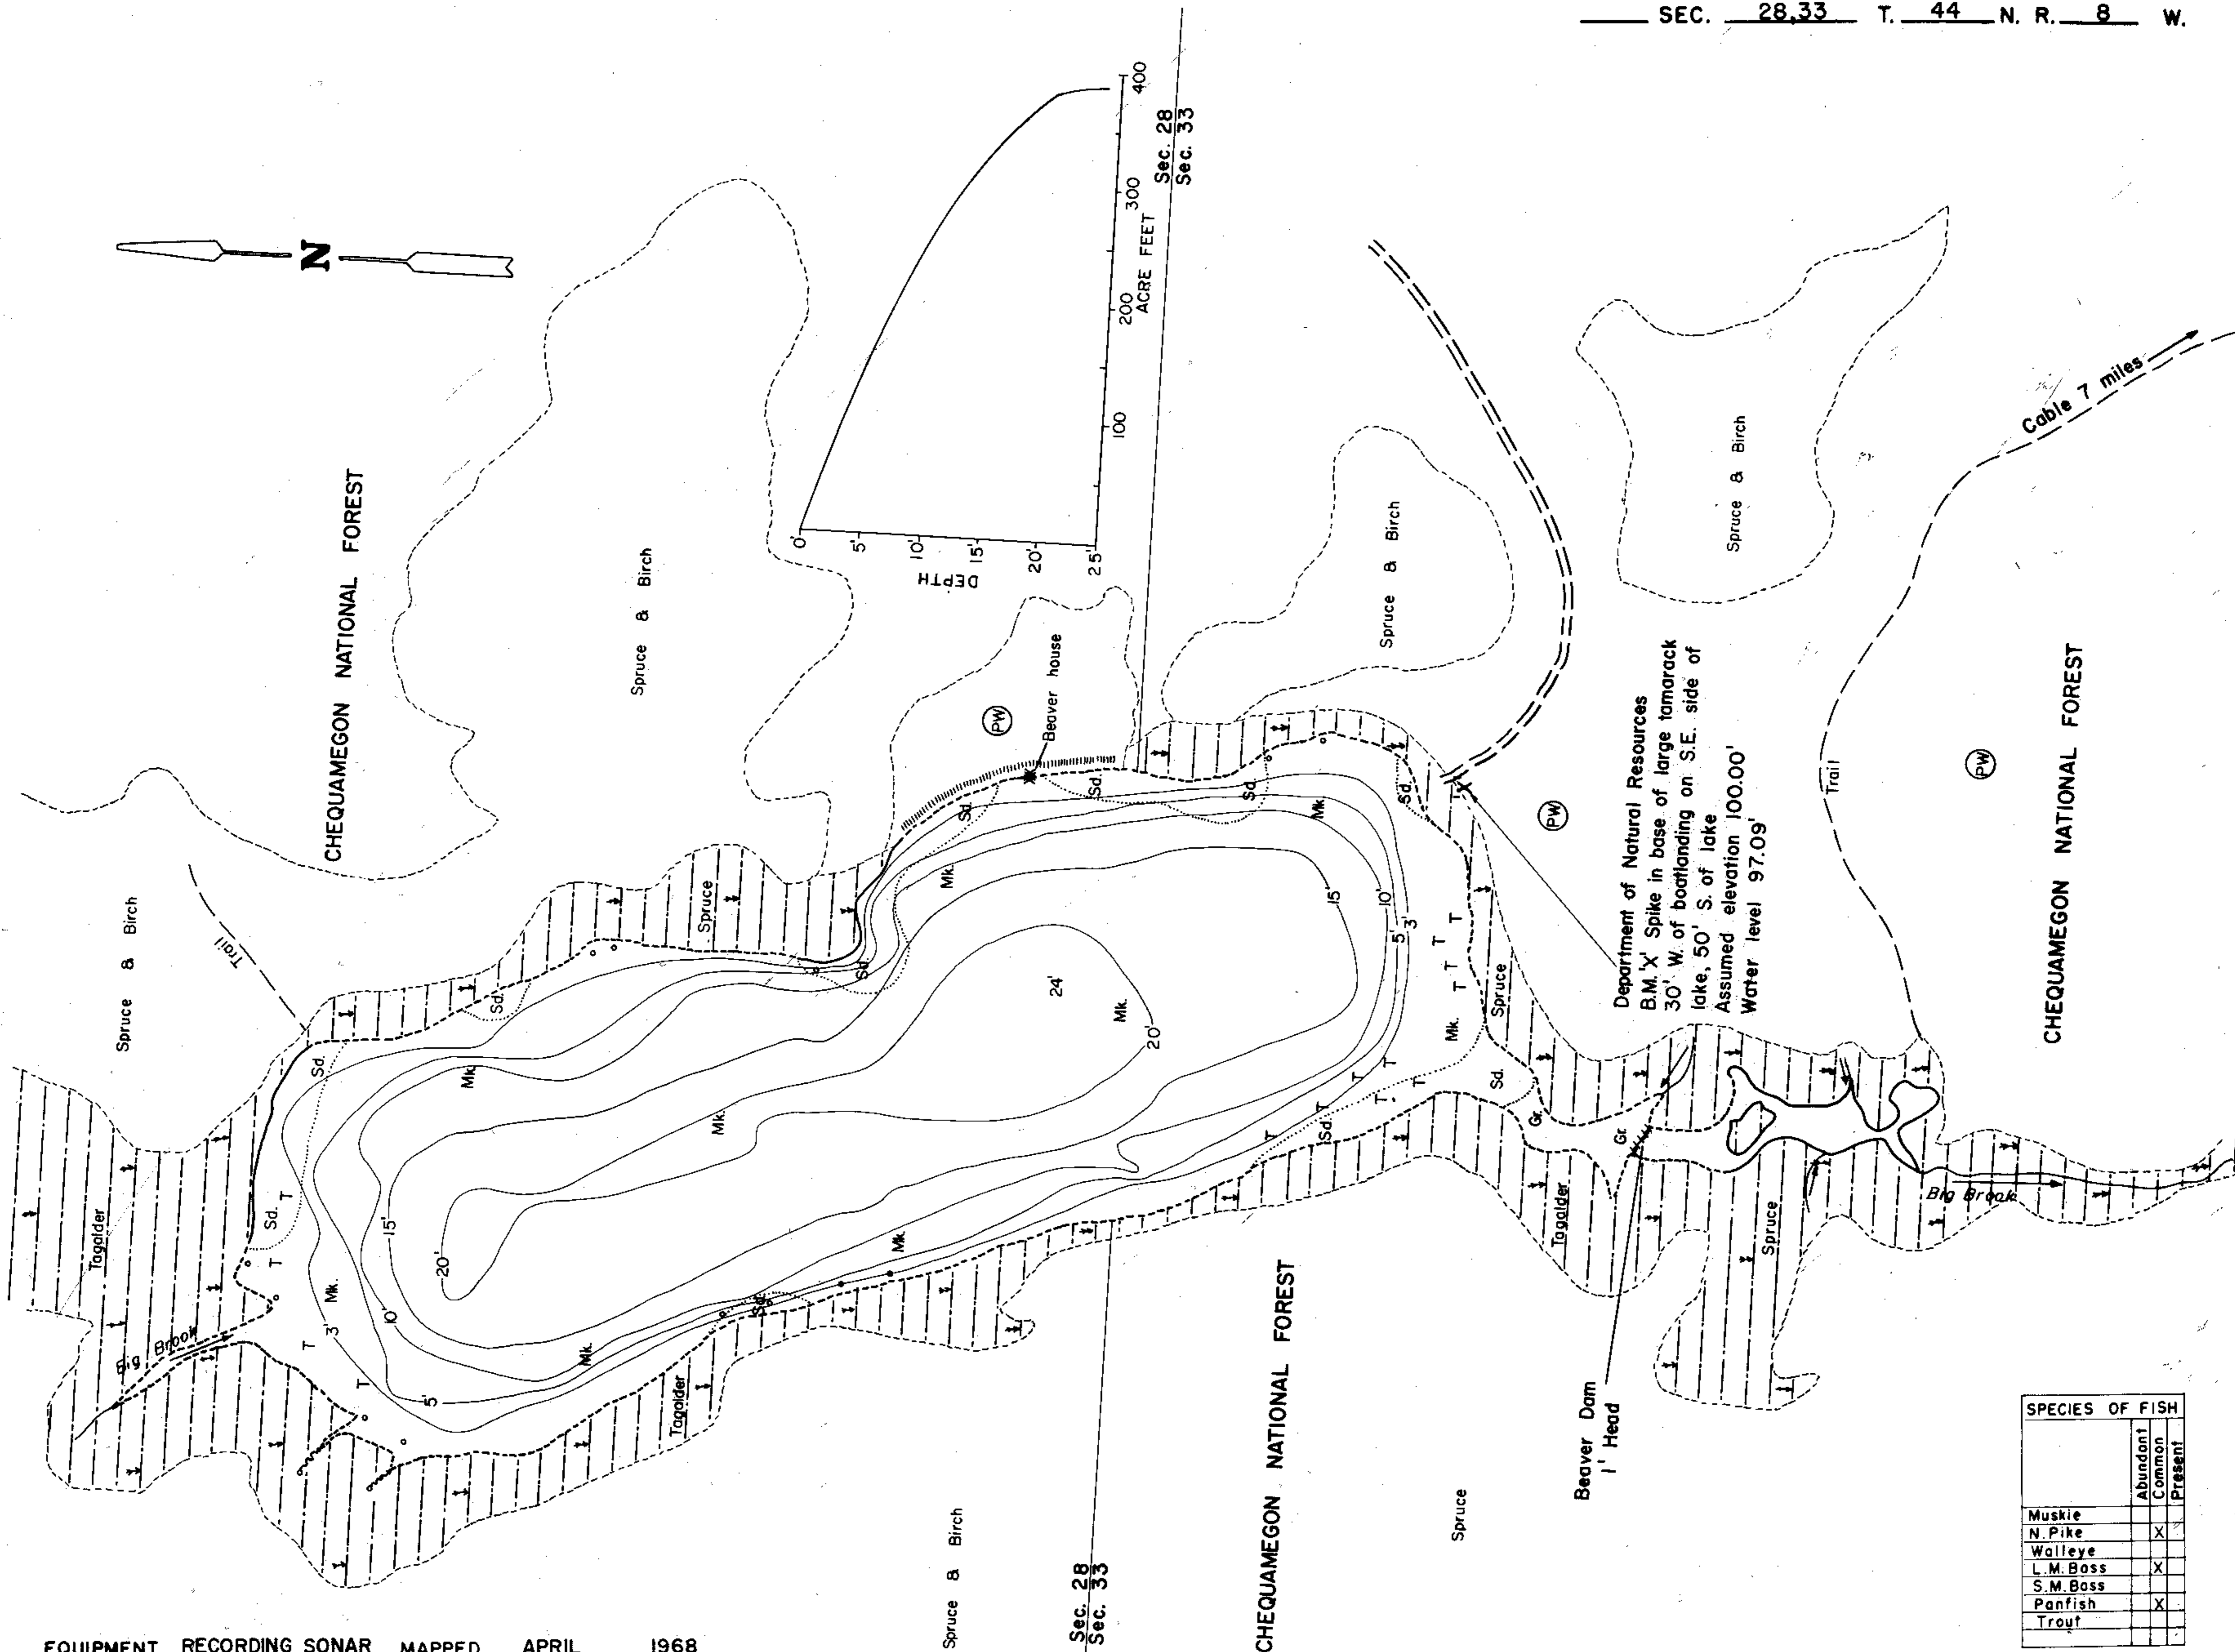
WATER ELEV. 97.09

AREA 33.7 ACRES
UNDER 3FT. 19.3 %
OVER 20FT. 11.1 %
VOLUME 388.55 ACRE FT.
TOTAL ALK. 63 P.P.M.
SHORELINE 1.3 MILES
MAX. DEPTH 24 FEET
