EQUIPMENT RECORDING SONAR MAPPED JULY 1971

Source: Wisconsin Department of Natural Resources 608-266-2621  
Crystal Lake – Bayfield County, Wisconsin DNR Lake Map  
Date – Jul 1971 - Historical Lake Map - Not for Navigation  
A Public Document - Please Identify the Source when using it.

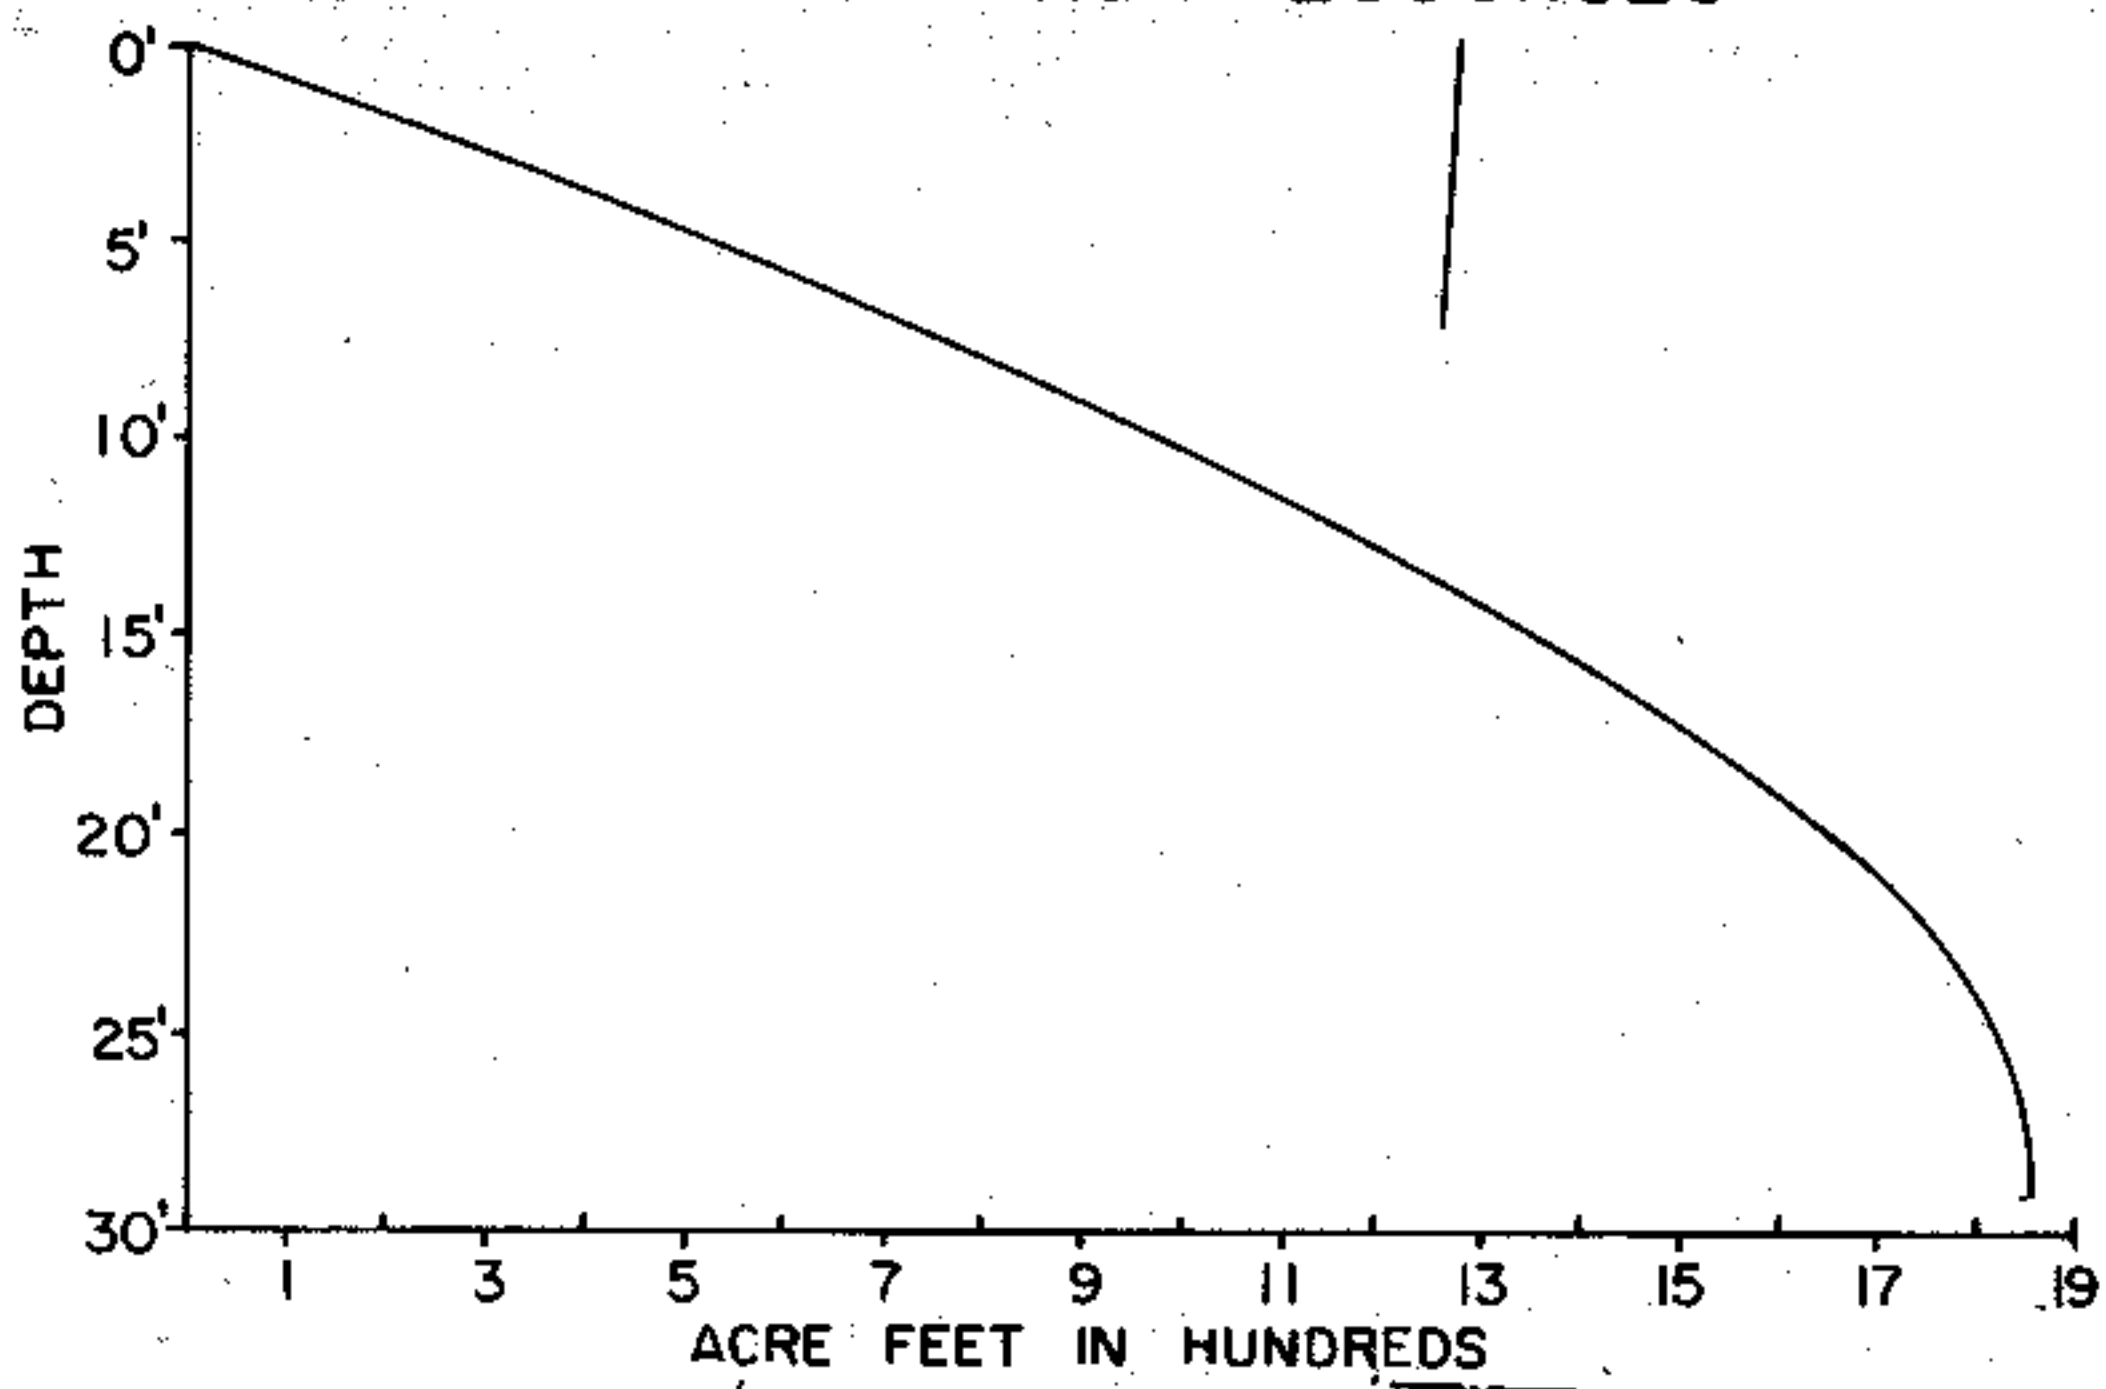
B.M. X 1367-A Bronze cap "D.N.R." in a 6" concrete post 65' S. of water, 35' W. of access & 20' S. of 4-10" Birch at public access on S. end of lake  
Assumed elevation 100.00'  
Water level 94.82' taken 7/27/72

WATER AREA 111.0 ACRES  
 UNDER 3 FT. 7 %  
 OVER 20 FT. 43 %  
 MAX. DEPTH 29 FEET.  
 TOTAL ALK. 10 P.P.M.  
 VOLUME 1858 ACRE FT.  
 SHORELINE 2.52 MILES  
 SHORELINE 2.54 MILES WITH IS.
