AREA 90.80 ACRES  
 UNDER 3FT. 14.20 %  
 OVER 20FT. 1 %  
 VOLUME 1036.36 ACRE FT.  
 TOTAL ALK. 4 P.P.M.  
 SHORELINE 1.77 MILES  
 MAX. DEPTH 21 FEET

Source: Wisconsin Department of Natural Resources 608-266-2621  
Kern Lake – Bayfield County, Wisconsin DNR Lake Map  
Date – Aug 1965 - Historical Lake Map - Not for Navigation  
A Public Document - Please Identify the Source when using it.

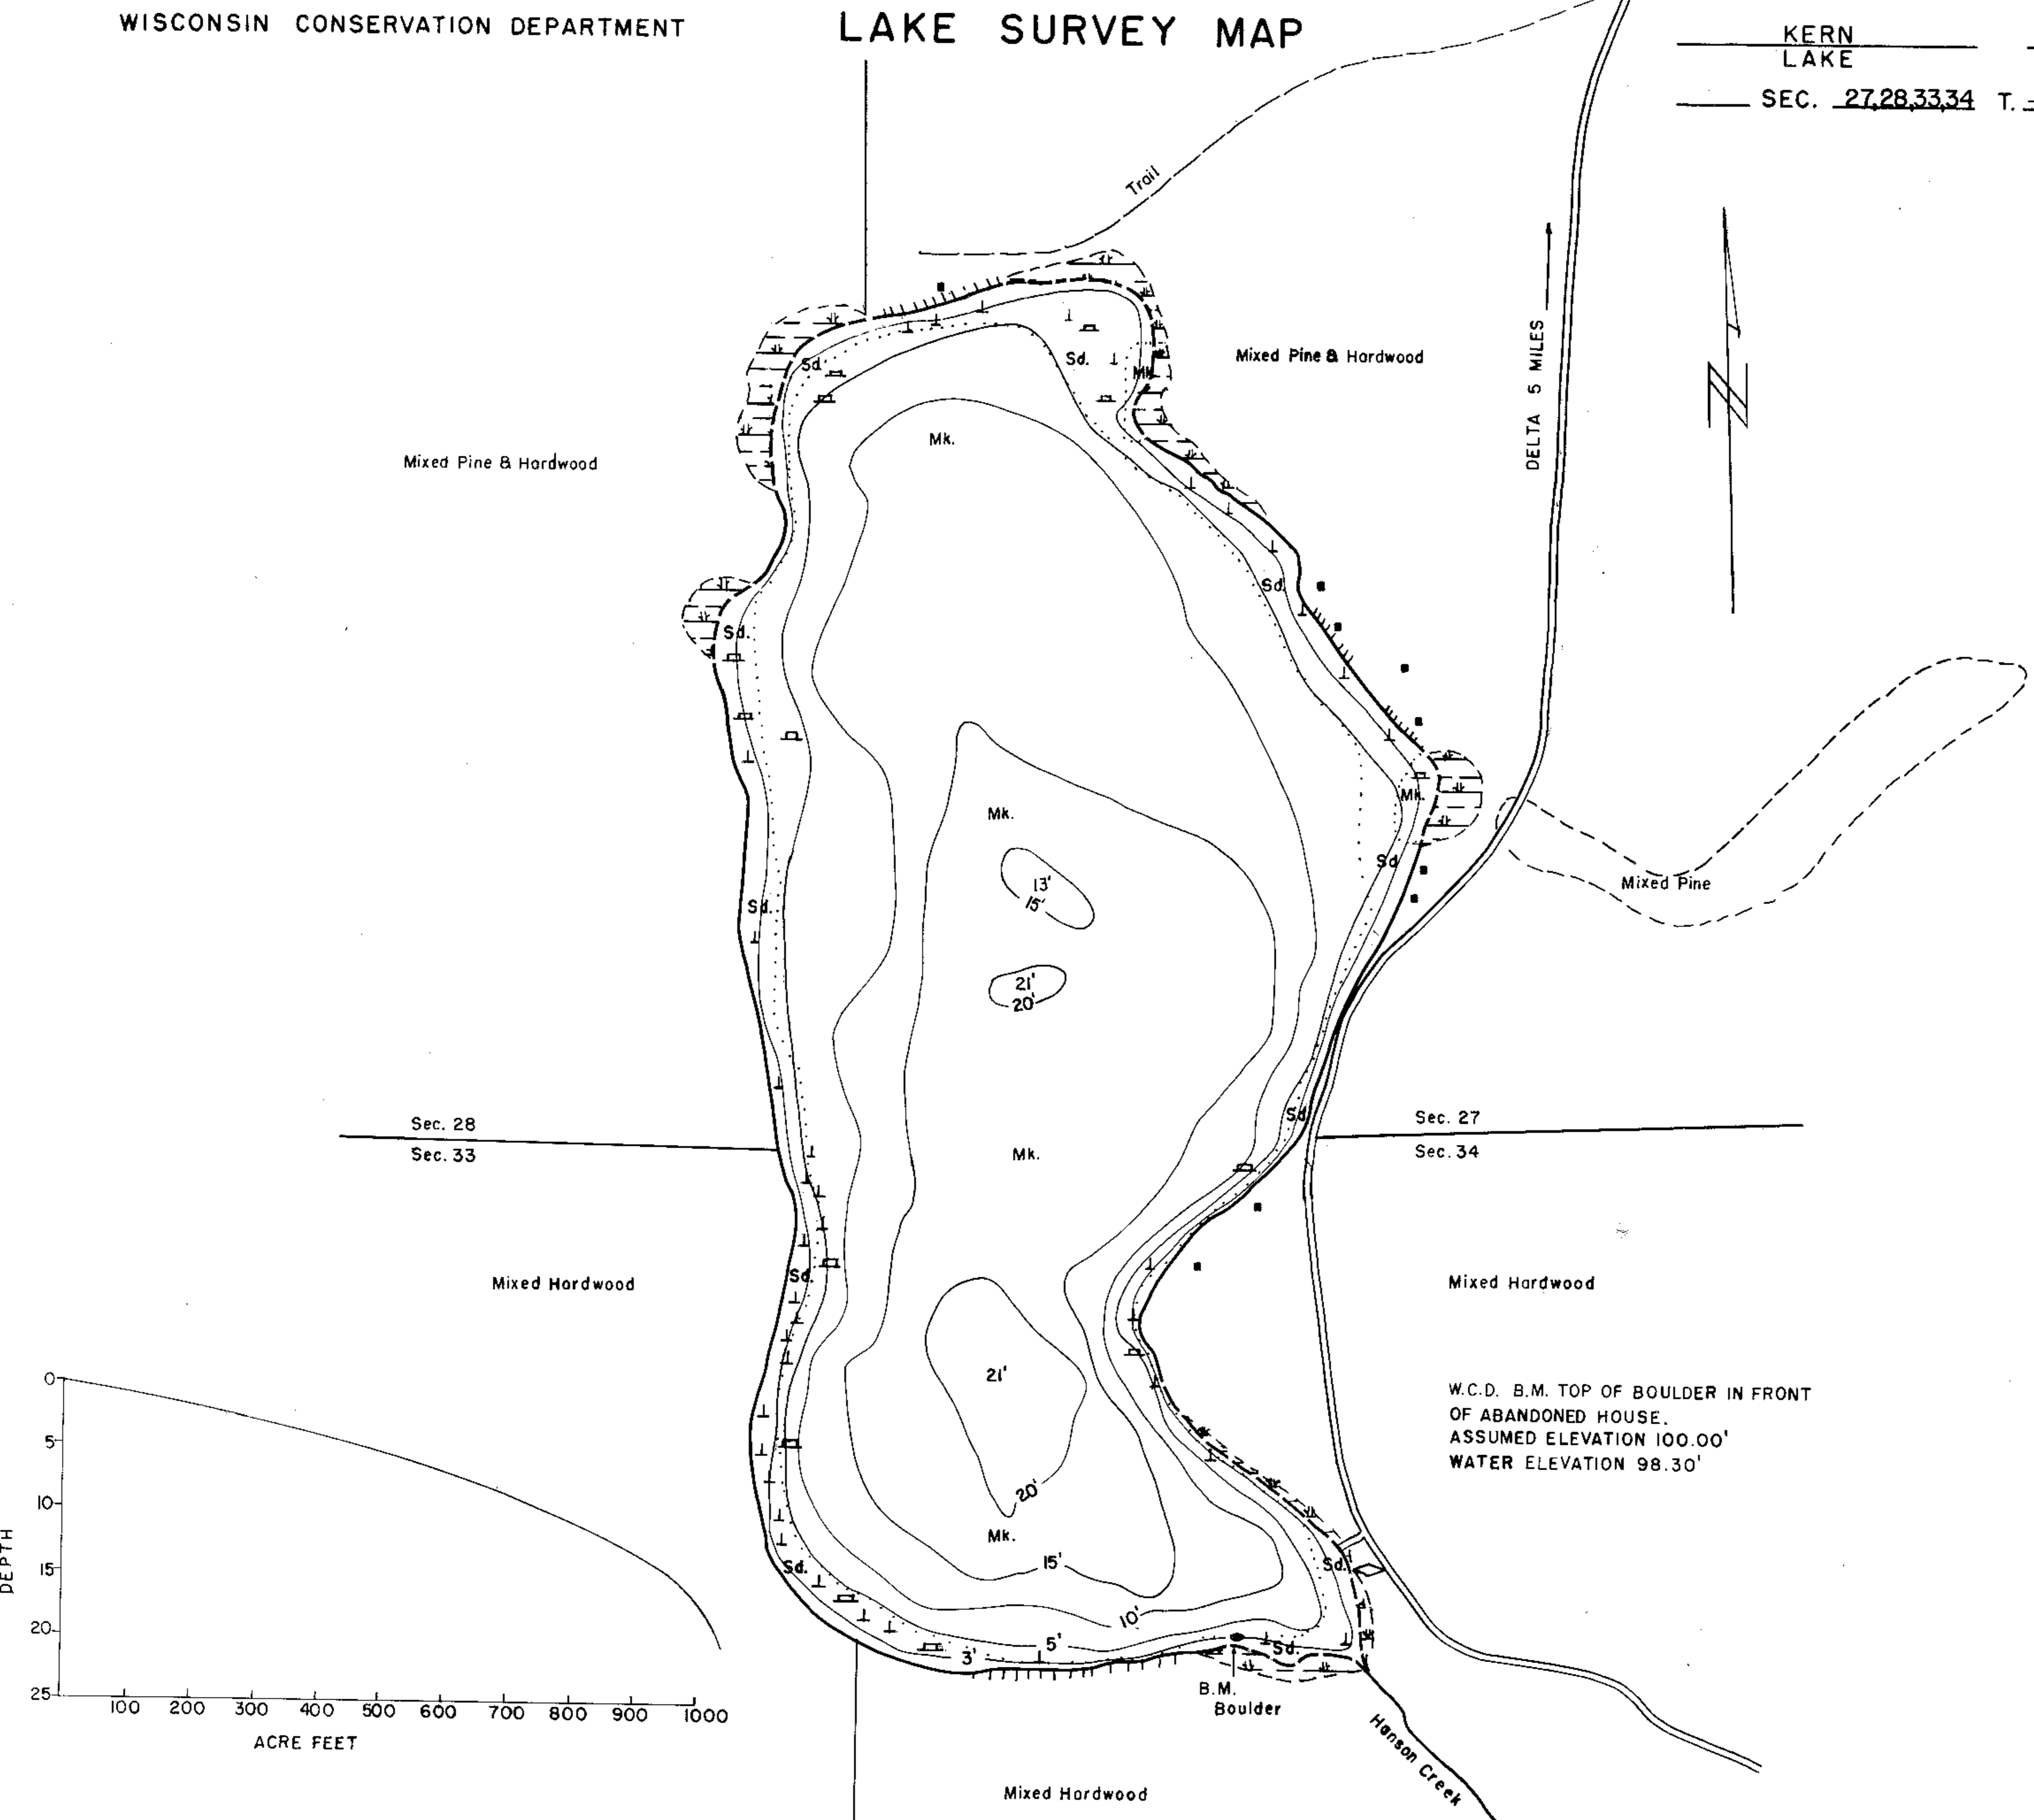
W.C.D. B.M. TOP OF BOULDER IN FRONT OF ABANDONED HOUSE. ASSUMED ELEVATION 100.00' WATER ELEVATION 98.30'

EQUIPMENT RECORDING SONAR MAPPED AUGUST 1965  
 MO. YR.
