EQUIPMENT RECORDING SONAR MAPPED JUNE 1968

Source: Wisconsin Department of Natural Resources 608-266-2621
Seitz Lake – Ashland County, Wisconsin DNR Lake Map
Date – Jun 1968 - Historical Lake Map - Not for Navigation
A Public Document - Please Identify the Source when using it.

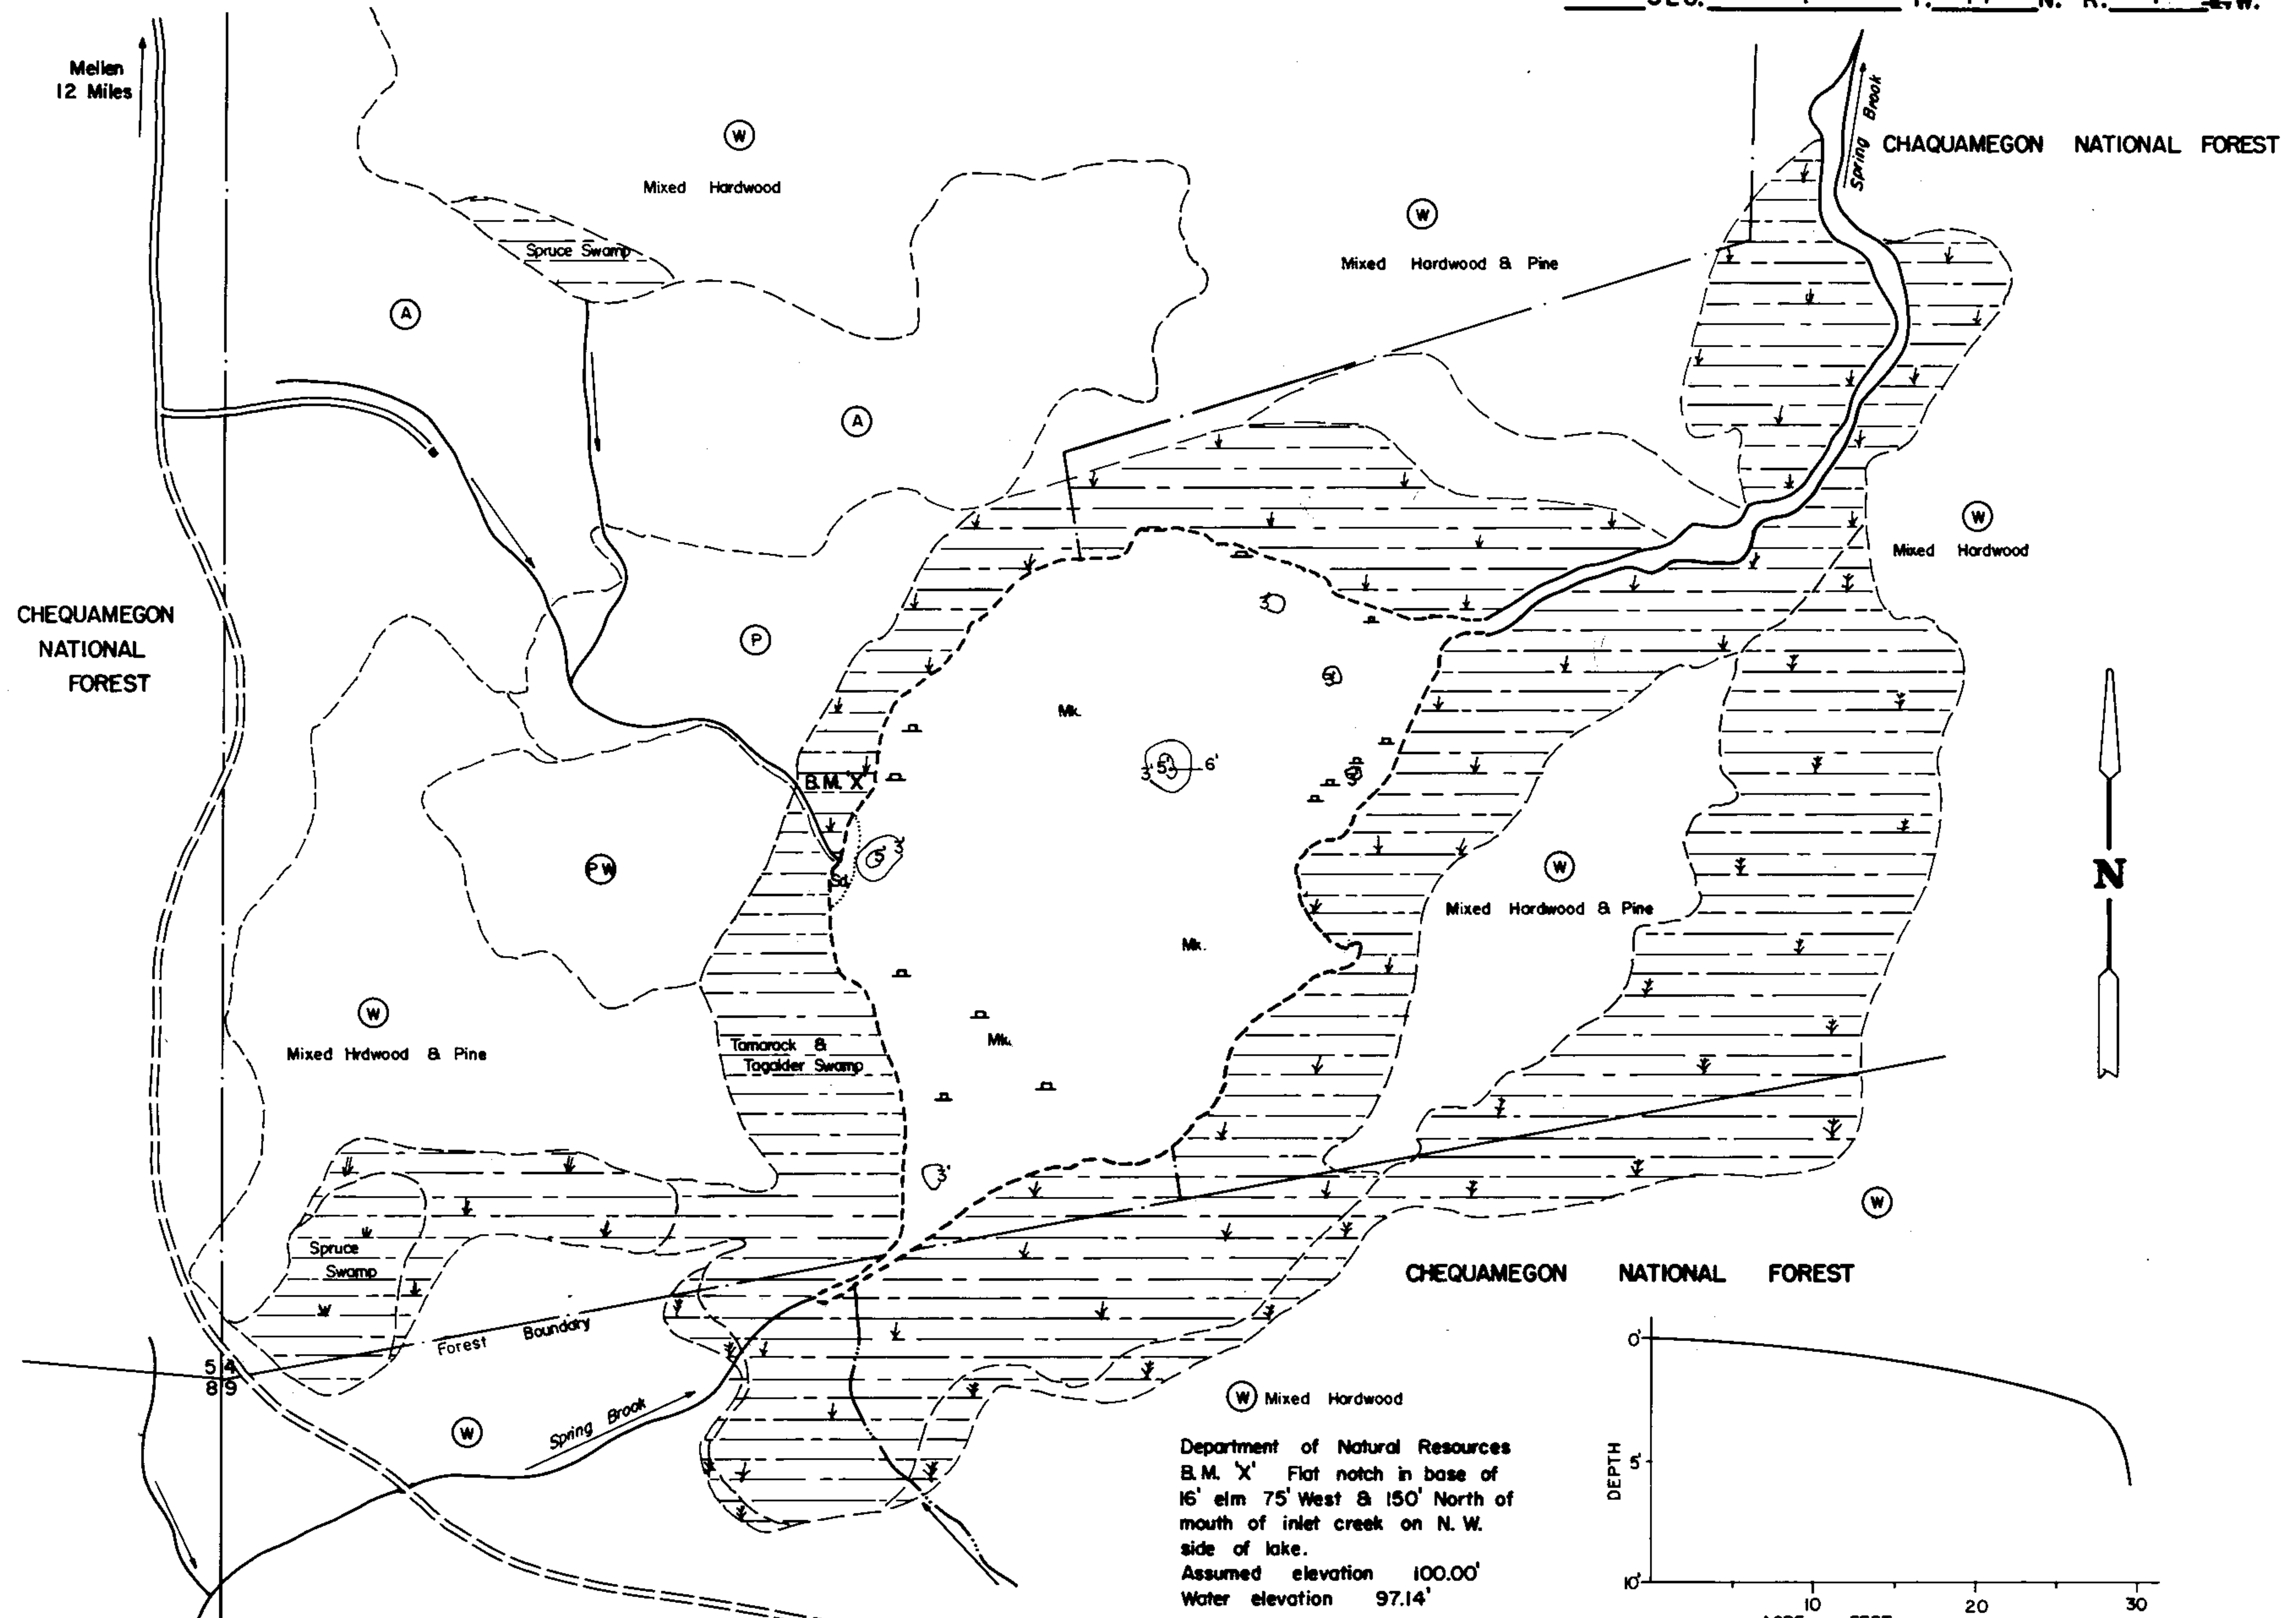
Department of Natural Resources
B.M. 'X' Flat notch in base of
16' elm 75' West & 150' North of
mouth of inlet creek on N.W.
side of lake.
Assumed elevation 100.00'
Water elevation 97.14'

WATER AREA 18.7 ACRES
UNDER 3 FT. 97.5 %
OVER 20 FT. 0 %
MAX. DEPTH 6 FEET.
TOTAL ALK. 59 P.P.M.
VOLUME 29.4 ACRE FT.
SHORELINE .78 MILES
