Source: Wisconsin Department of Natural Resources 608-266-2621  
Island Lake - Vilas County, Wisconsin DNR Lake Map  
Date – Aug 1973 - Historical Lake Map - Not for Navigation  
A Public Document - Please Identify the Source when using it.

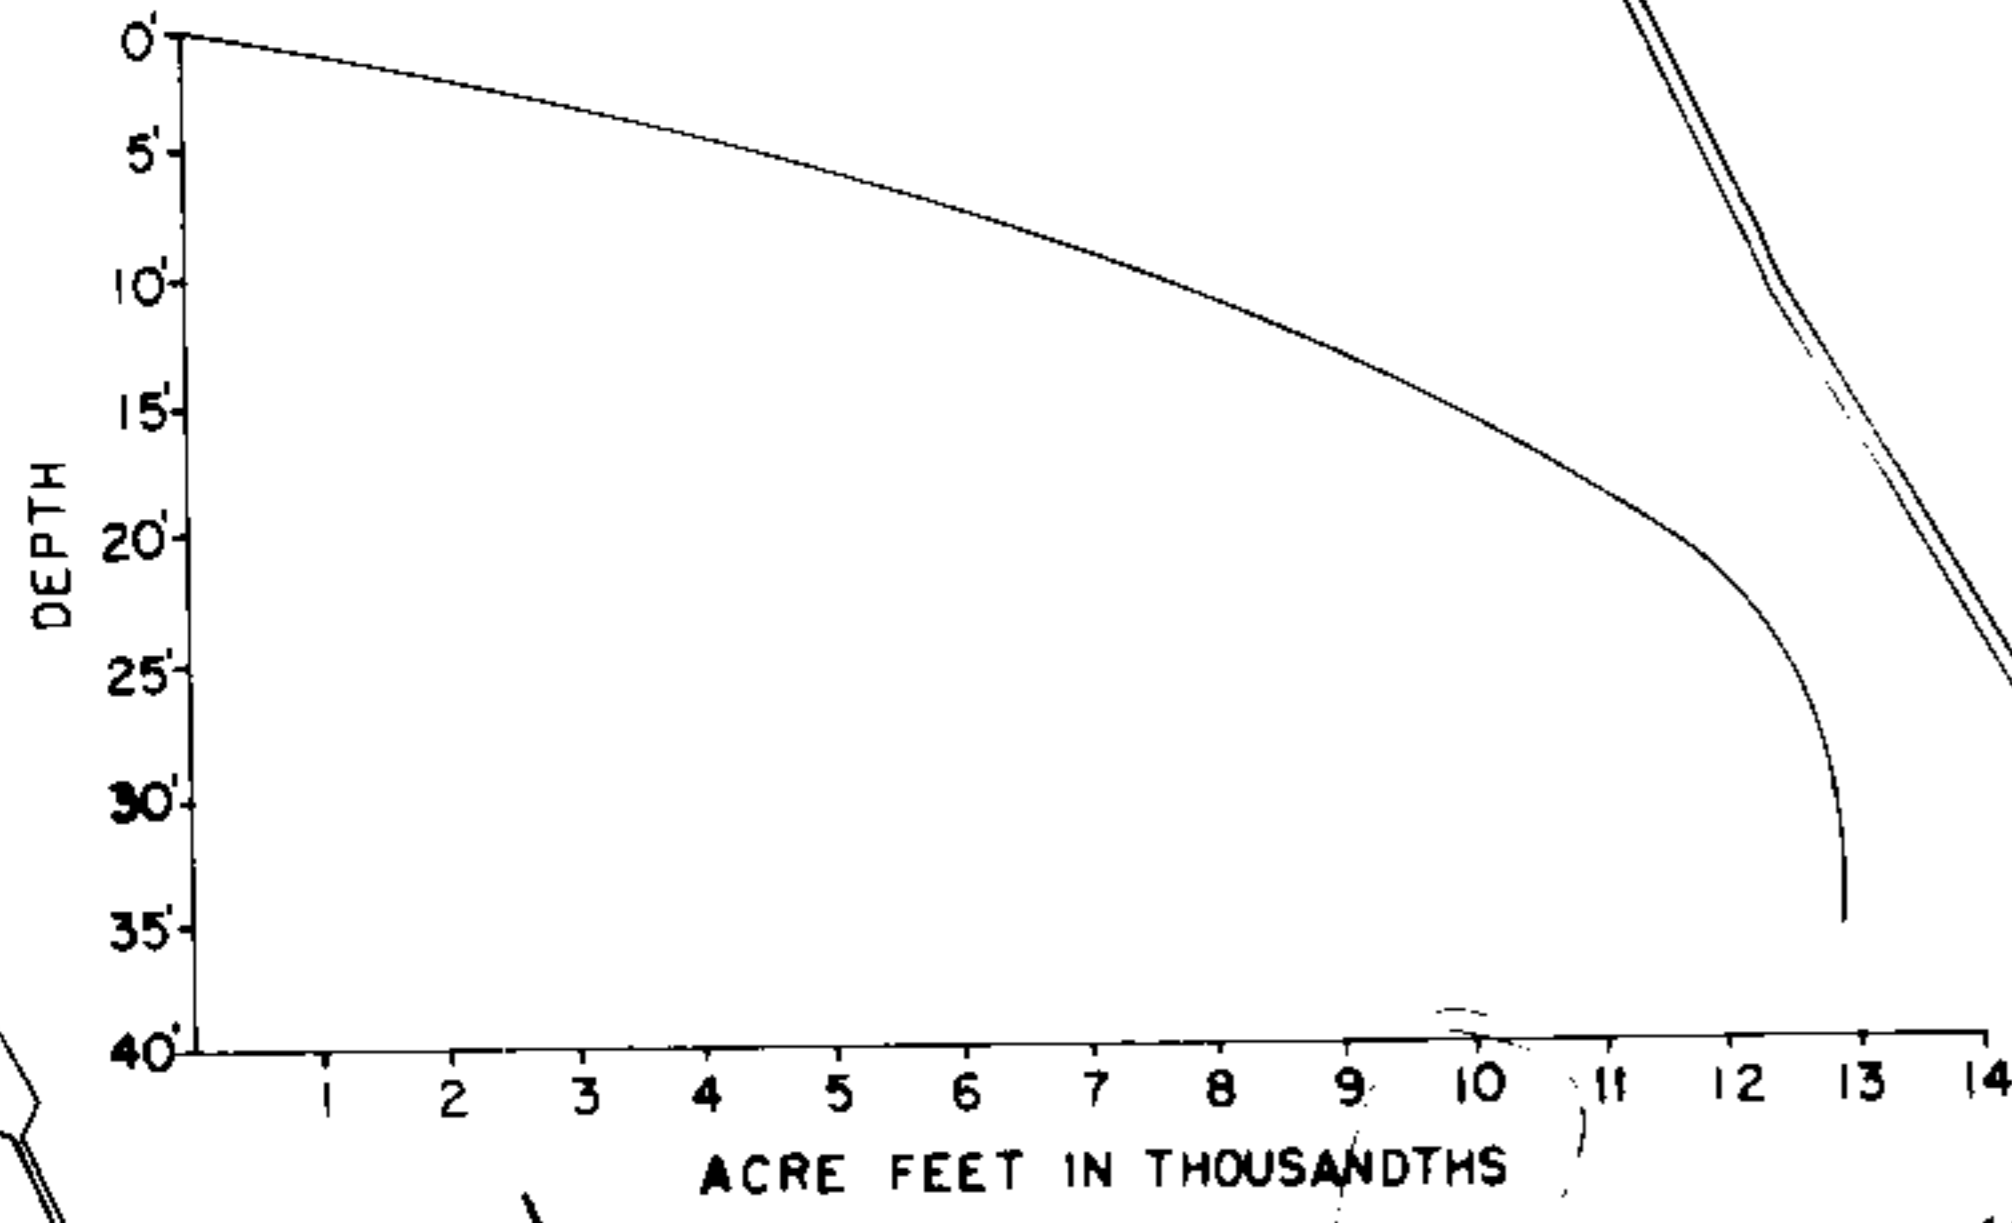
EQUIPMENT RECORDING SONAR MAPPED		AUG. 1973	
TOPOGRAPHIC SYMBOLS		LAKE BOTTOM SYMBOLS	
(B) Brush	Steep slope	P. Peat	B. Boulders
(PW) Partially wooded	----- Indefinite shoreline	Mk. Muck	⊙ Stumps & Snags
(W) Wooded	----- Marsh	C. Clay	⊙ Rock danger to navigation
(C) Cleared	----- Spring	M. Marl	T. Submergent vegetation
(P) Pastured	----- Intermittent stream	Sd. Sand	⊥ Emergent vegetation
(A) Agricultural	----- Permanent inlet	St. Silt	⊥ Floating vegetation
B.M. Bench Mark	----- Permanent outlet	Gr. Gravel	⊥ Brush shelters
■ Dwelling	----- Dam	R. Rubble	A State camp site
□ Resort	----- D.N.R. State owned land	Br. Bedrock	
□ Camp

Note:  
B.M. Located on Rest Lake Dam  
(Part of Manitowish Chain)  
Water Gauge Reading  
Assumed elevation=100.00'  
Water elevation=91.50'

WATER AREA 1,022.5 ACRES  
 UNDER 3 FT. 17 %  
 OVER 20 FT. 28 %  
 MAX. DEPTH 35' FEET.  
 TOTAL ALK. 37 P.P.M.  
 VOLUME 12,966.8 ACRE FT.  
 MAIN SHORELINE 14.36 MI.  
 ISLAND SHORELINE 2.39 MI.
