Report
Aquatic Plant Management Plan
Oxbow Lake
Presque Isle Town Lakes Committee

August 6, 2009

Project Number 004010-09001-0

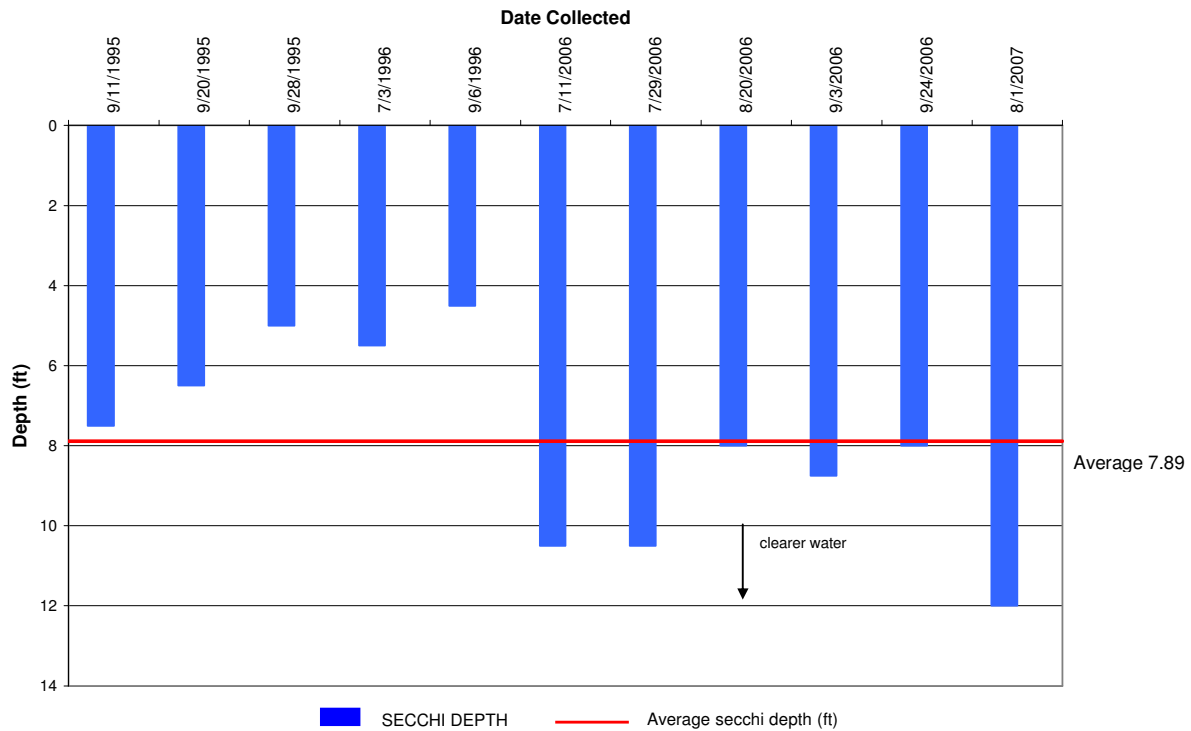
Oxbow Lake Secchi Readings

The historical water clarity average based on Secchi Disk readings is 7.89 feet (2.28 meters) and ranges from five to 12 feet. The Wisconsin average Secchi Disk reading in 2005 was 10 feet (Larry Bresina, The Secchi Disk and Our Eyes - Working Together To Measure Clarity of Our Lakes; internet document). The following graph illustrates the historical water clarity measurements on Oxbow Lake, data collected in 2007 is included.

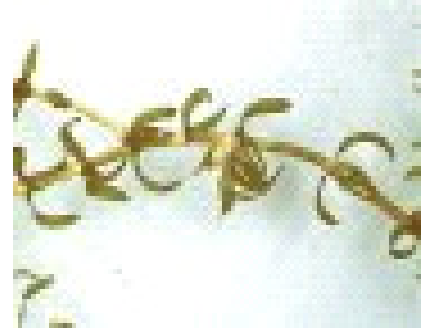
Elodea
Source: UW Herbarium Website

Elodea canadensis (elodea or common waterweed) is an abundant native plant species that is distributed statewide. It prefers soft substrate and water depths to 15 feet (Nichols, 1999). Elodea reproduces by seed and sprigs (USDA, 2002). The stems of elodea offer shelter and grazing to fish, but very dense elodea can interfere with fish movement. Elodea can be considered invasive at times and out-competes other more desirable plants. Note: *Elodea nuttalli* was also noted in the lake.

The most abundant aquatic plant identified during the aquatic plant survey was elodea or common waterweed (*Elodea canadensis*). It exhibited a 22.2% frequency of occurrence (percent of photic zone intercept points at which the taxa was detected). It was present at 48.8% of the sites with vegetation, and had a 24.2% relative frequency of occurrence. Table 4 includes the abundance statistics for each species.

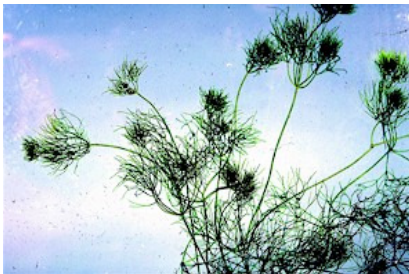
Nitella sp.
Source: UW Herbarium Website

Nitella (Nitella sp.), a macroalgae was the second most abundant species occurring at 13.3% of the photic zone. It was present at 29.3% of the sites with vegetation and had a 14.5% relative frequency of occurrence. .

Nitella sp. (nitella) is a type of macroalgae that looks like a vascular plant. Nitella is similar in appearance to muskgrass and is often found in similar habitats. However, Nitella can be distinguished from muskgrass by its smooth stems and smooth branches (Borman, et al., 1997).
