MEMORANDUM

DATE: November 28, 2001

TO: GILBERT LAKE ADVANCEMENT ASSOCIATION

SUBJECT: 2001 Aquatic plant survey and milfoil treatment results

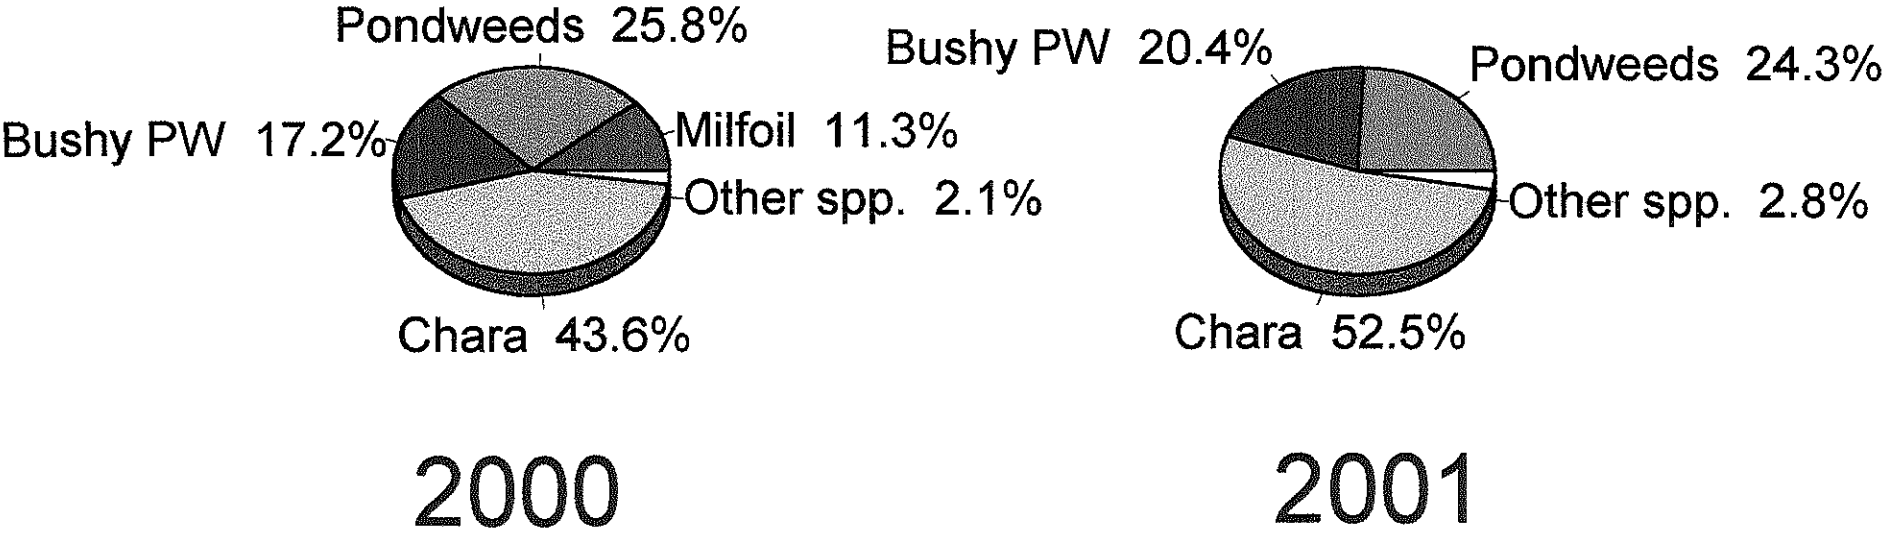
Figure 1. Relative abundance of aquatic plants found in Gilbert Lake

Analyses were done on these data sets (paired *t*-tests) to determine whether differences between the two years were statistically significant (Table 2). Significant differences were found for musk grass, which had a 13% increase, and for Eurasian watermilfoil, which was completely absent. Differences for all other plants were not considered statistically significant. The pie charts shown in Figure 1 reflect these changes in plant species composition.
