## **AMENDMENT**

### **Aquatic Plant Management Plan, Lake Waubesa, Lower Rock River Basin, Dane County Wisconsin**

**Approved by the Dane County Lakes and Watershed Commission on April 10, 2014 and by the  
Wisconsin Department of Natural Resources on March 27, 2014**

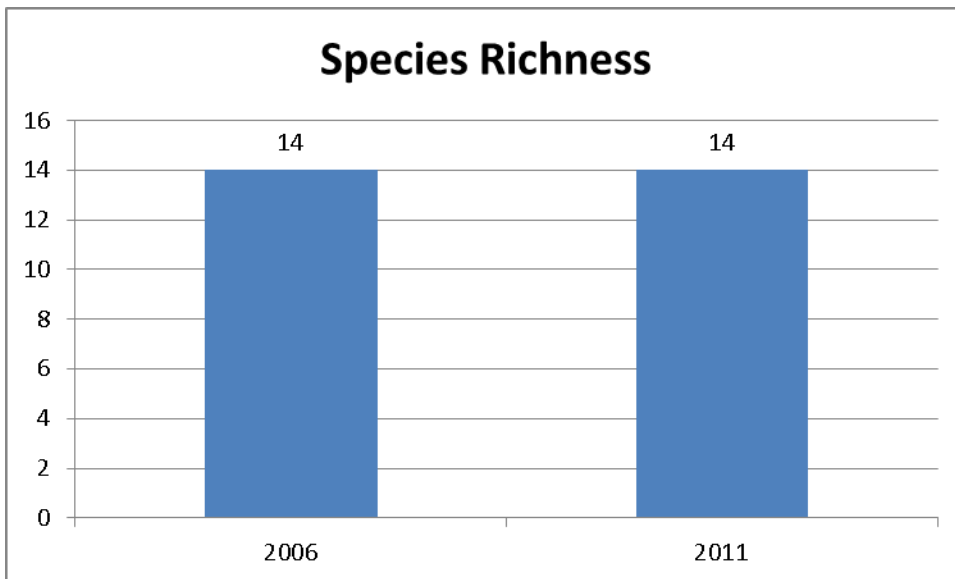
**Figure 1. Species richness – Lake Waubesa 2006 - 2011**

Table 1 below indicates species present during the 2011 survey, and Figure 1 indicates species richness from 2006-2011.

Species richness is a count of the total number of different plant species found in a lake. Generally, the better the water quality the higher the species richness count.

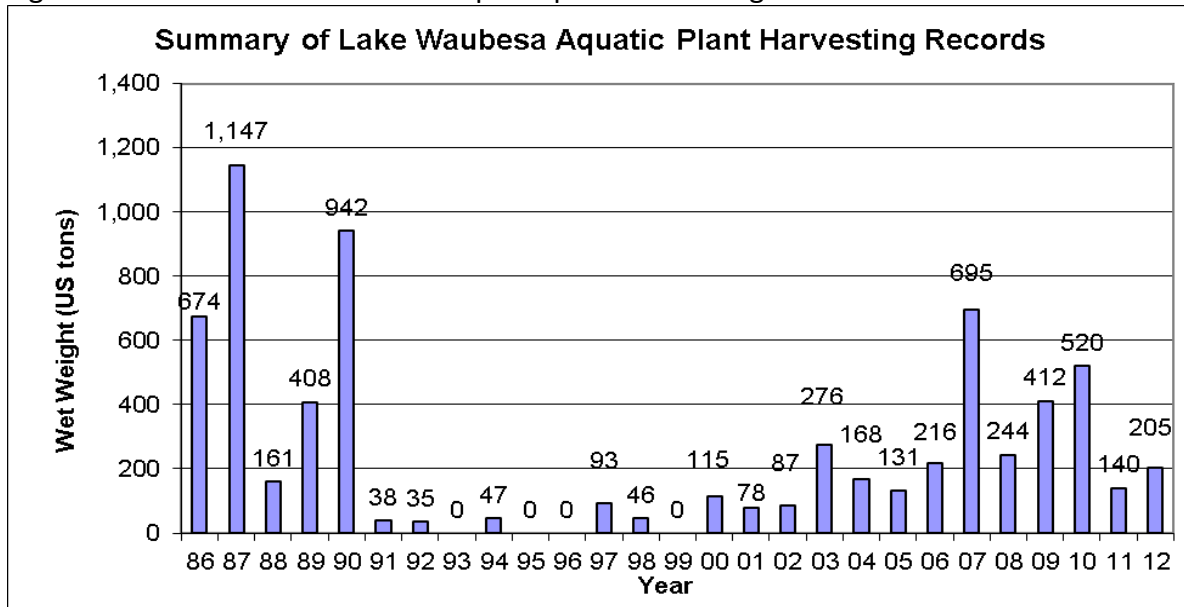
Figure 3. Historical Lake Waubesa aquatic plant harvesting records

Figure 3 summarizes Dane County’s mechanical harvesting operations in Lake Waubesa since 1986. Figure 4 indicates chemical treatments of aquatic plants by private entities.

Please note that, starting in 2006, Dane County changed the way it records total harvested plant weight. In the 2011 aquatic plant management plan for Lake Waubesa, one truck load of harvested plants was equated with one ton. Beginning in 2006, Dane County uses a formula to more precisely estimate the wet weight of one truck load, expressed in U.S. tons. What may

seem to be a dramatic increase in harvested plant amounts compared to 2005 and earlier is likely mostly due to this change in estimating harvested weights.

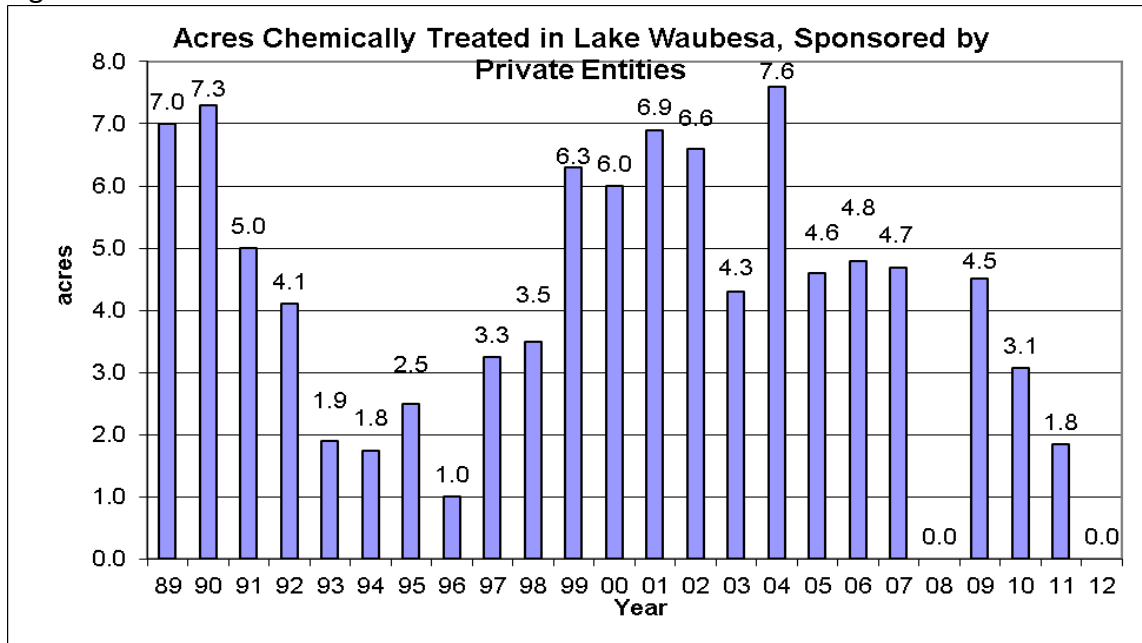
Figure 4. Historical Lake Waubesa chemical treatment records

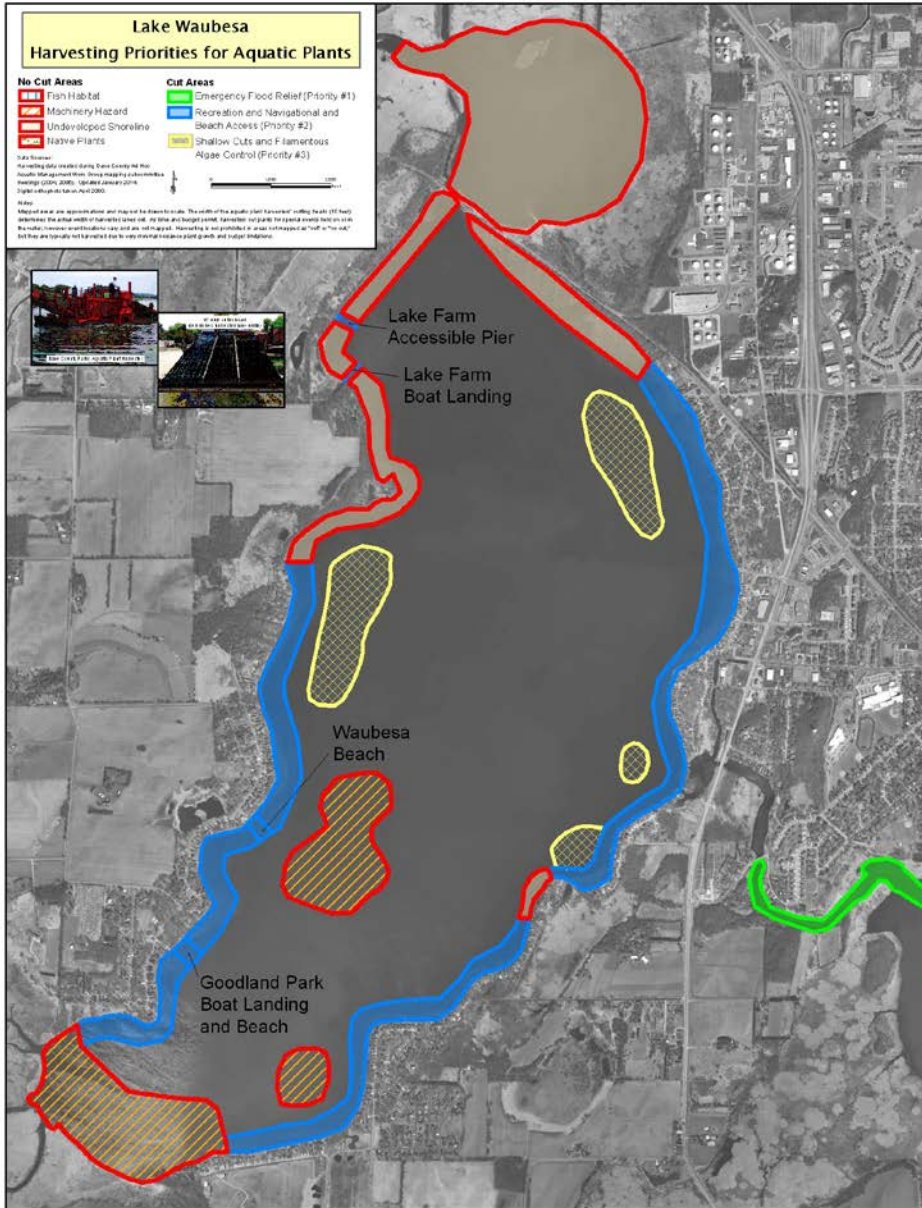
Figure 6. Lake Waubesa harvesting priorities

Figure 6 is the proposed updated mechanical harvesting priority map for Lake Waubesa. Changes from the 2011 map are the addition of “experimental shallow cuts and filamentous algae” cuts on a reef along the west shore, on the northeast shore, and near Babcock Park and extending south. Additional background on harvesting priorities is found in the Lake Management Operations Manual and posted on the Office of Lakes and Watersheds website ([www.danewaters.com](http://www.danewaters.com)). Annual training and daily supervision of harvester operators reinforce that plants should be harvested only from these planned areas, unless a variance from the plan has been approved by Wisconsin DNR. Actual effort is dictated based on plant conditions, as evaluated and reported by Dane County’s Plant Scout.
