Angelo Project

ROCK INFILTRATION PIT: SANDY HOOK COURT

BLMD-054

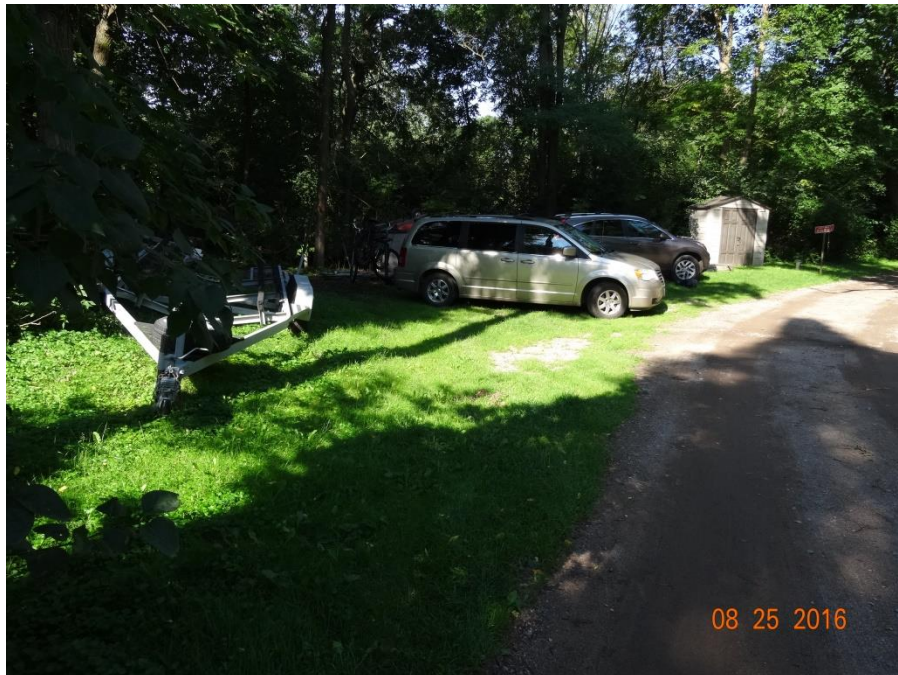
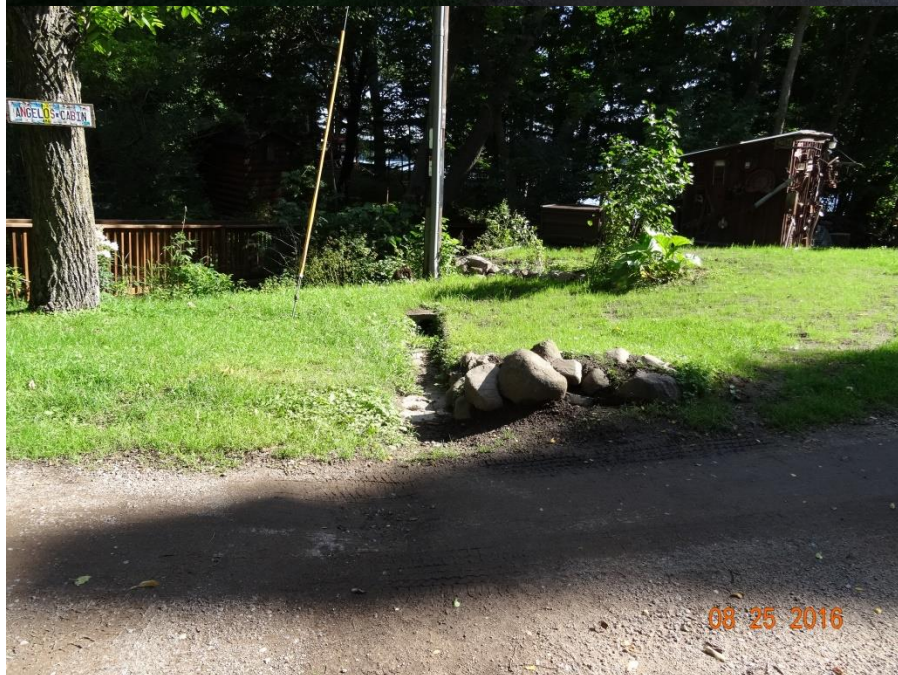
BEFORE: Runoff travels down gravel road, crosses at Angelo property and flows in a channel to Bone Lake.

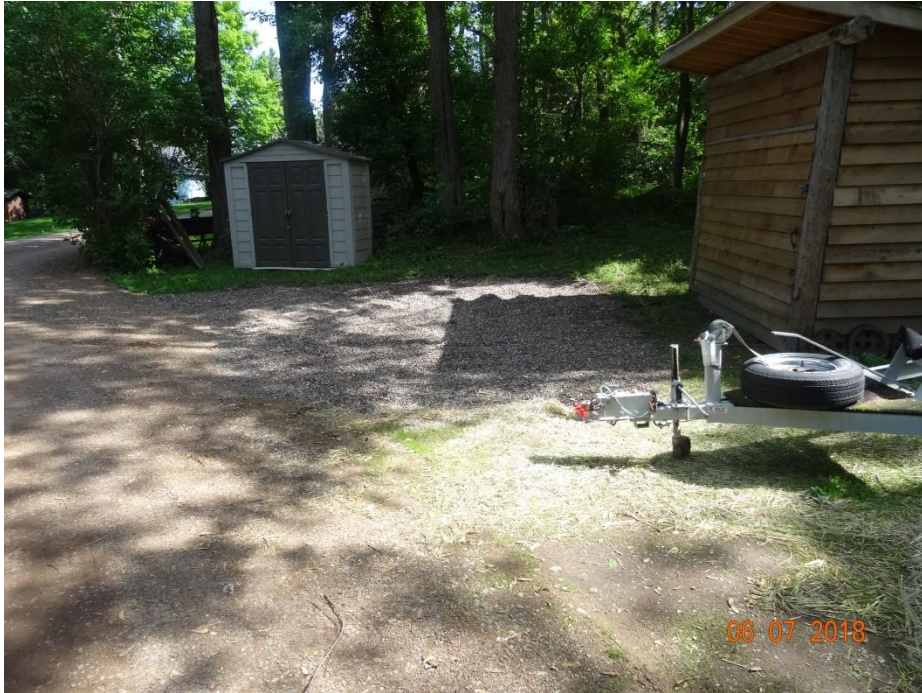
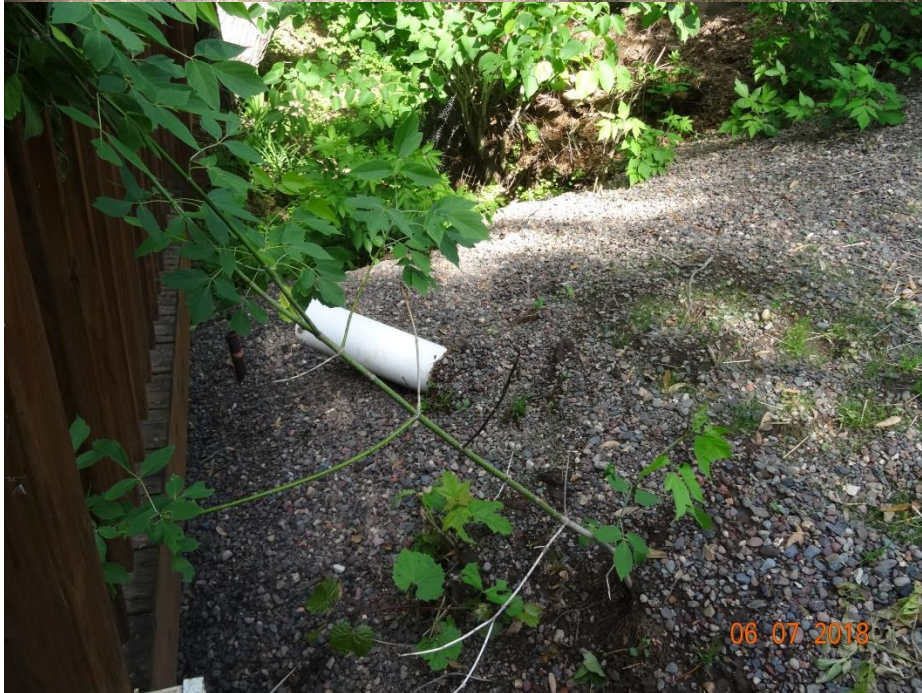
AFTER: Runoff flows to rock infiltration pit with PVC overflow. Capacity of pit and infiltration to substrate allows little discharge to the channel to Bone Lake.
