LAKE BELLE VIEW / SUGAR RIVER RESTORATION PROJECT SUMMARY
JULY 2011

PROJECT SETTING

DESCRIPTION OF PROJECT

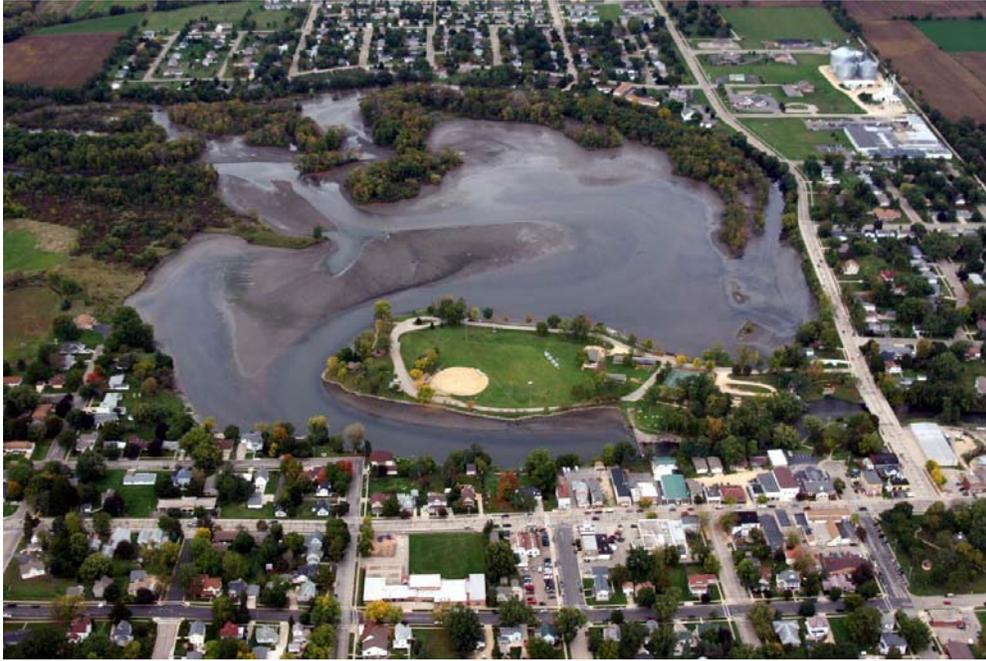
Photo 1: Lake Belle View Prior to Construction (2010 Drawdown)

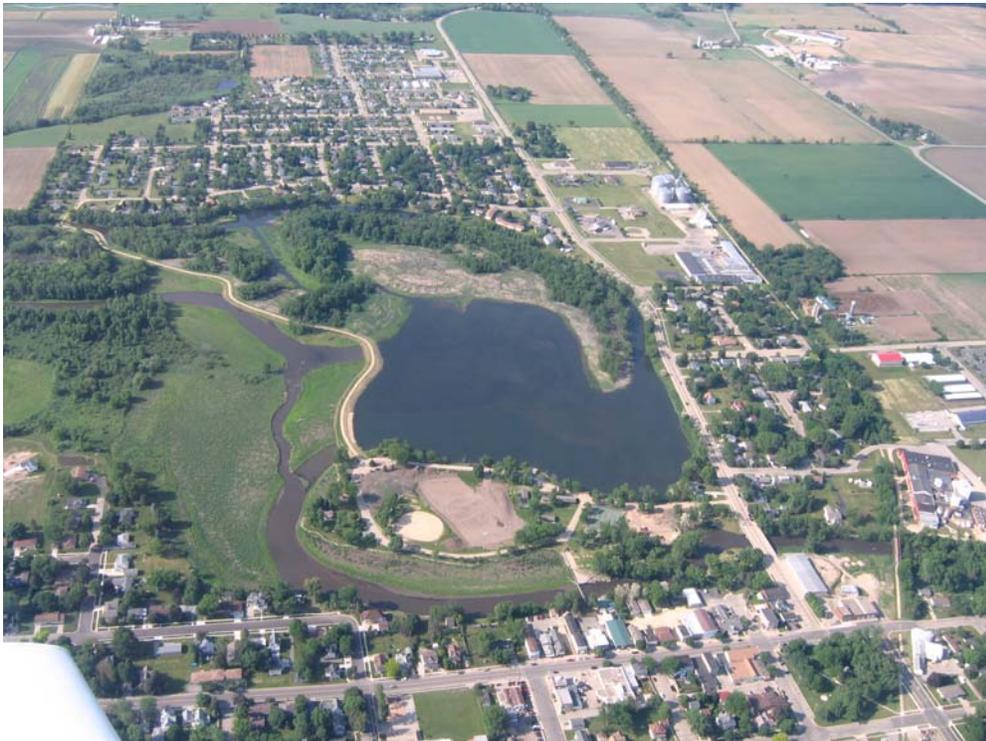
- Water Quality Improvement - Significant qualitative improvement in the water quality of the restored portion of the lake has been observed (Photos 2 & 4). Photo2 clearly indicates significant improvement in water clarity when comparing the Sugar River on the west side of the separation berm to the restored portion of Lake Belle View on the east side of the separation berm. Quantitative measurements of water quality improvement will be collected starting this fall and will be ongoing for at least the next five years per permit requirements.

Photo 2: Lake Belle View After Construction of Separation Berm, Lake Deepening, and Habitat Earthwork (June 2011)

lake, and discharges over the existing dam. Berm and landscaping construction is complete. This project is now being monitored for proper vegetation restoration. Water clarity has been greatly improved as noted on the before and after photos included at the end of this report. Note the high sediment load within the Sugar River and the visibility of the bottom in the newly restored portion of Lake Belle View.

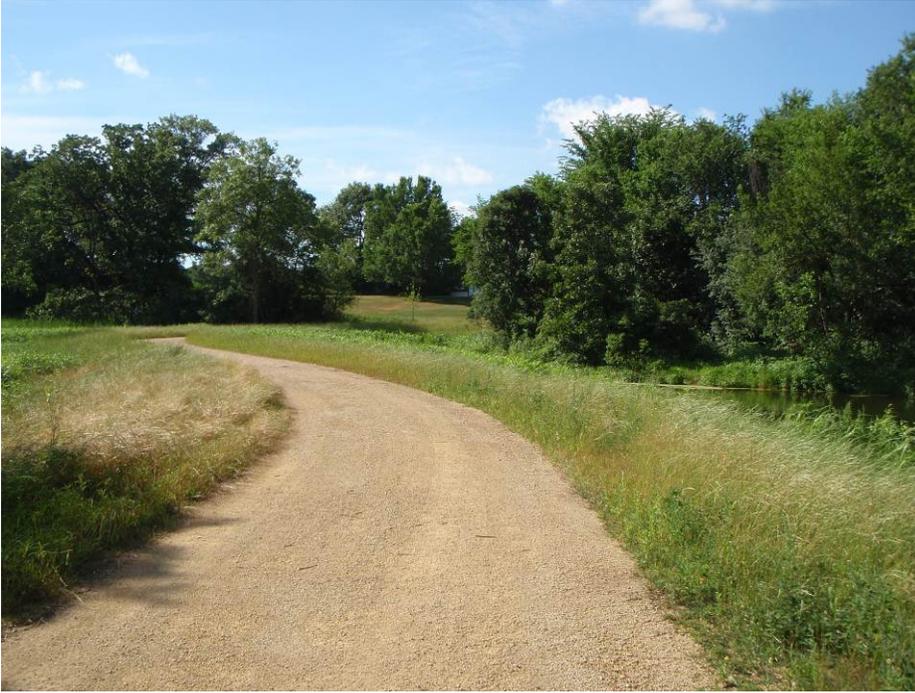
Photo 3: Separation Berm and Walking Path (June 2011)

To prevent any floodplain increases the berm is designed to overtop at specially constructed overflow sections to allow events that are greater than the 25-year flood to pass into the lake. The general construction of the berm allows for portage and passage of small personal watercraft between the lake and river system.

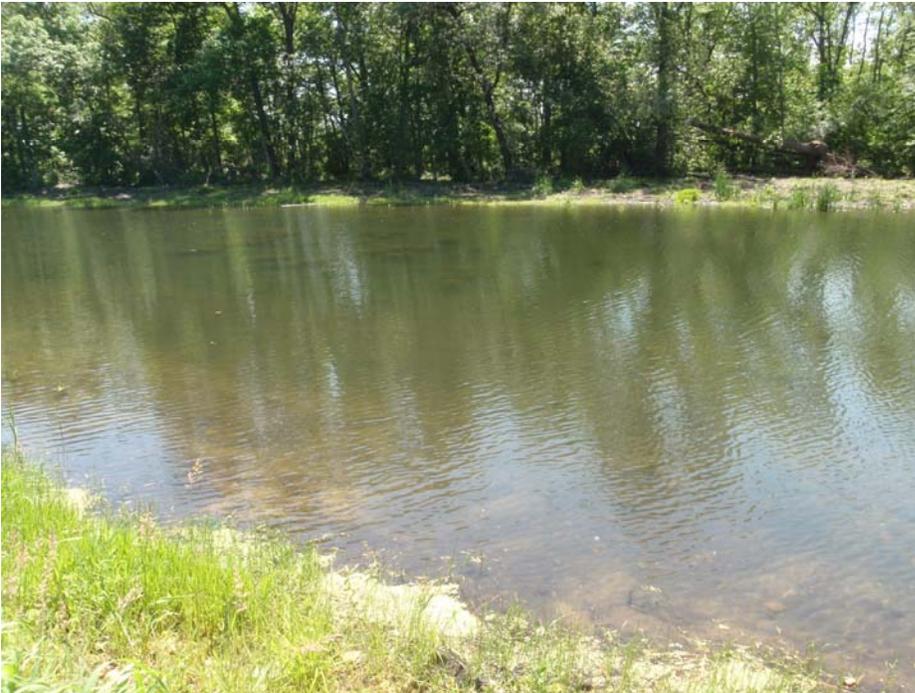
Photo 4: North Channel Portion of Lake Belle View Water Depths ~4 feet - Note the Water Clarity (June 2011)
